**Geophysical, Archaeological, and Architectural Investigations at
101 Ranch Historic District,
Ponca City vicinity, Kay County, Oklahoma**

Prepared by
URS Corporation
Dallas, Texas

Contract Number: EC-1217H
Task Order Number: 009
URS Project Number: 37974201

September 2012

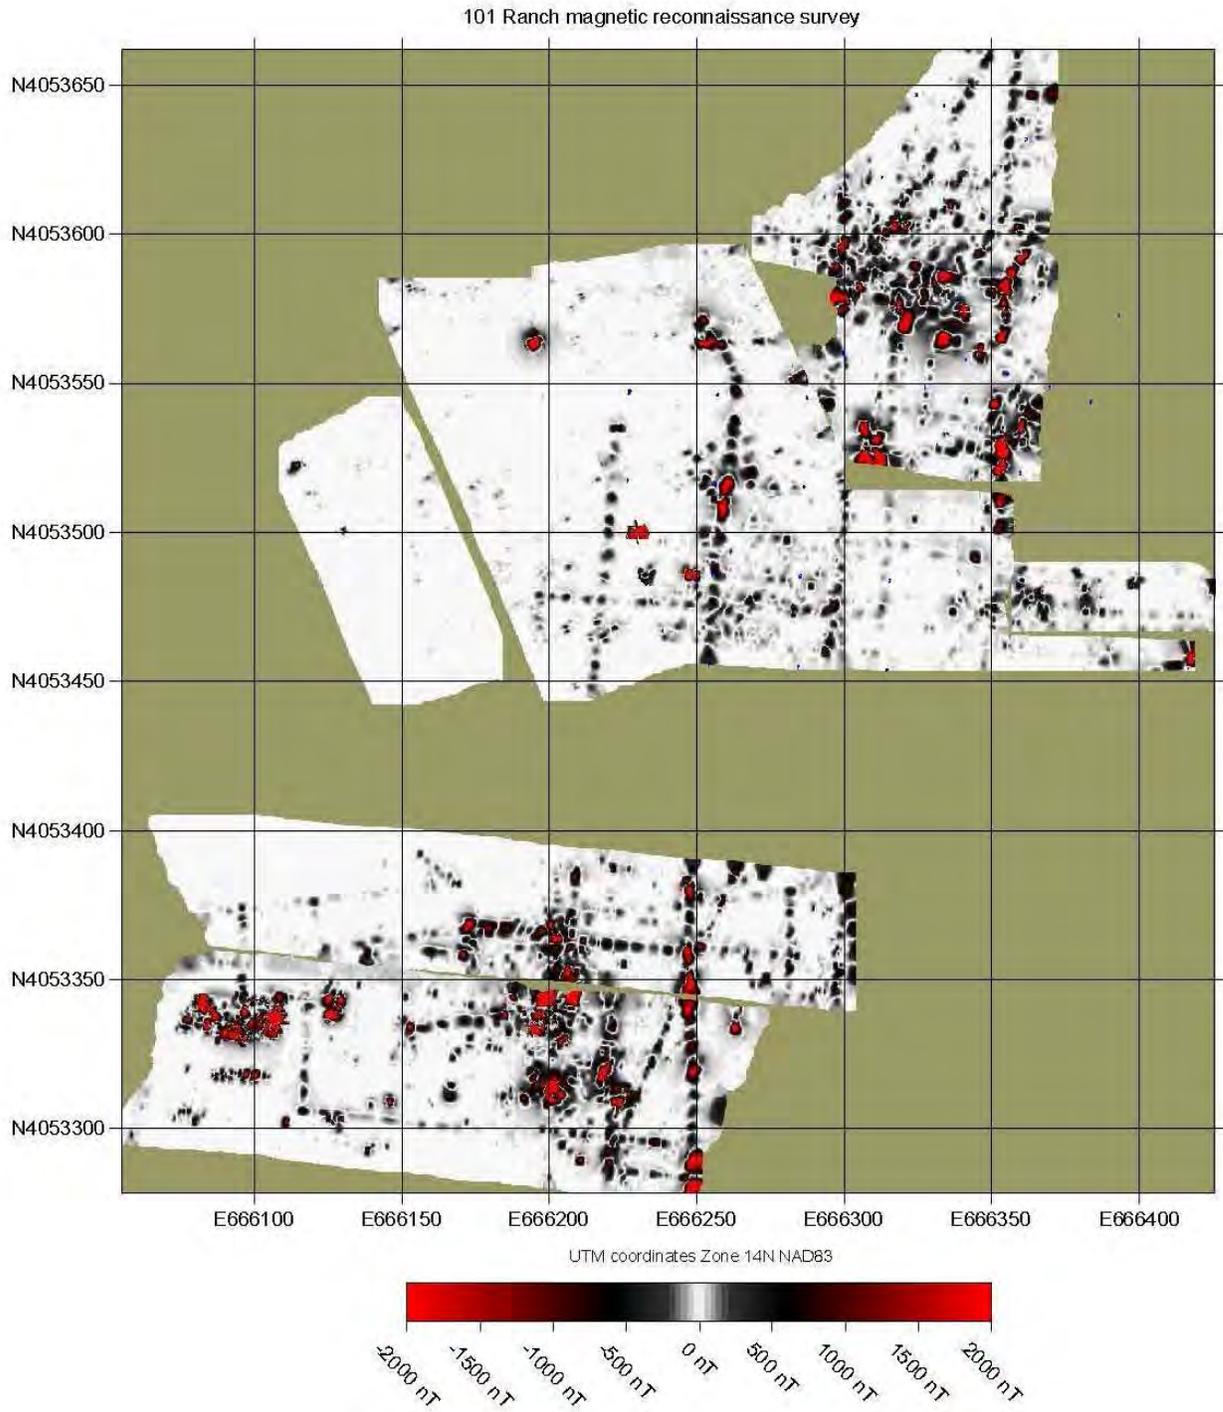
Figure 67: Magnetic survey results (high contrast): The natural magnetic background is relatively uniform, expressed as values near zero (medium gray) in this plot. Positive and negative deviations from the mean can generally be assumed to be cultural. In general this dataset is dominated by ferrous metal, which occurs in great quantities. Ferrous metal objects are typically expressed as bipolar anomalies - having both positive and negative poles - which are pervasive throughout much of the area surveyed. Ferrous metal (iron and steel) is very highly magnetic, and can be assumed to be the source of most of the variance in the colored range of the scale, although fired brick architecture is another possible source. Weaker anomalies in the white-gray-black range of the scale may be caused by smaller masses of metal, especially if the anomalies are spatially small. If these weak anomalies are larger and more diffuse, they may be caused by organic enrichment, soil disturbance, non-reinforced concrete, or a variety of cultural and natural phenomena. This type of subtle variance is difficult to distinguish in this dataset, which is dominated by very high amplitude “clutter” caused by ferrous metal. Another source of magnetic anomalies can be burned materials, including rock and soil. Anomalies caused by burning can vary in strength from very weak to relatively strong.

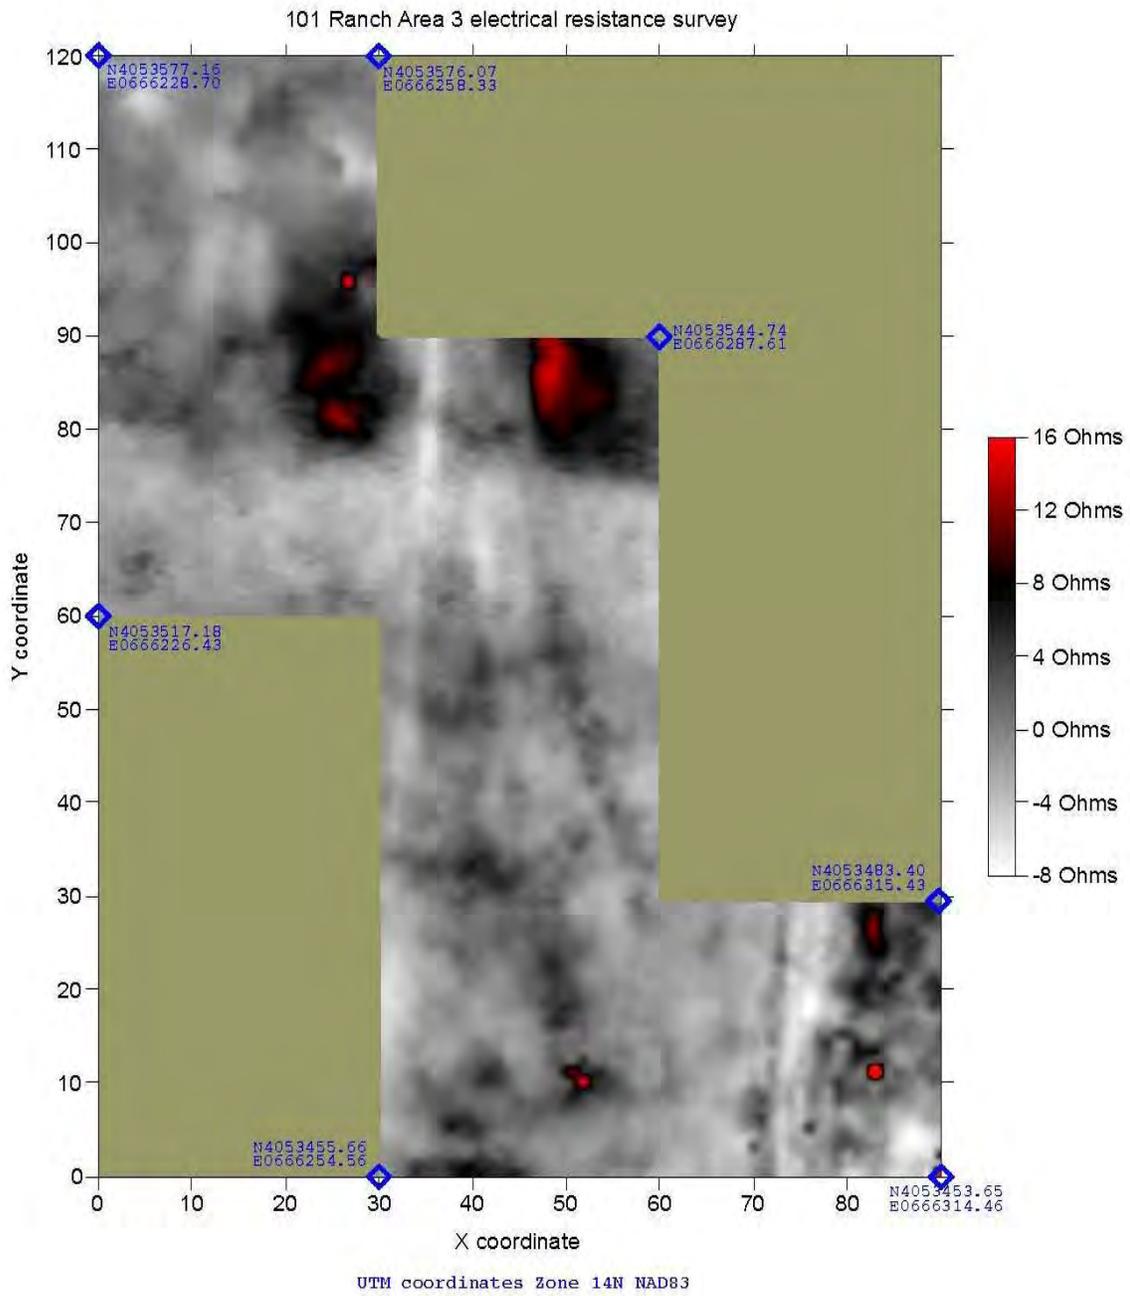
Figure 74: Electrical resistance survey, Area 3.

The geophysical survey did not detect evidence of intact foundations in the locations of the horse barns, mule barn, and round barn, and, in fact, the data indicate those foundations have likely been removed. However, the data also indicate the potential for subsurface features or deposits in other areas. In particular, the locations of worker housing between the White House remains and the silos, as well as the location of the first dining hall and ranch store exhibit a potential for subsurface features or cultural deposits. If these anomalies represent features or archaeological deposits associated with either worker housing or the original dining hall and store, they could be significant. Other areas of potential interest occur behind the ranch store remains in the area of the first horse barn and in the areas of the meat packing plant and hog barns. The resistivity data indicate potential features in Area 2, which is north of the ranch store remains. While historic photographs from the ranch do not indicate any structure at this location, the anomalies should be investigated prior to any ground disturbance. The other interesting finding from the geophysical data is the detection of the underground utilities that served the ranch headquarters complex.

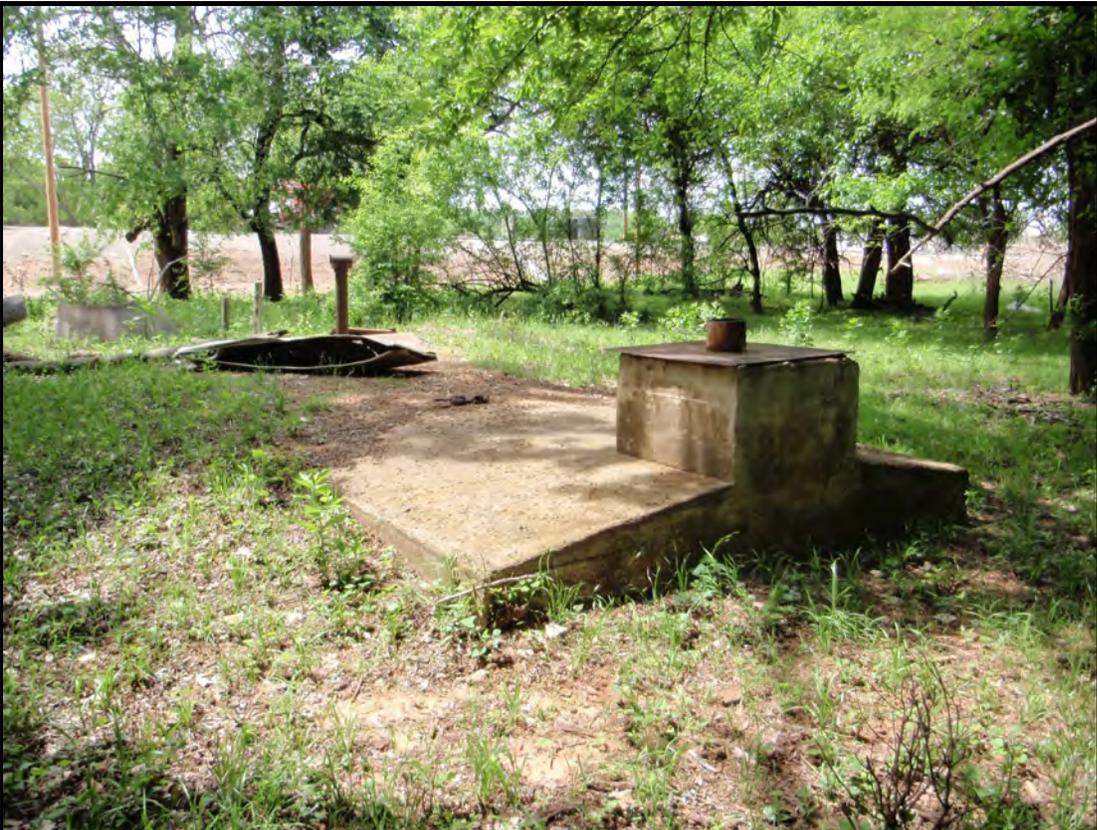
Figure 87	Date: 2011

Direction Photo Taken: east		
Description: Cellar found near the school house footers.

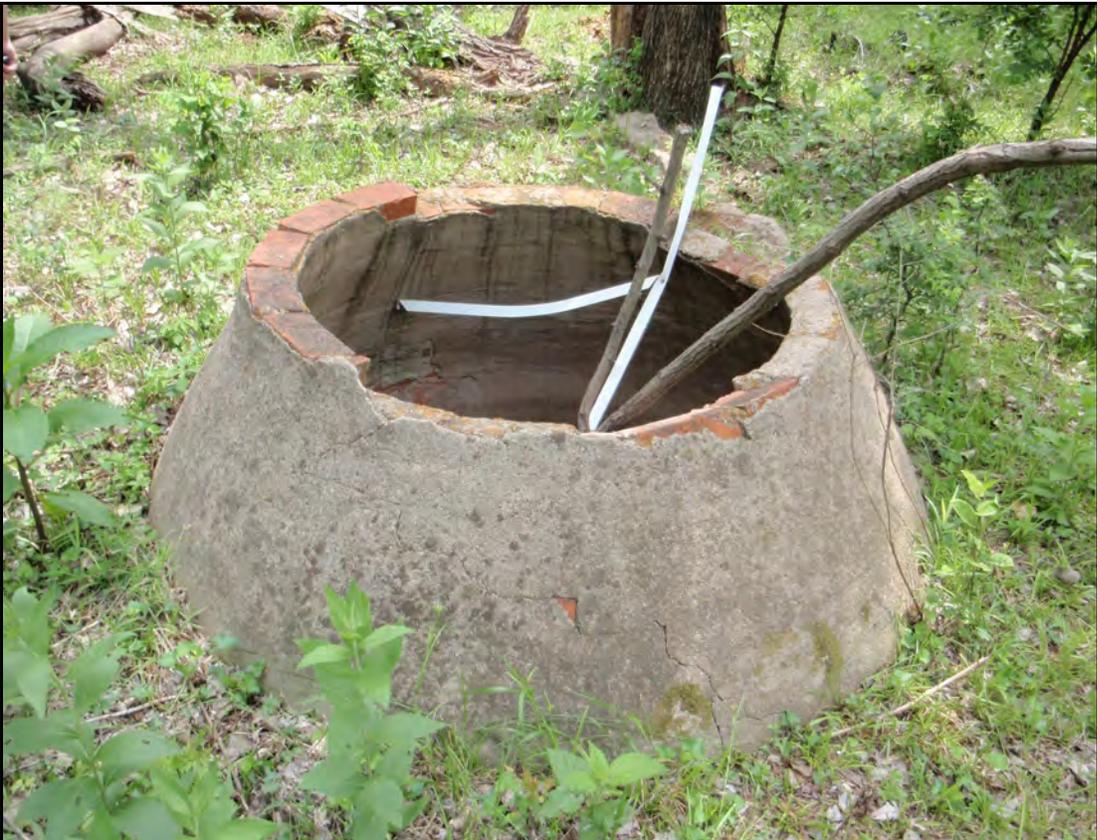
Figure 88	Date: 2011

Direction Photo Taken: east		
Description: Cistern found near the school house footers.

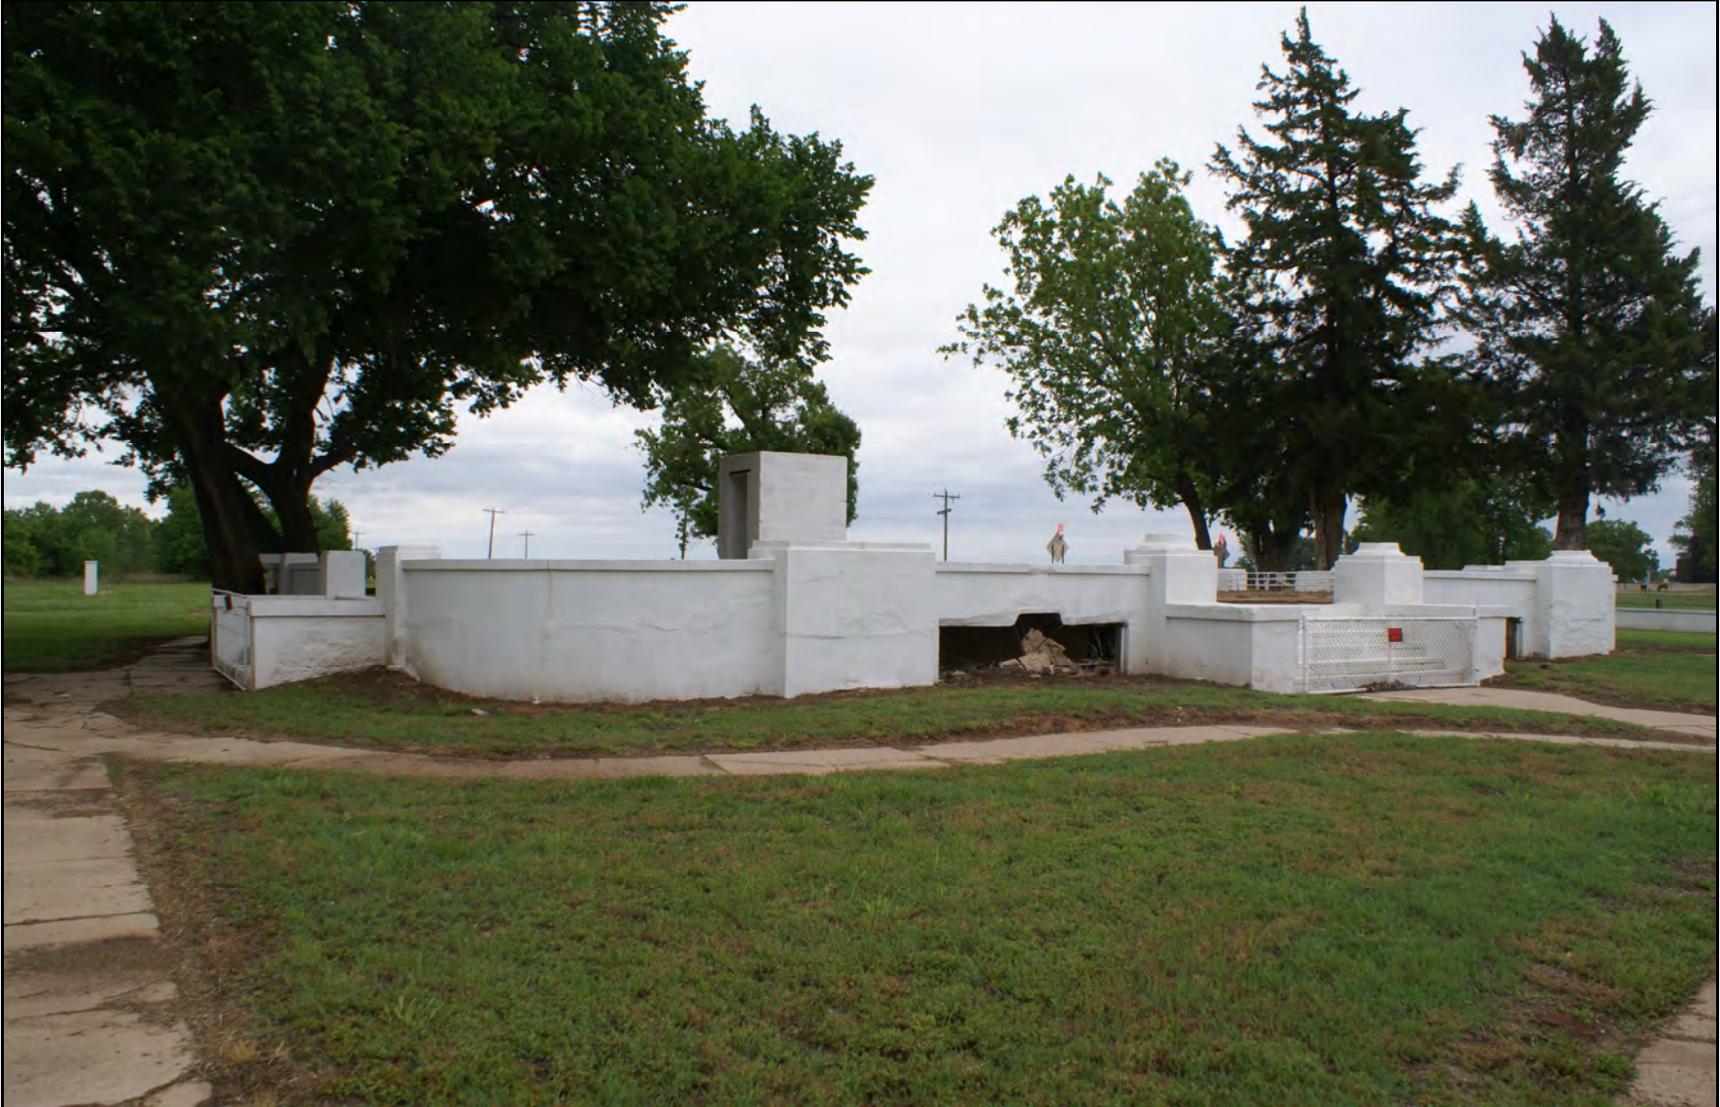
Figure A79

Oblique view of south side of existing White House foundation.

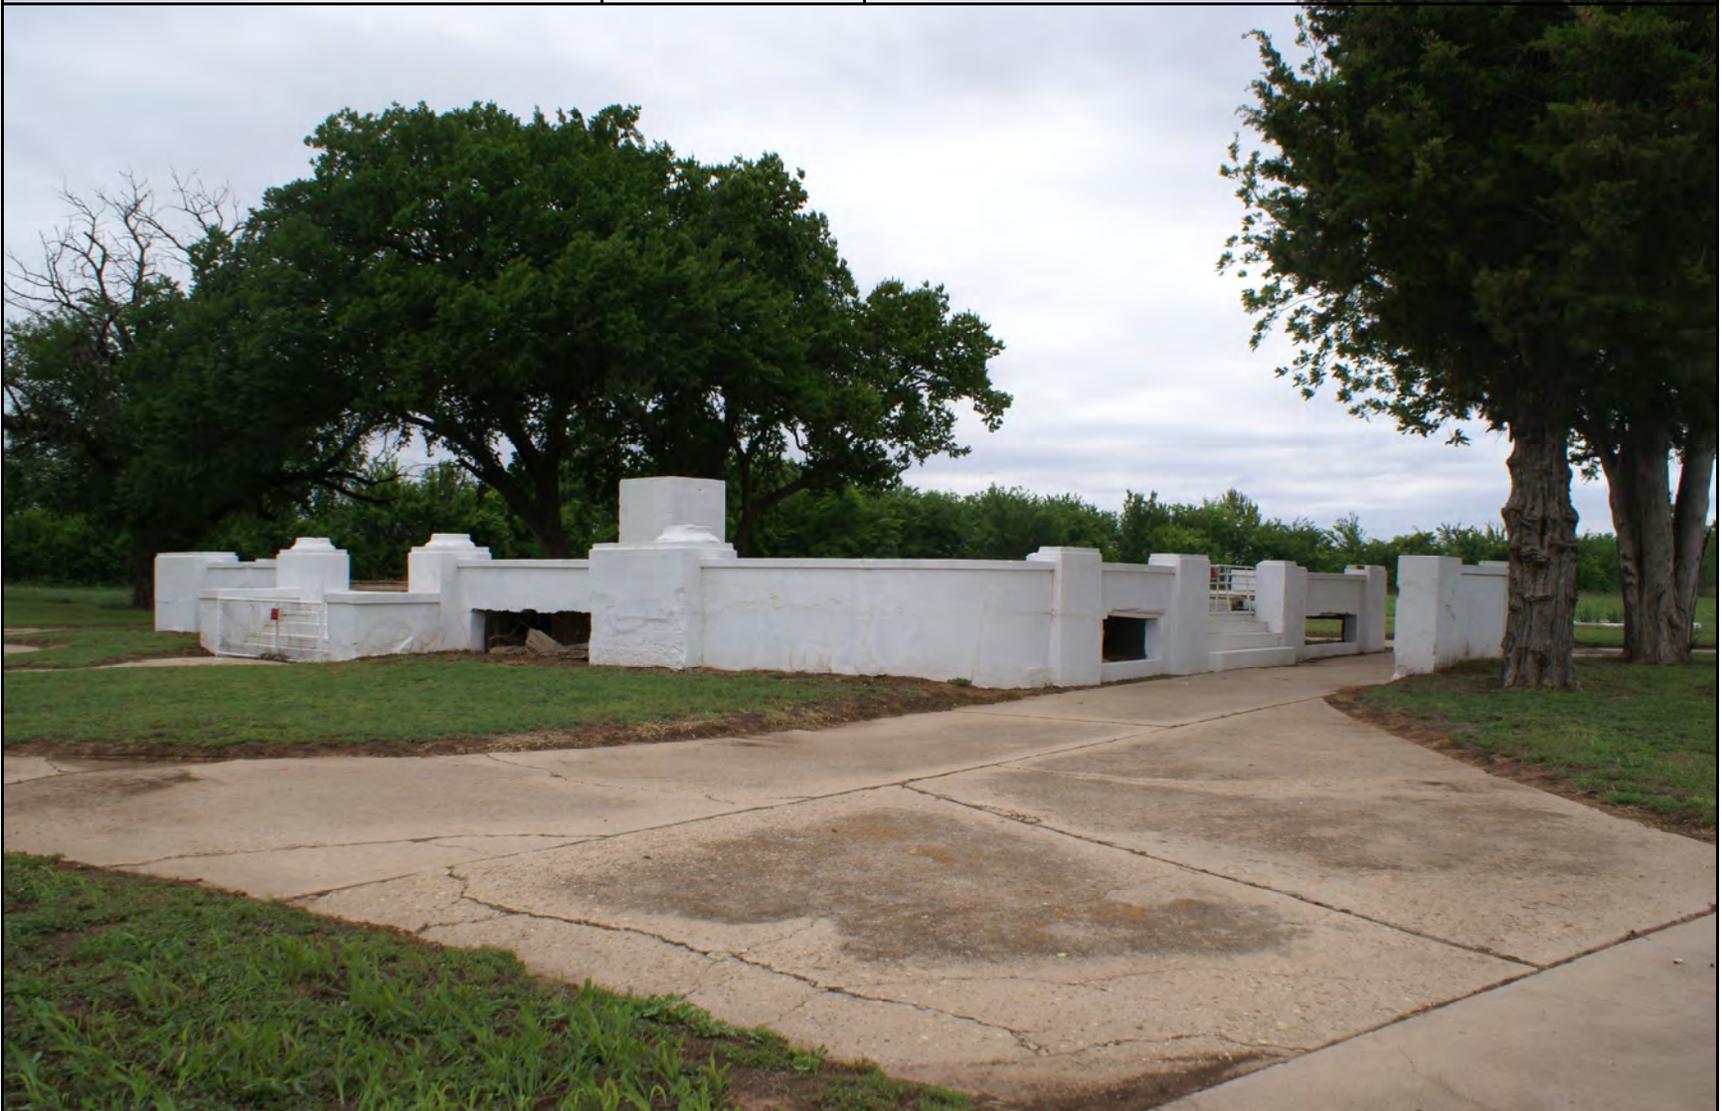
Figure A80

Oblique view of south and east sides of existing White House foundation.

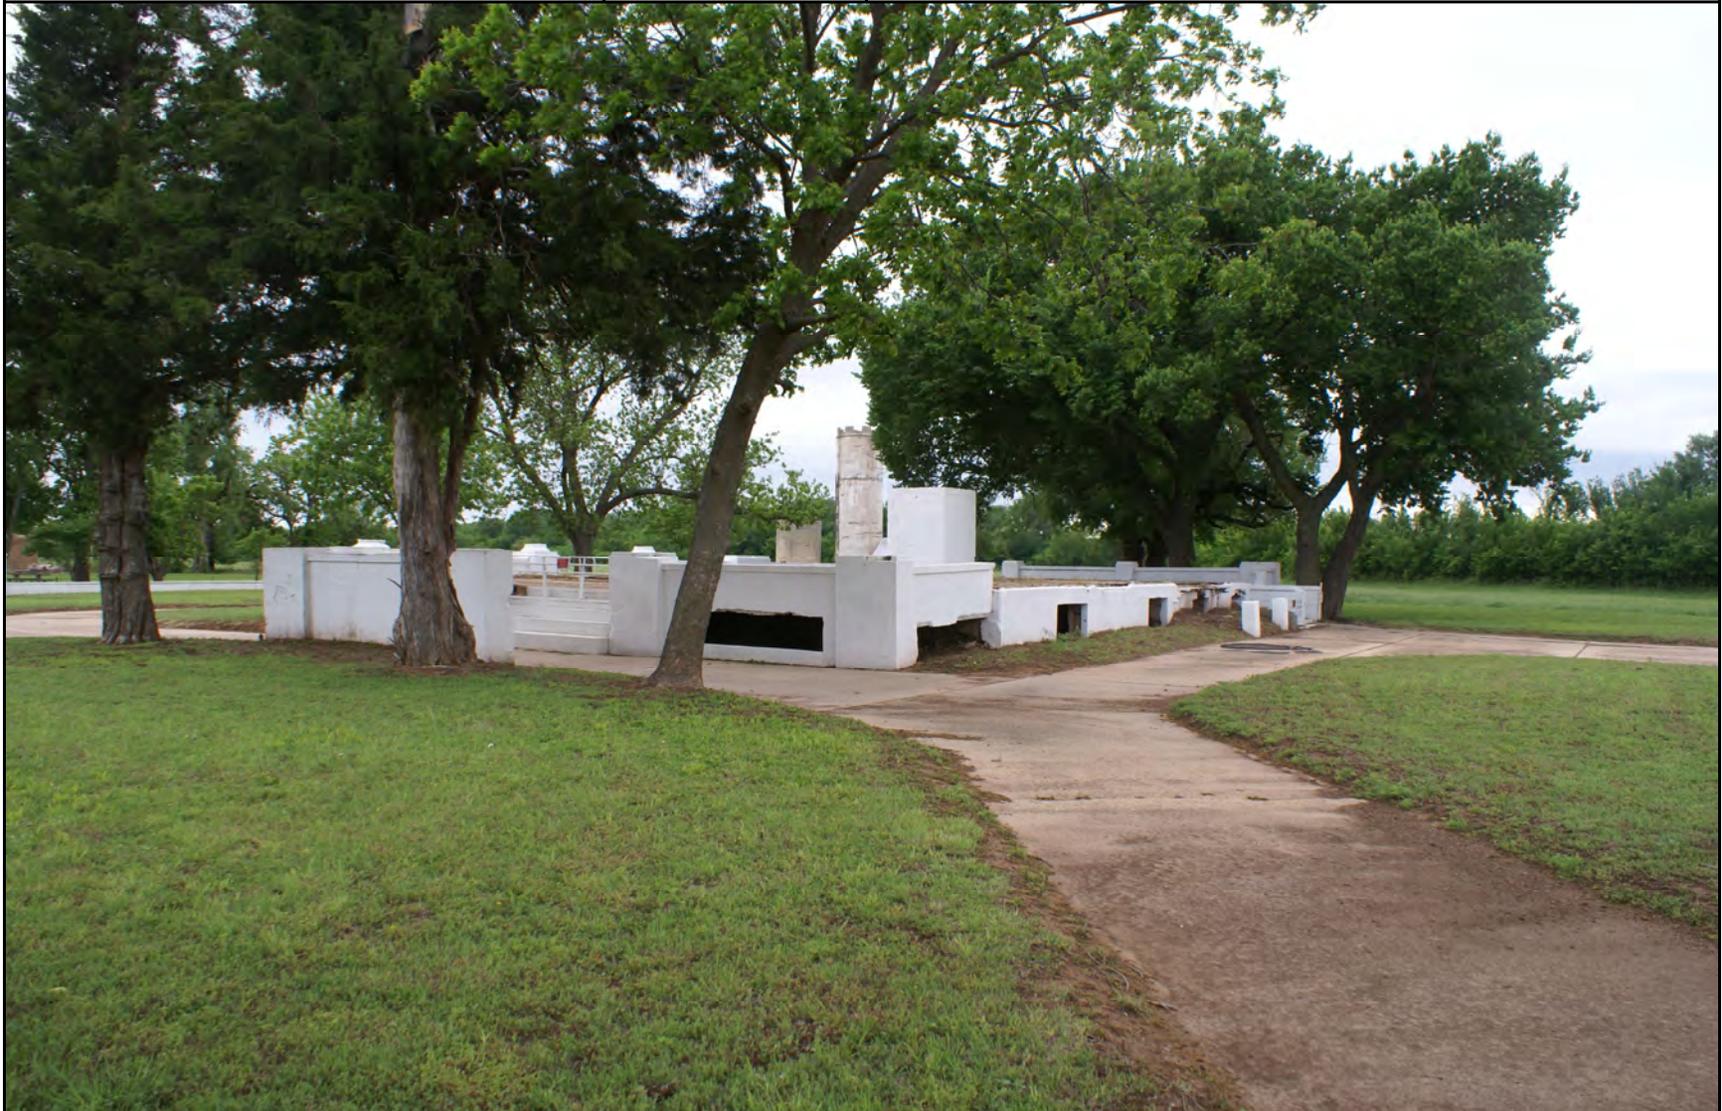
Figure A81

Oblique view of north and east sides of existing White House foundation.

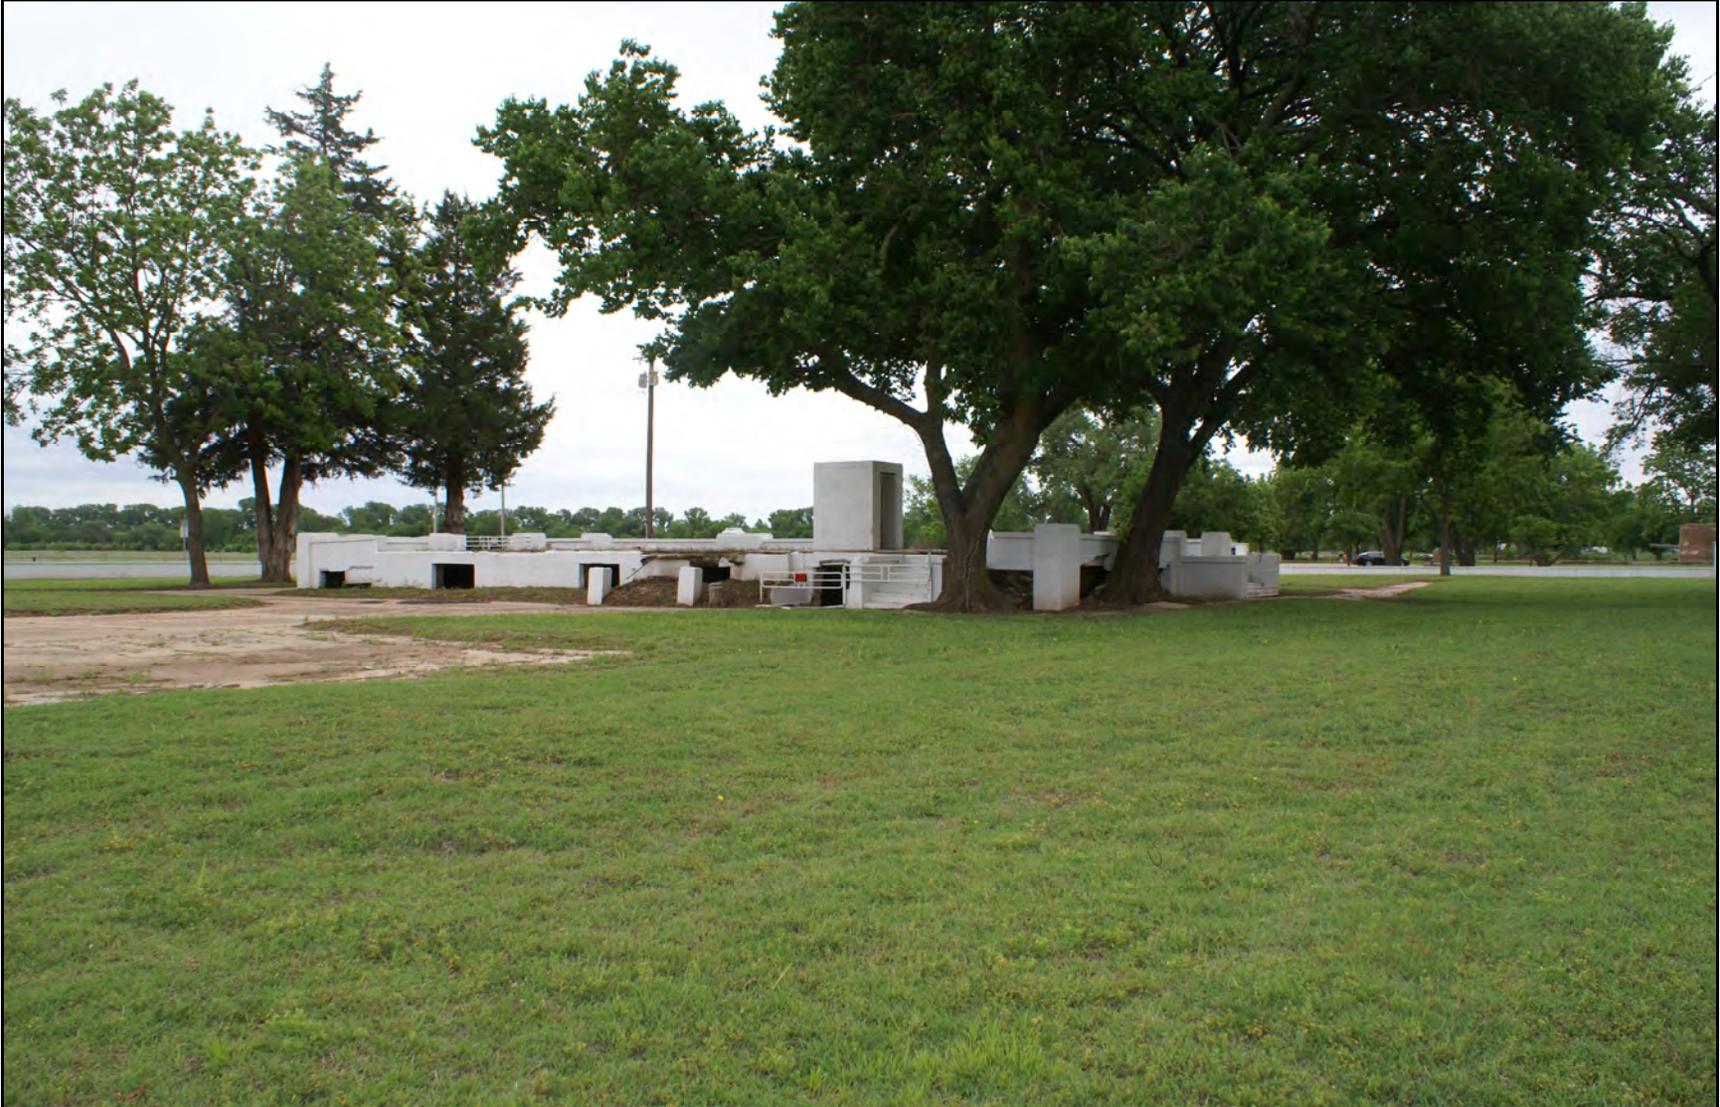
Figure A82

Oblique view of north and west sides of the existing White House foundation.

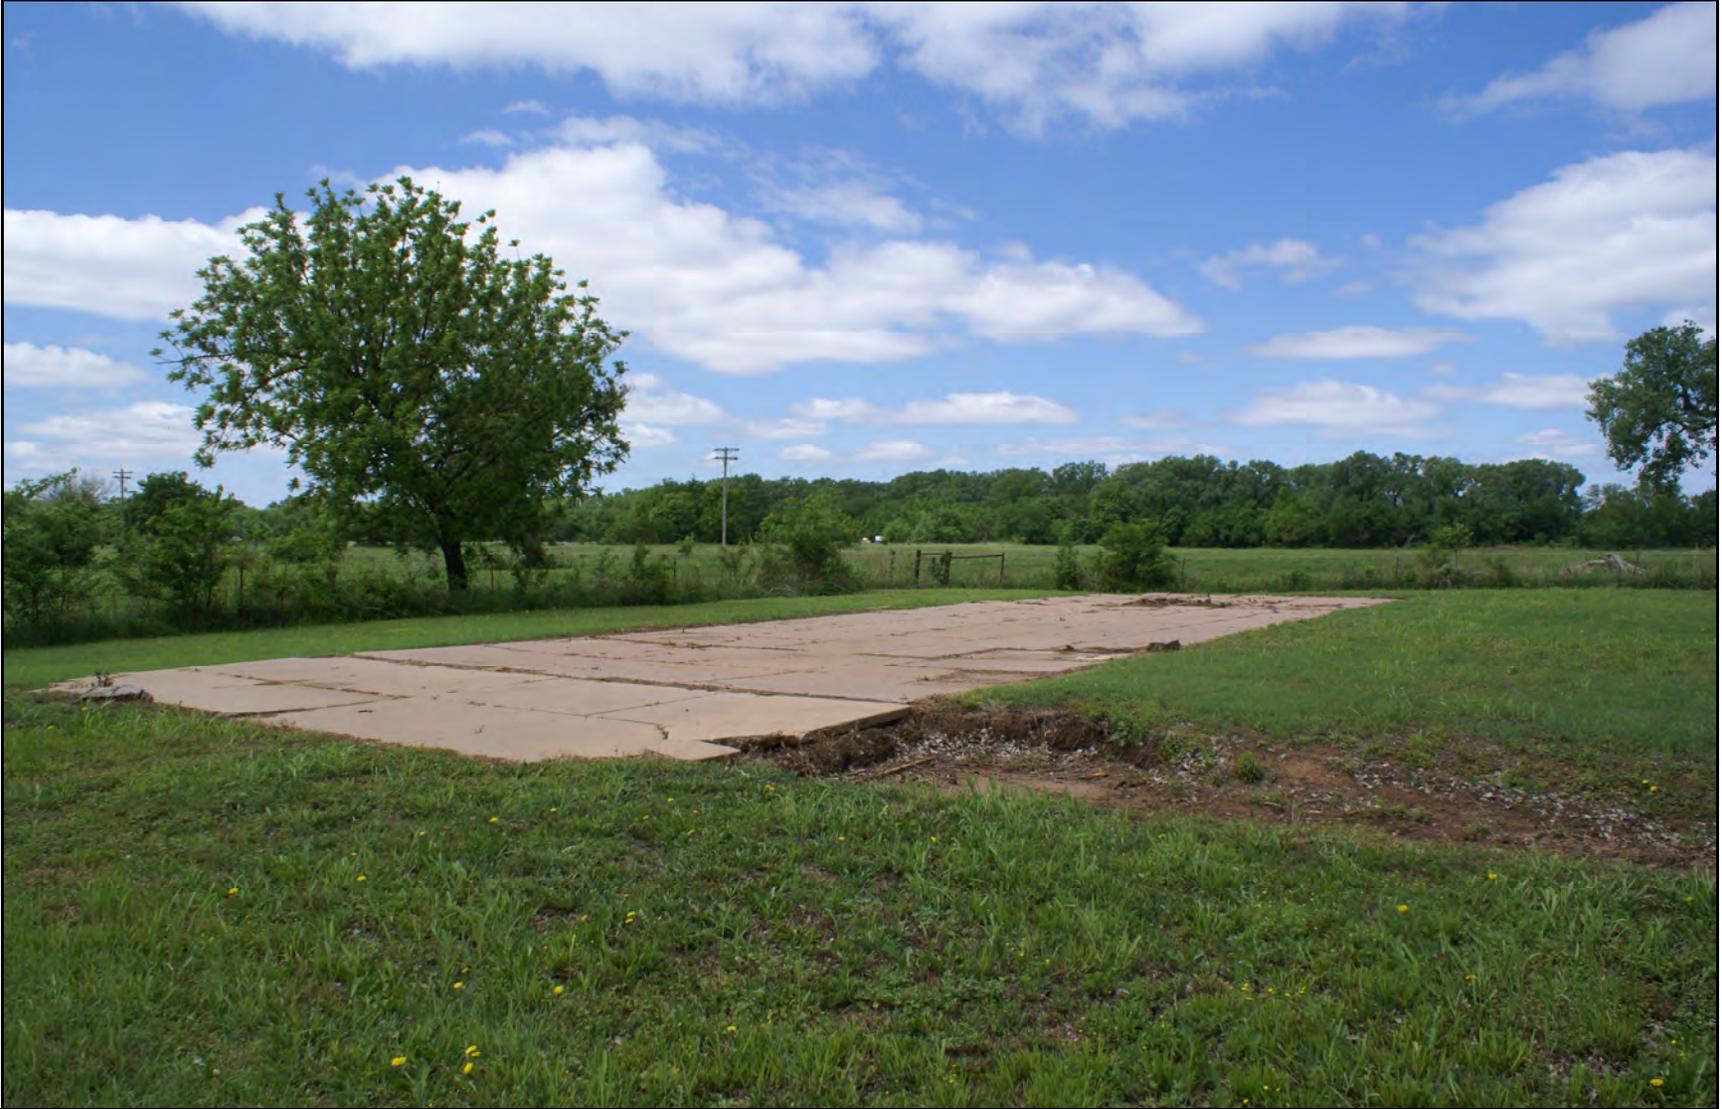
Figure A89

Oblique view of the hotel foundation slab.

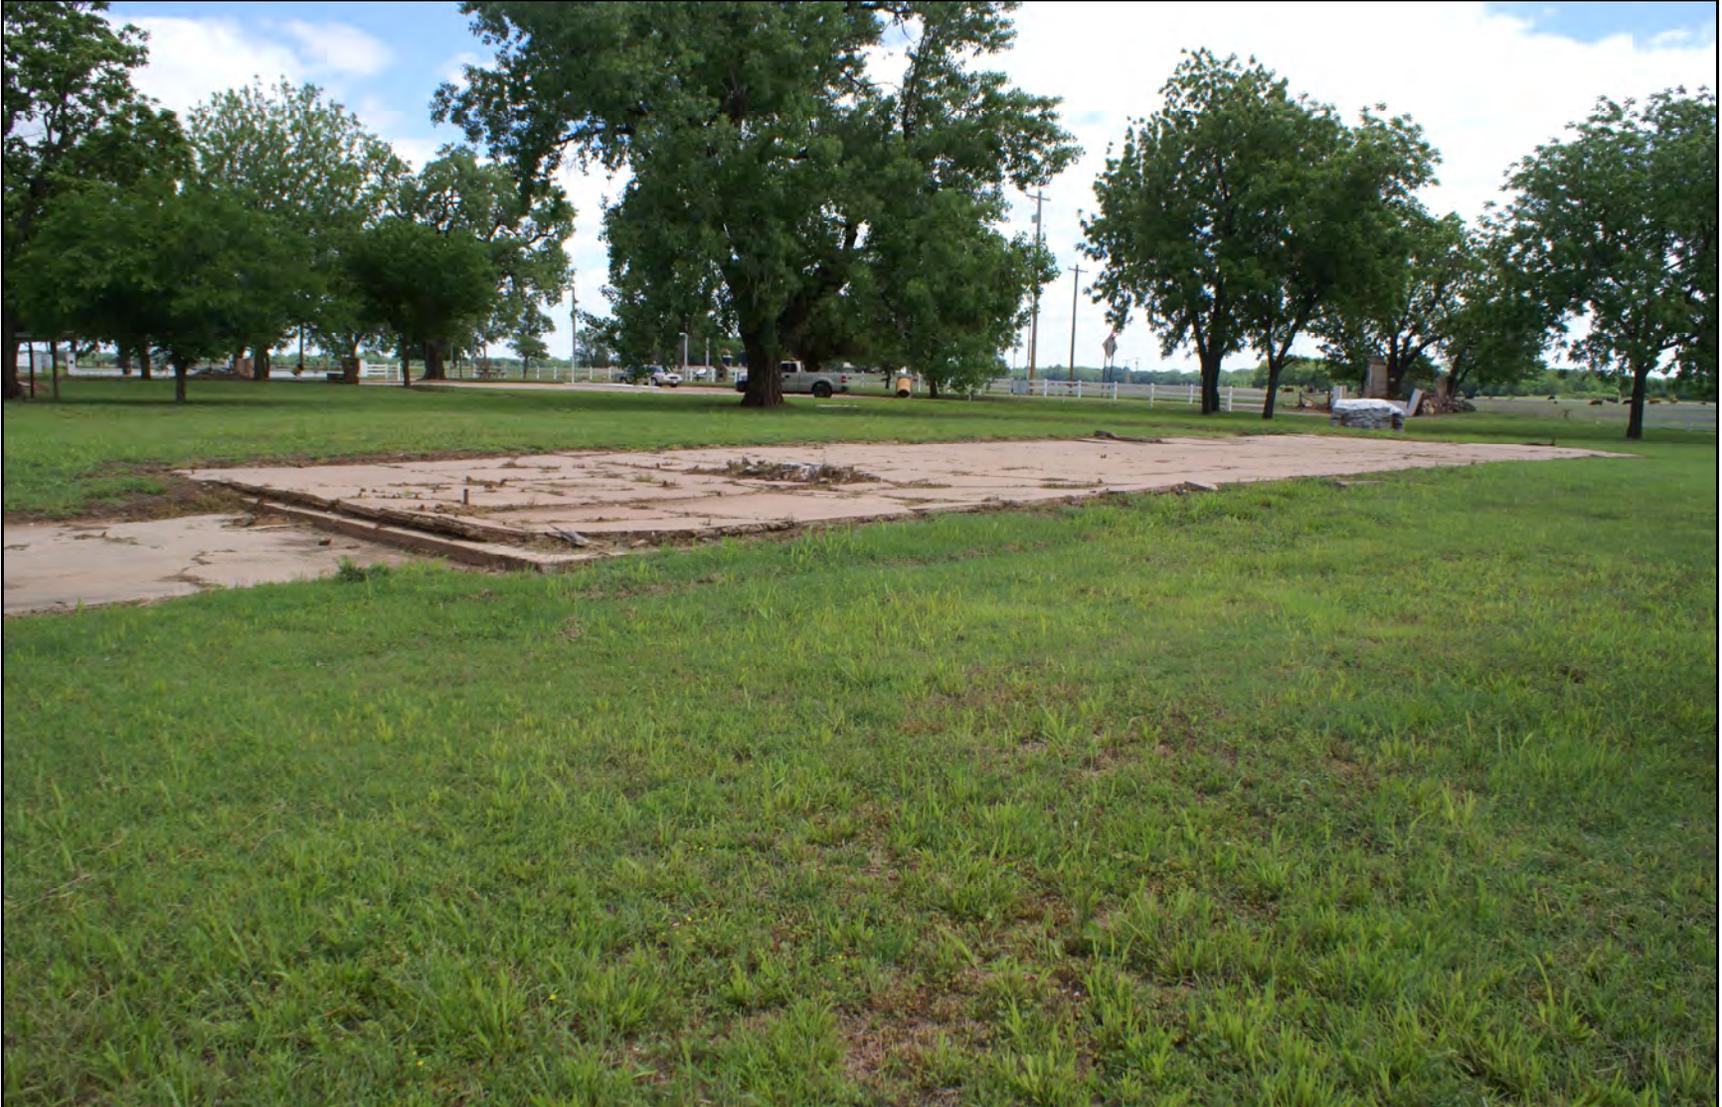
Figure A90

Oblique view of the hotel foundation slab.

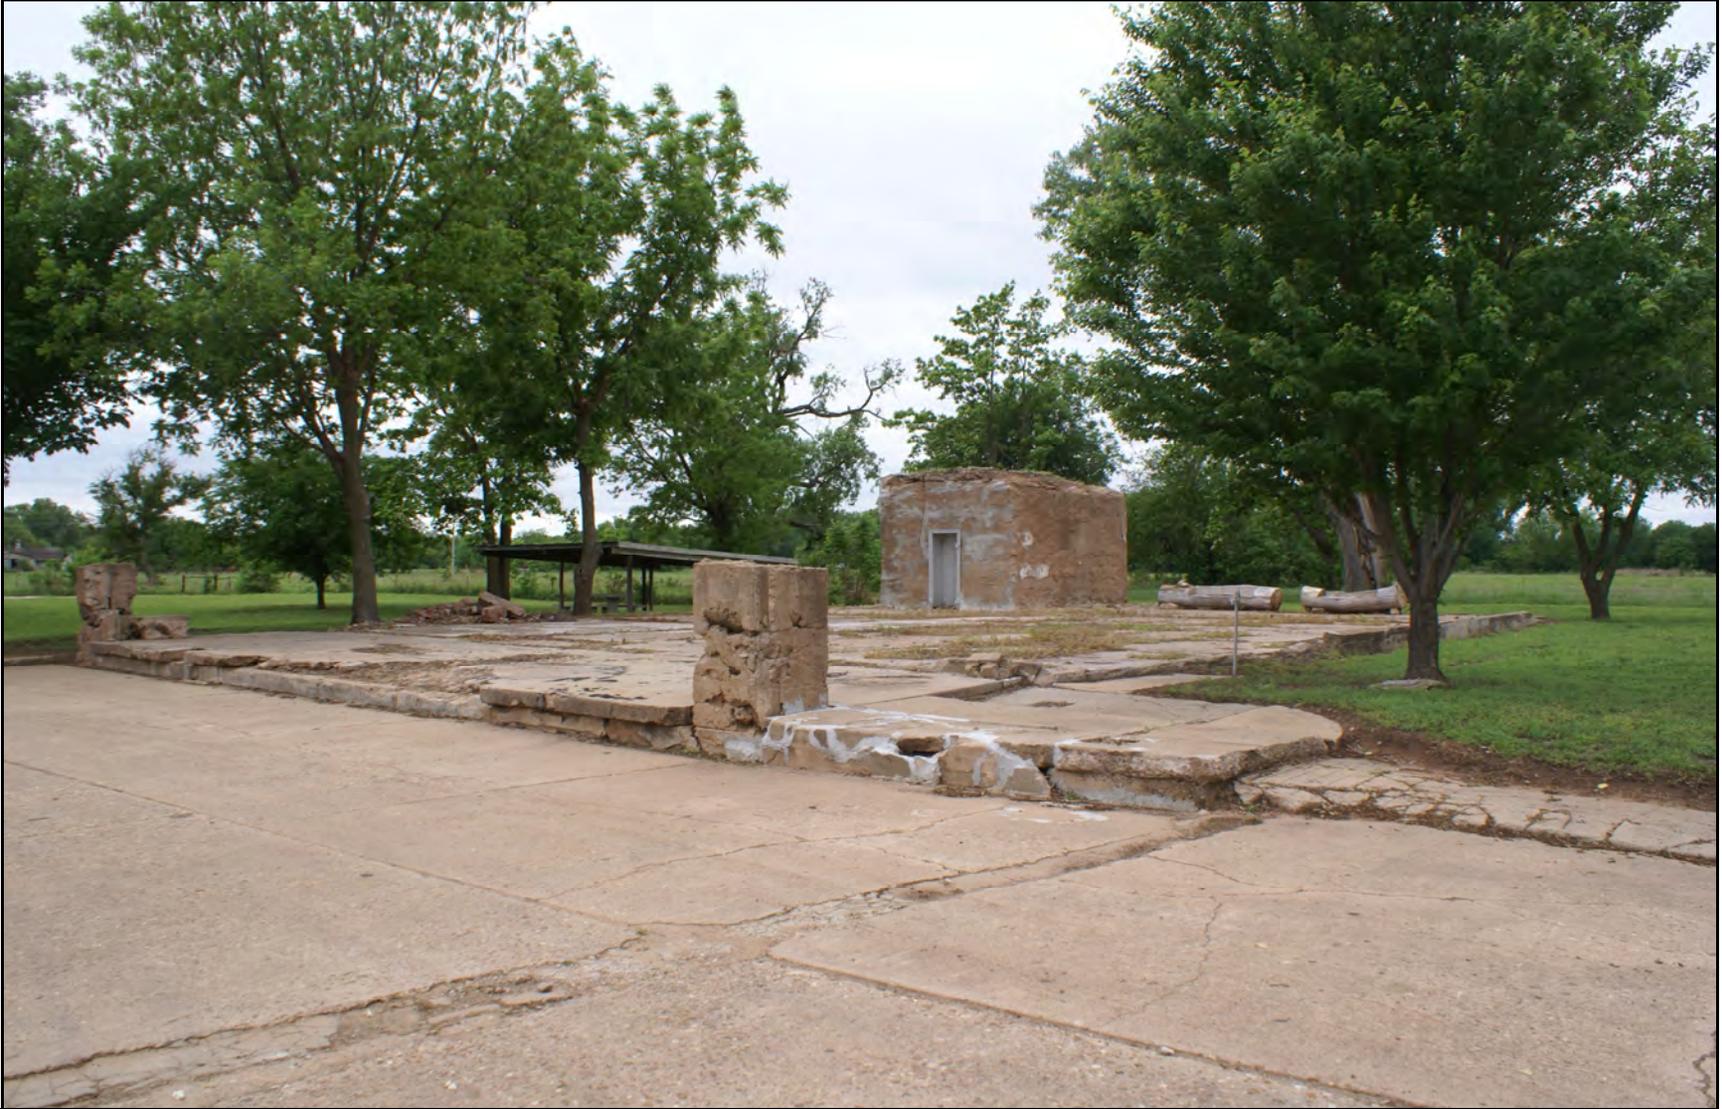
Figure A91

Oblique overview of the general store foundation slab.

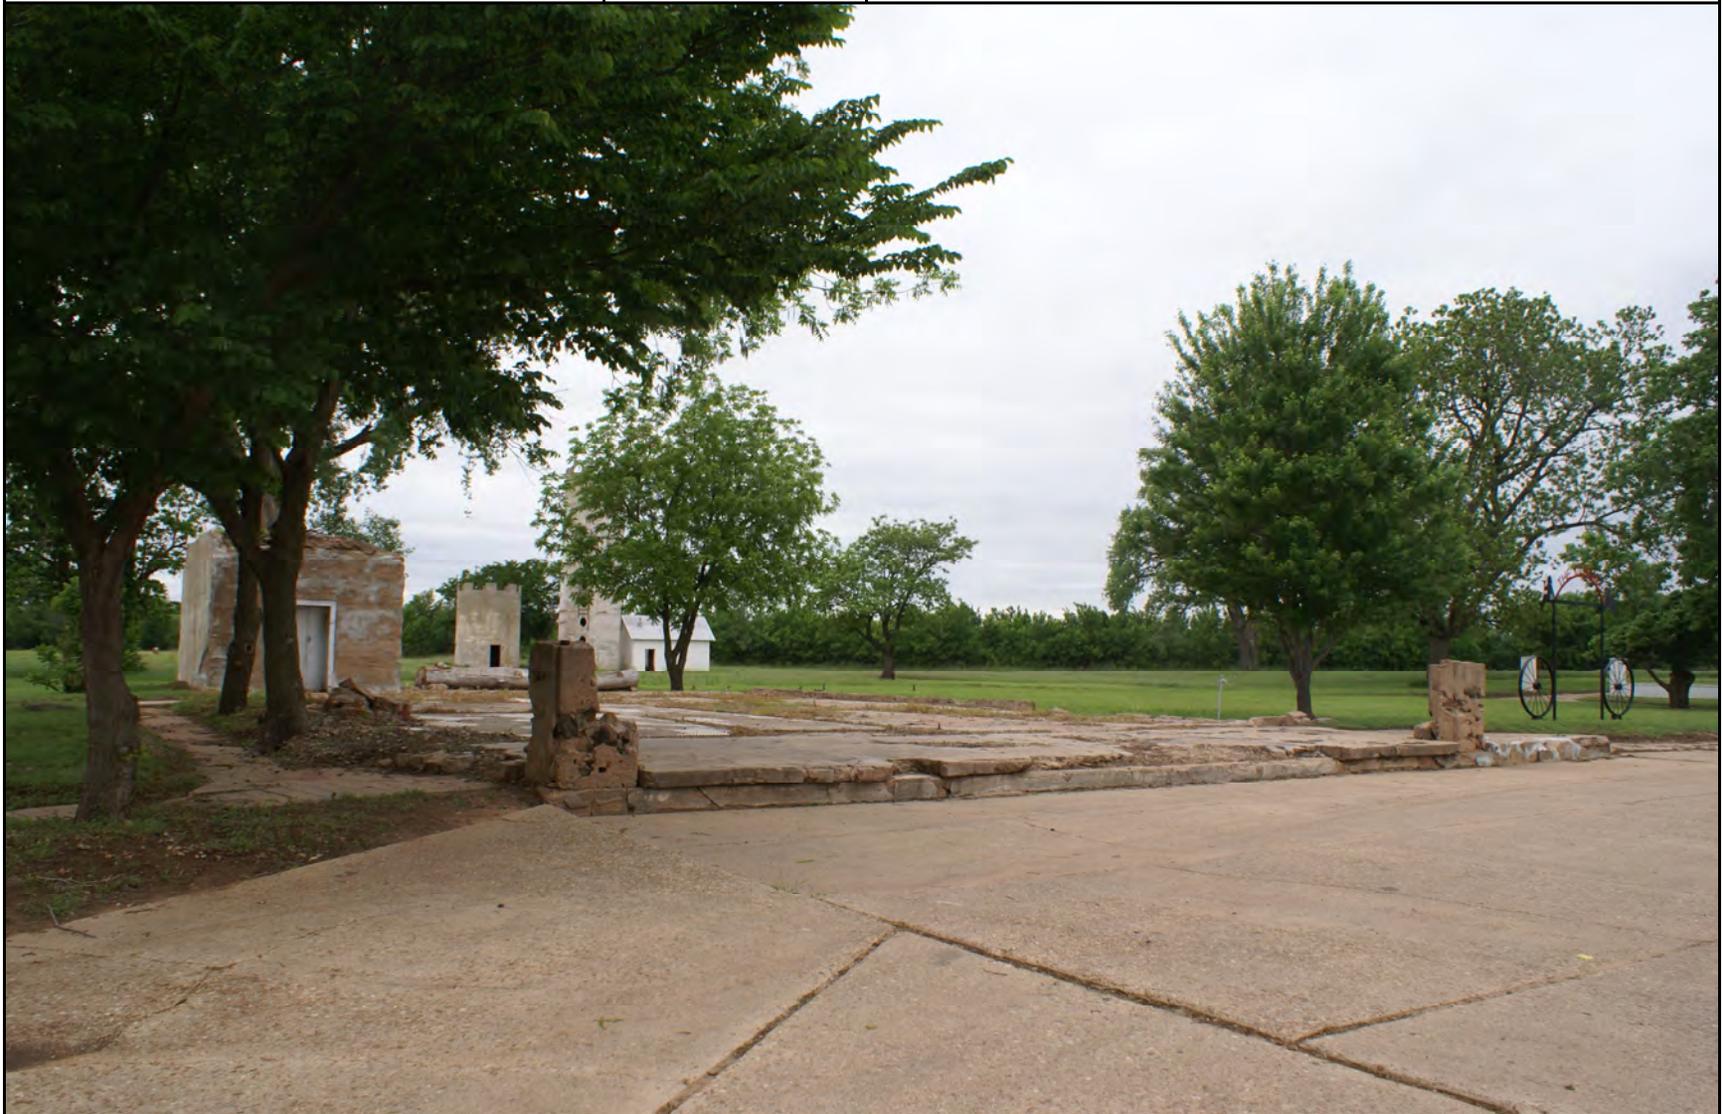
Figure A92

Oblique overview of the general store foundation slab.

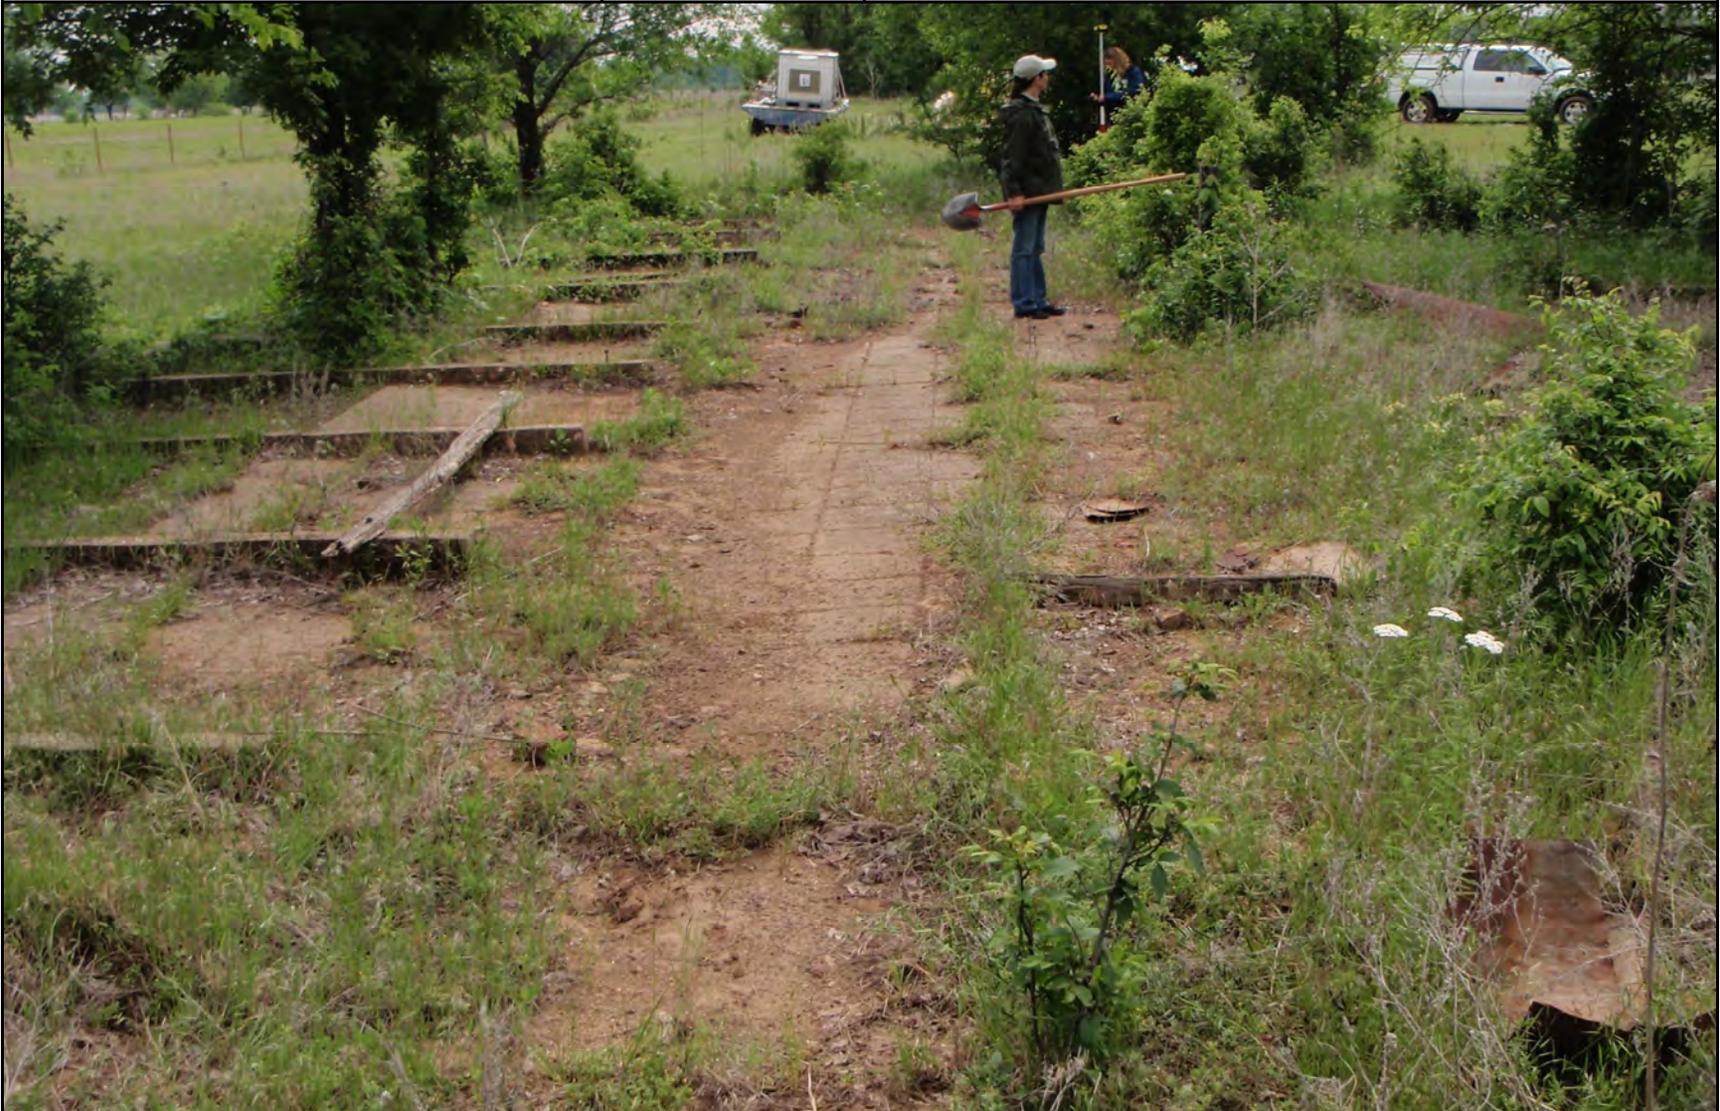
Figure A97

View of farrowing house foundation slab at the hog barn complex.
