**Geophysical, Archaeological, and Architectural Investigations at
101 Ranch Historic District,
Ponca City vicinity, Kay County, Oklahoma**

Prepared by
URS Corporation
Dallas, Texas

Contract Number: EC-1217H
Task Order Number: 009
URS Project Number: 37974201

September 2012

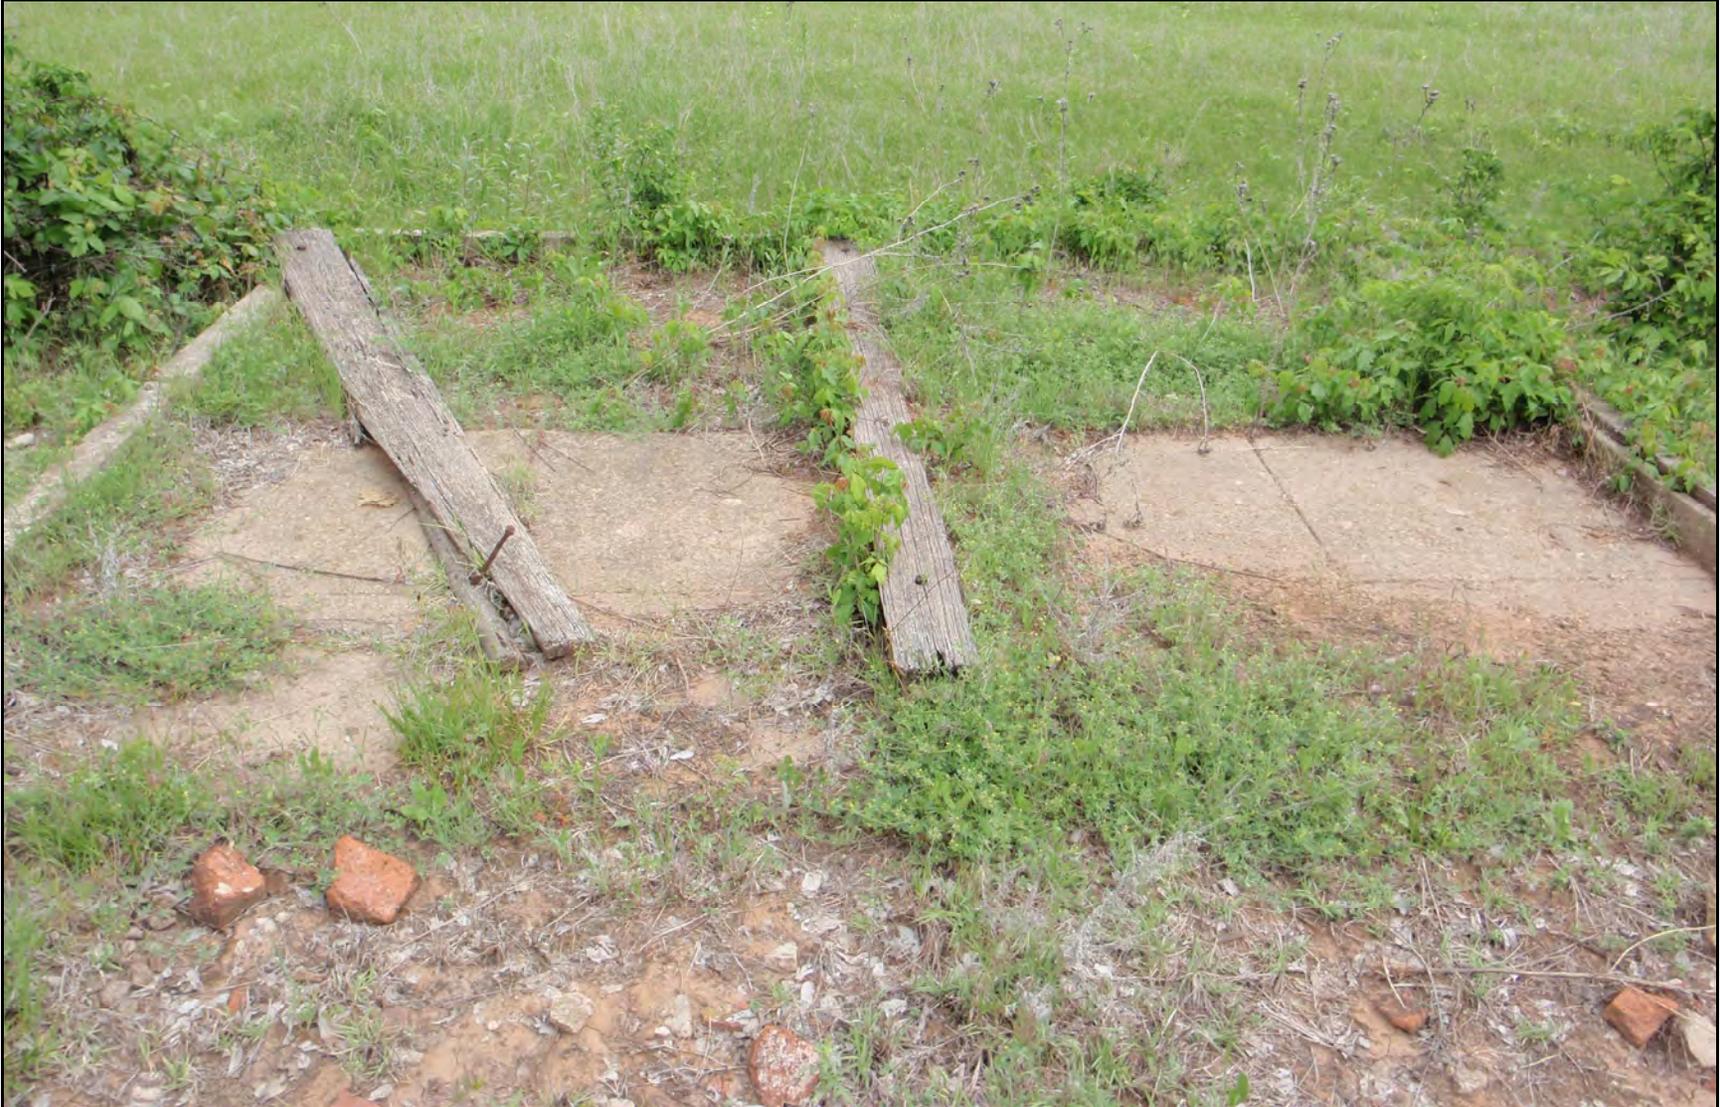
Figure A99

View of foundation slab at the farrowing house at the hog barn complex.

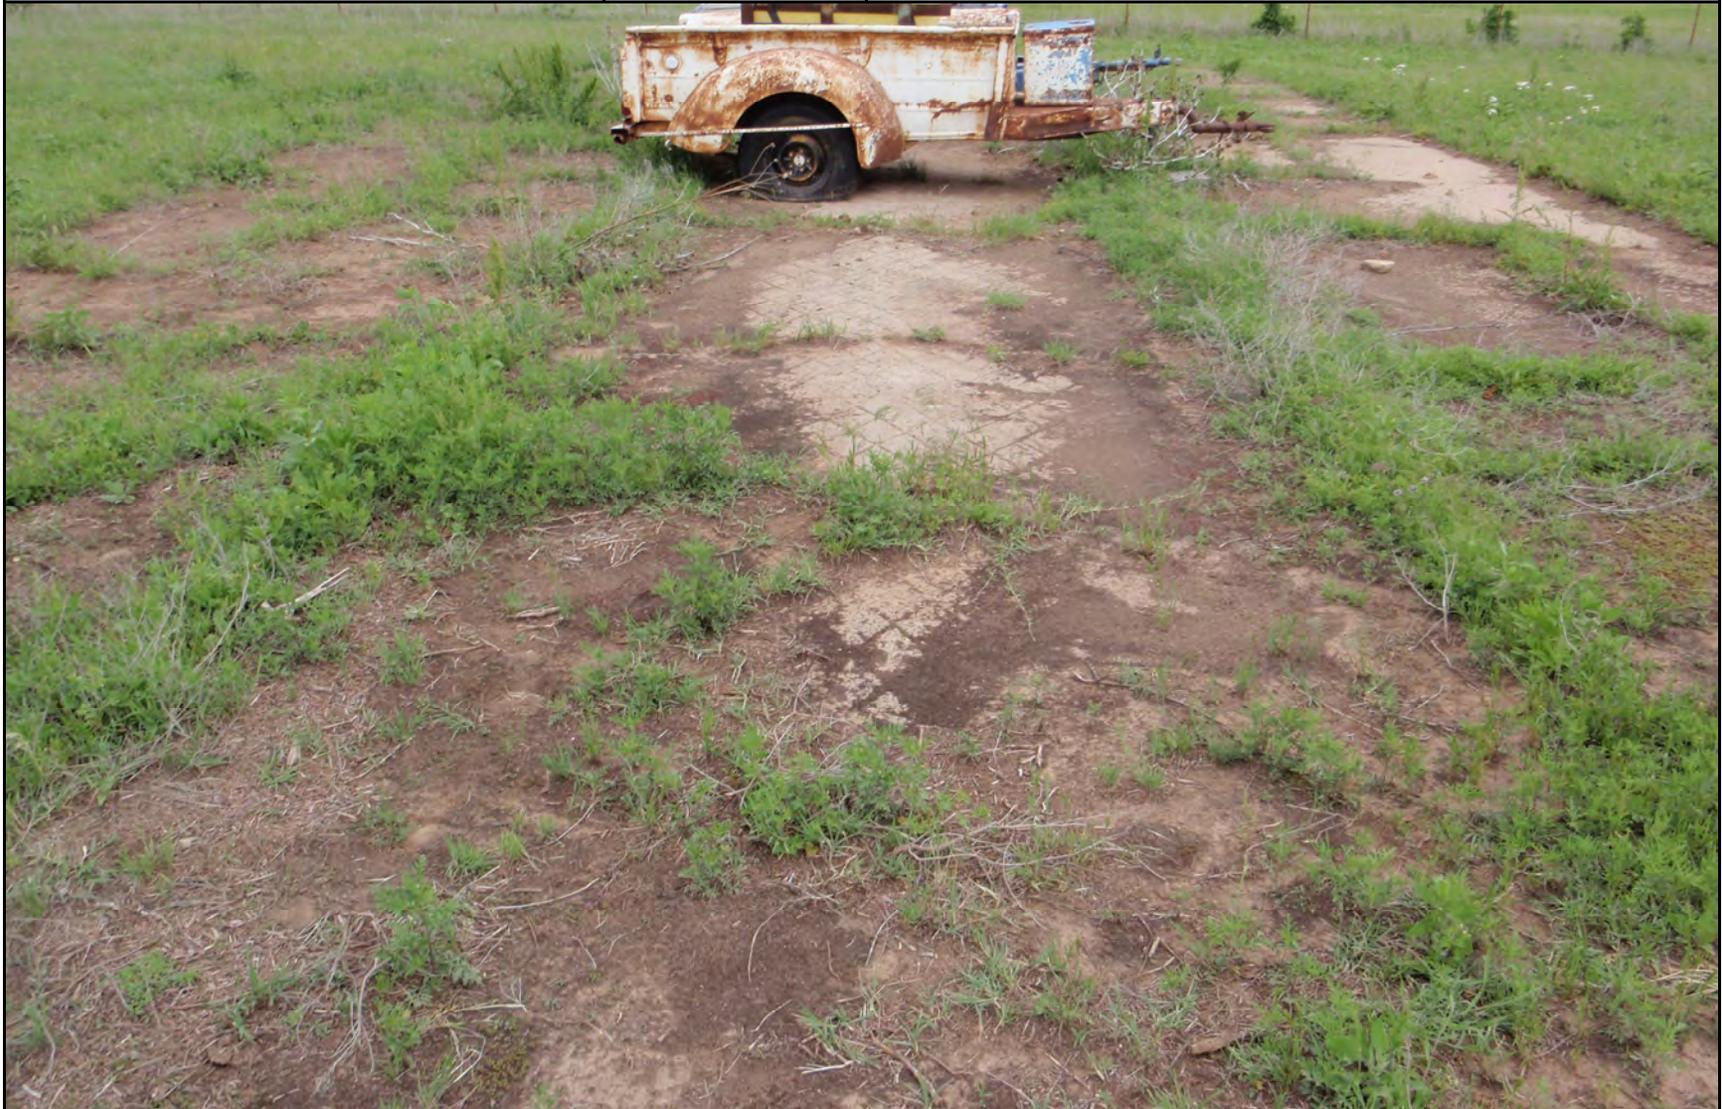
Figure A100

View of foundation slab of sow and pig nursery/farrowing house at hog barn complex.

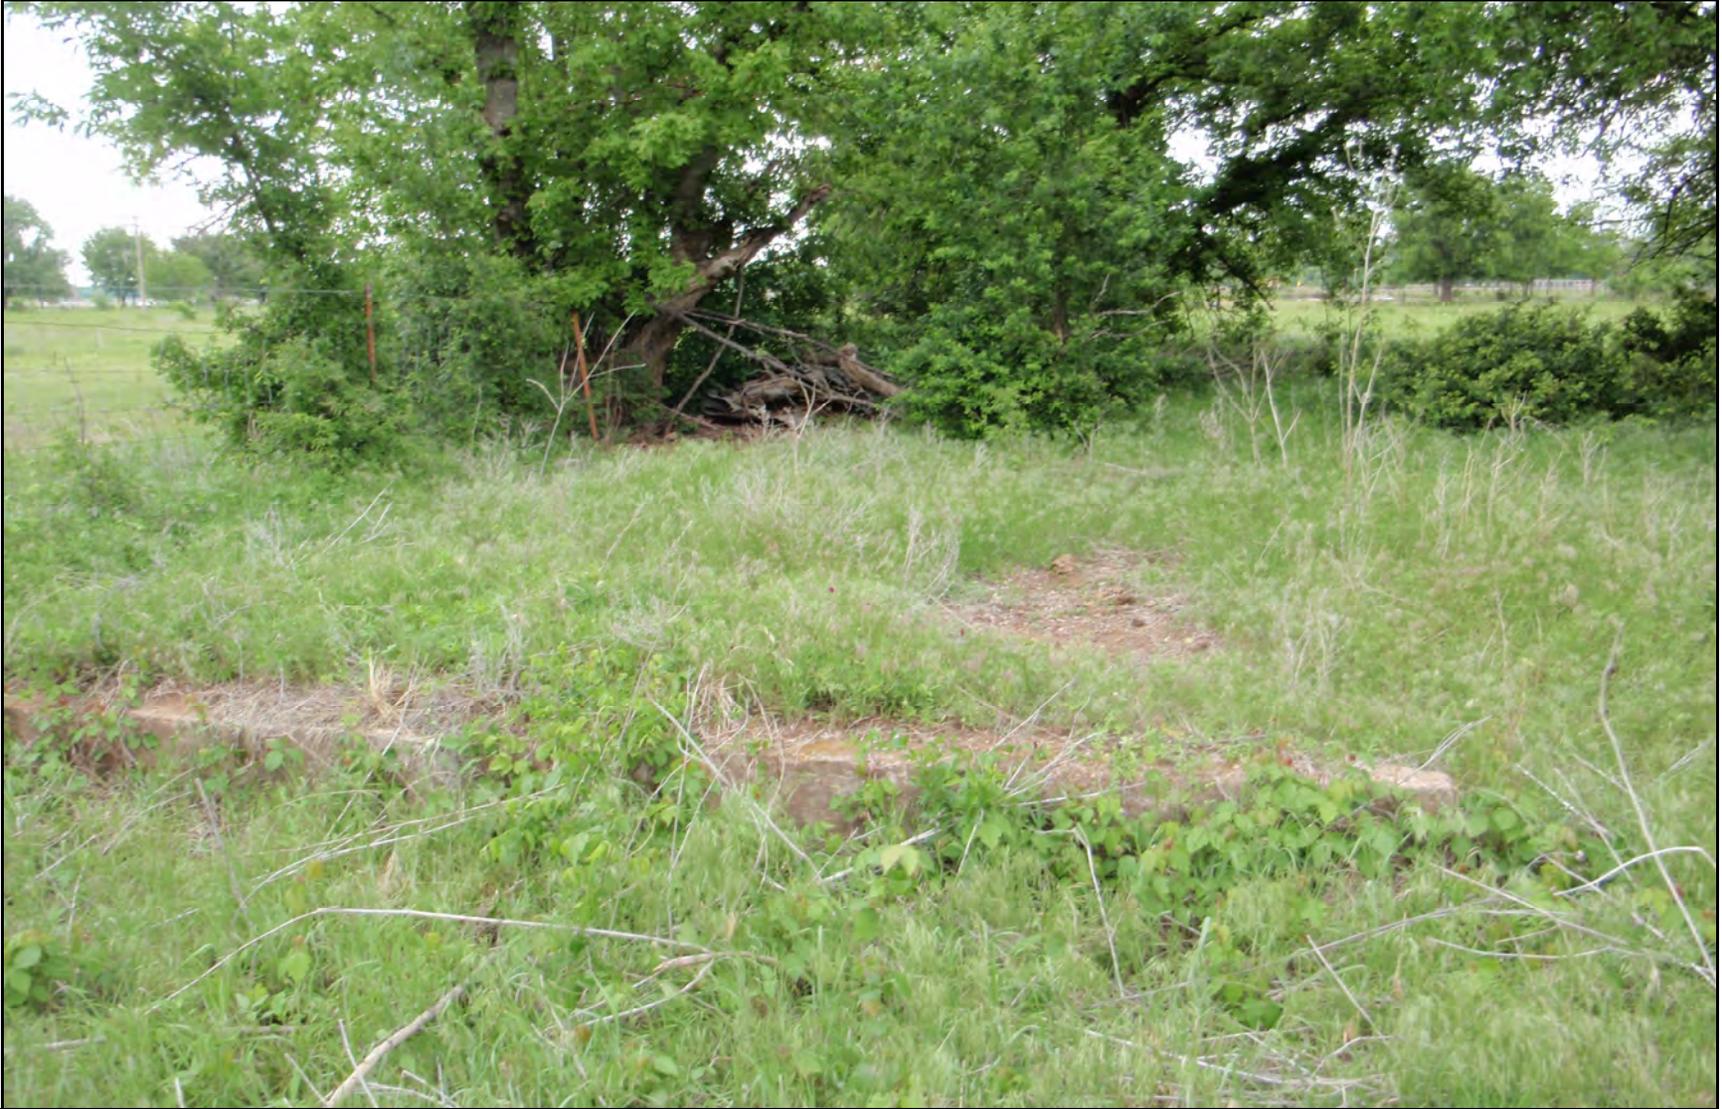
Figure A102

View of foundation slab at meat packing plant.

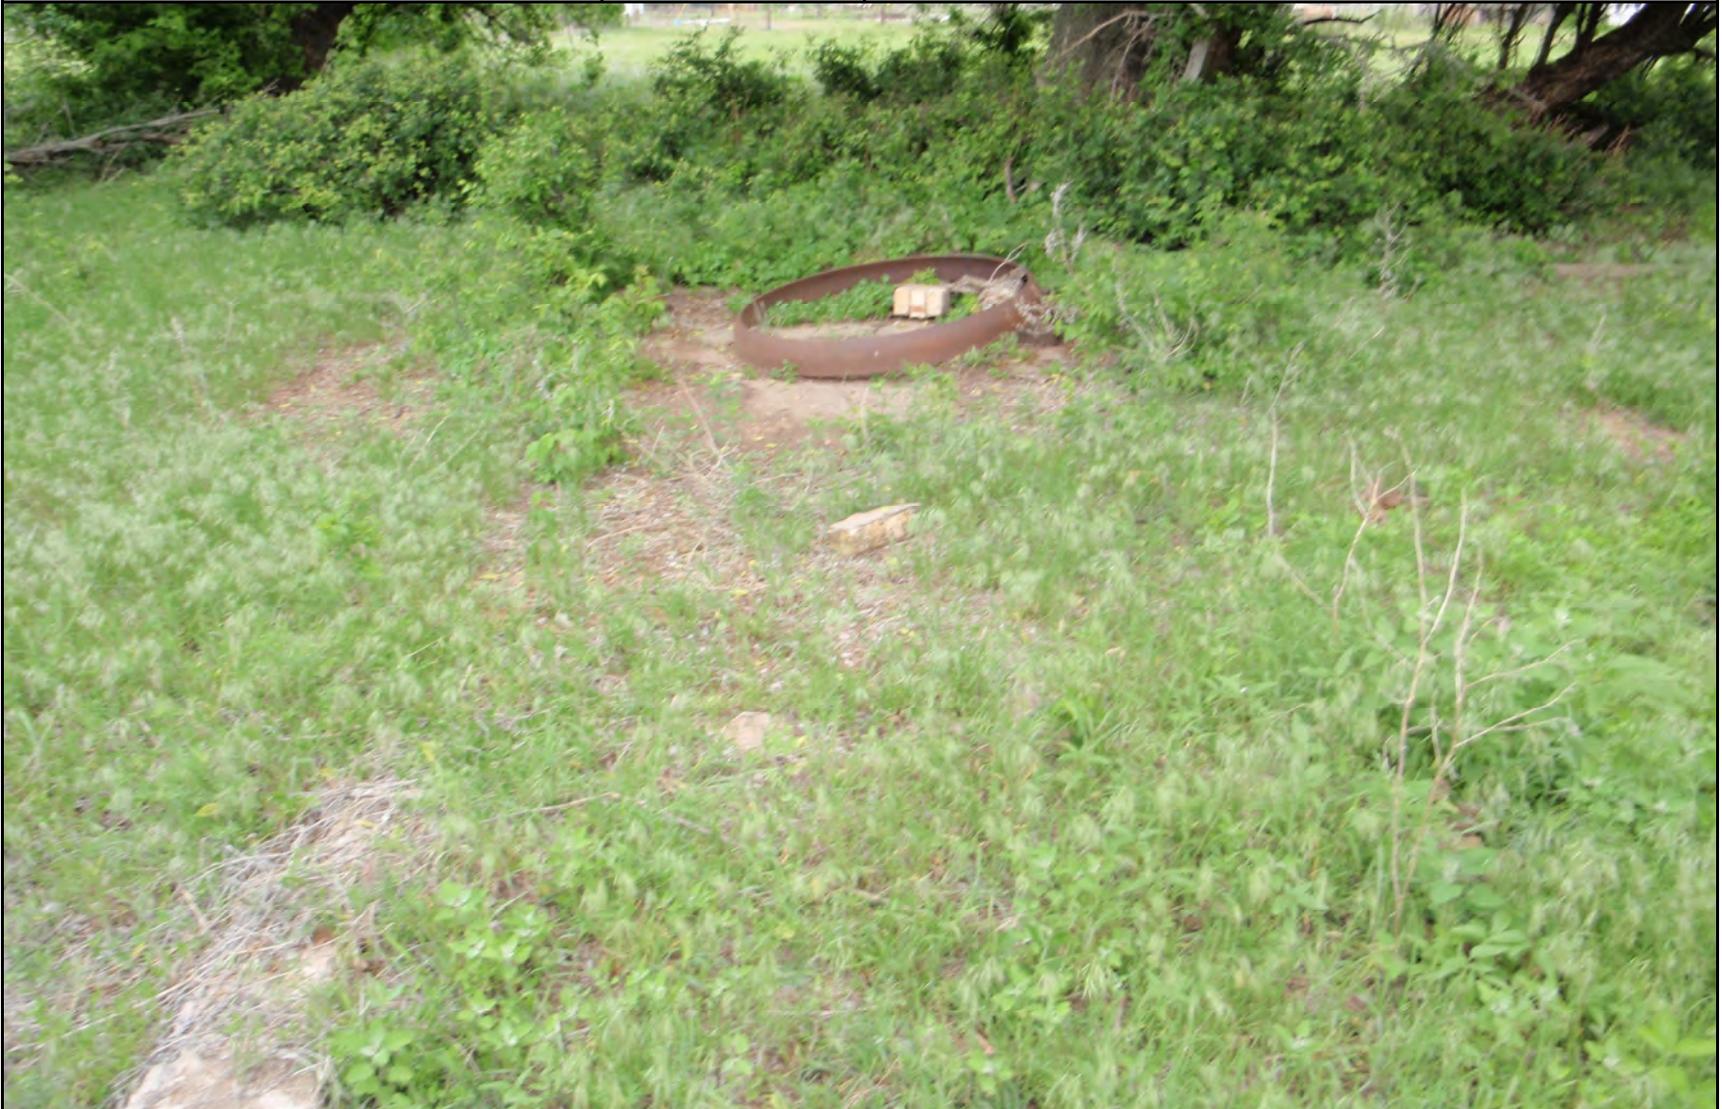
Figure A103

View of foundation slab at meat packing plant.

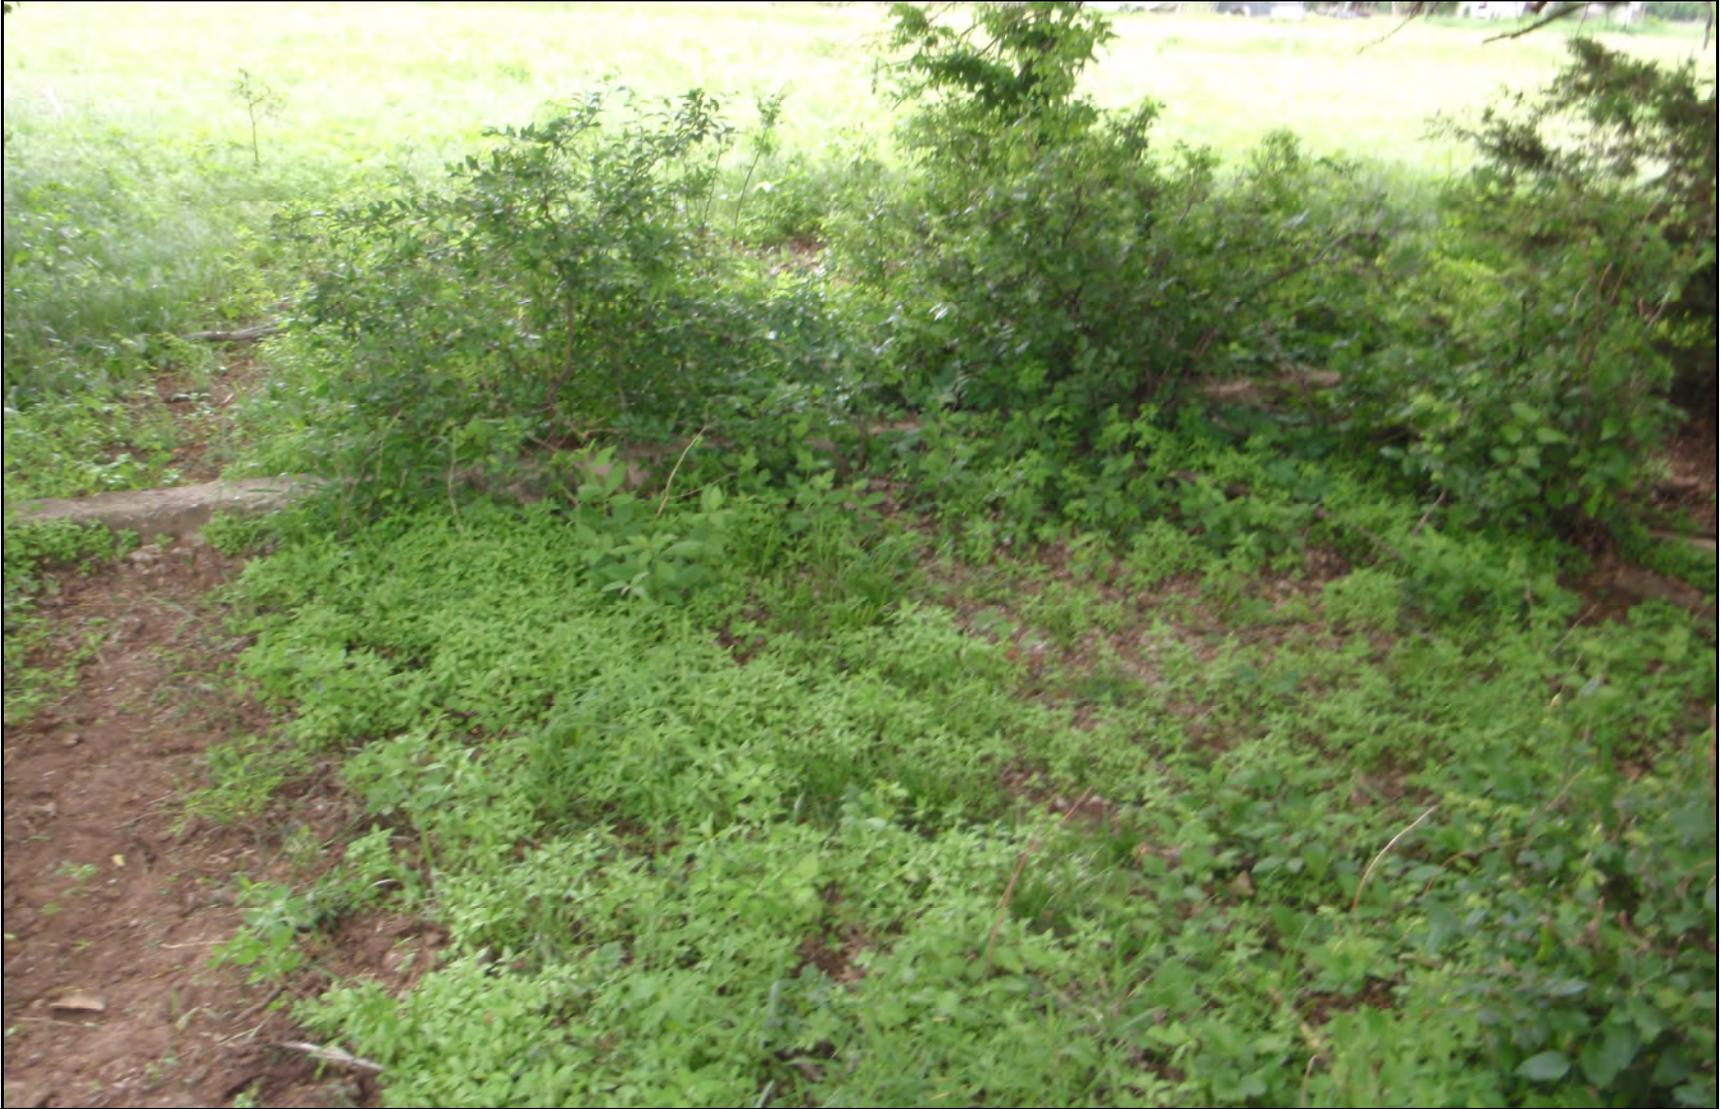
Figure A104

View of footer at meat packing plant.

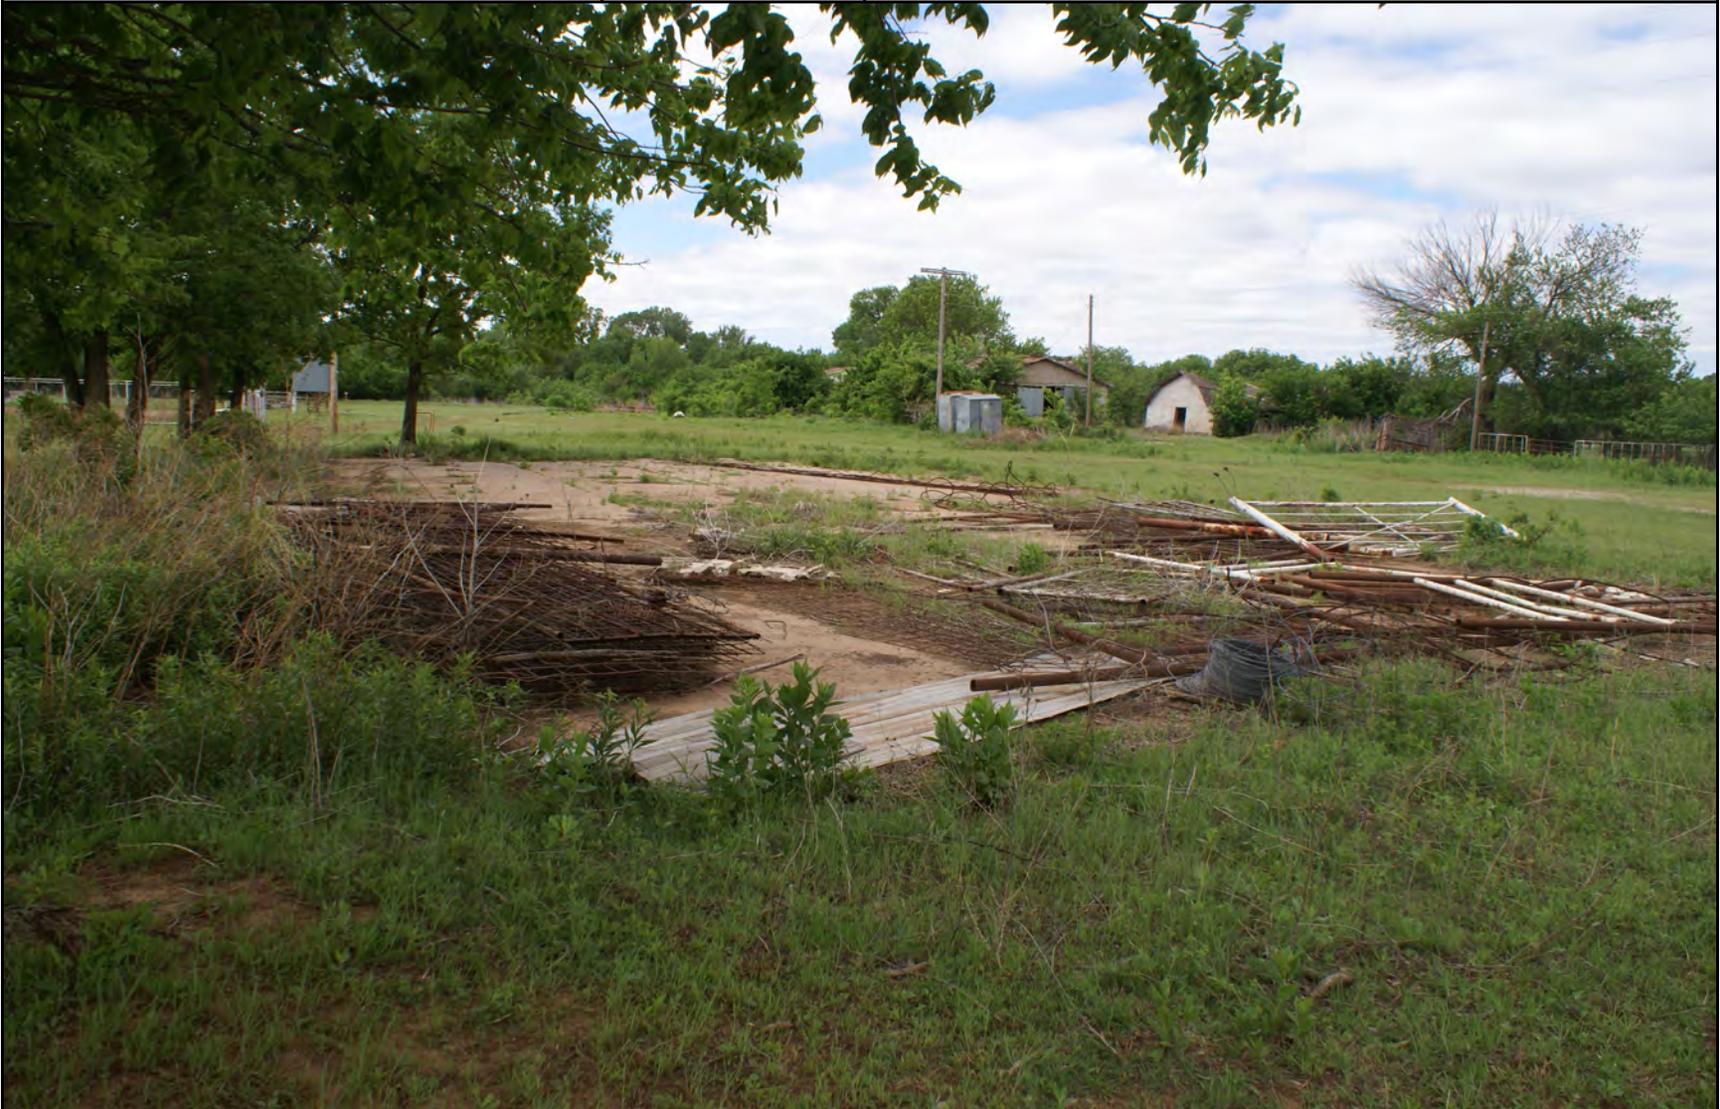
Figure A114

Overview of “elephant barn” foundation slab.

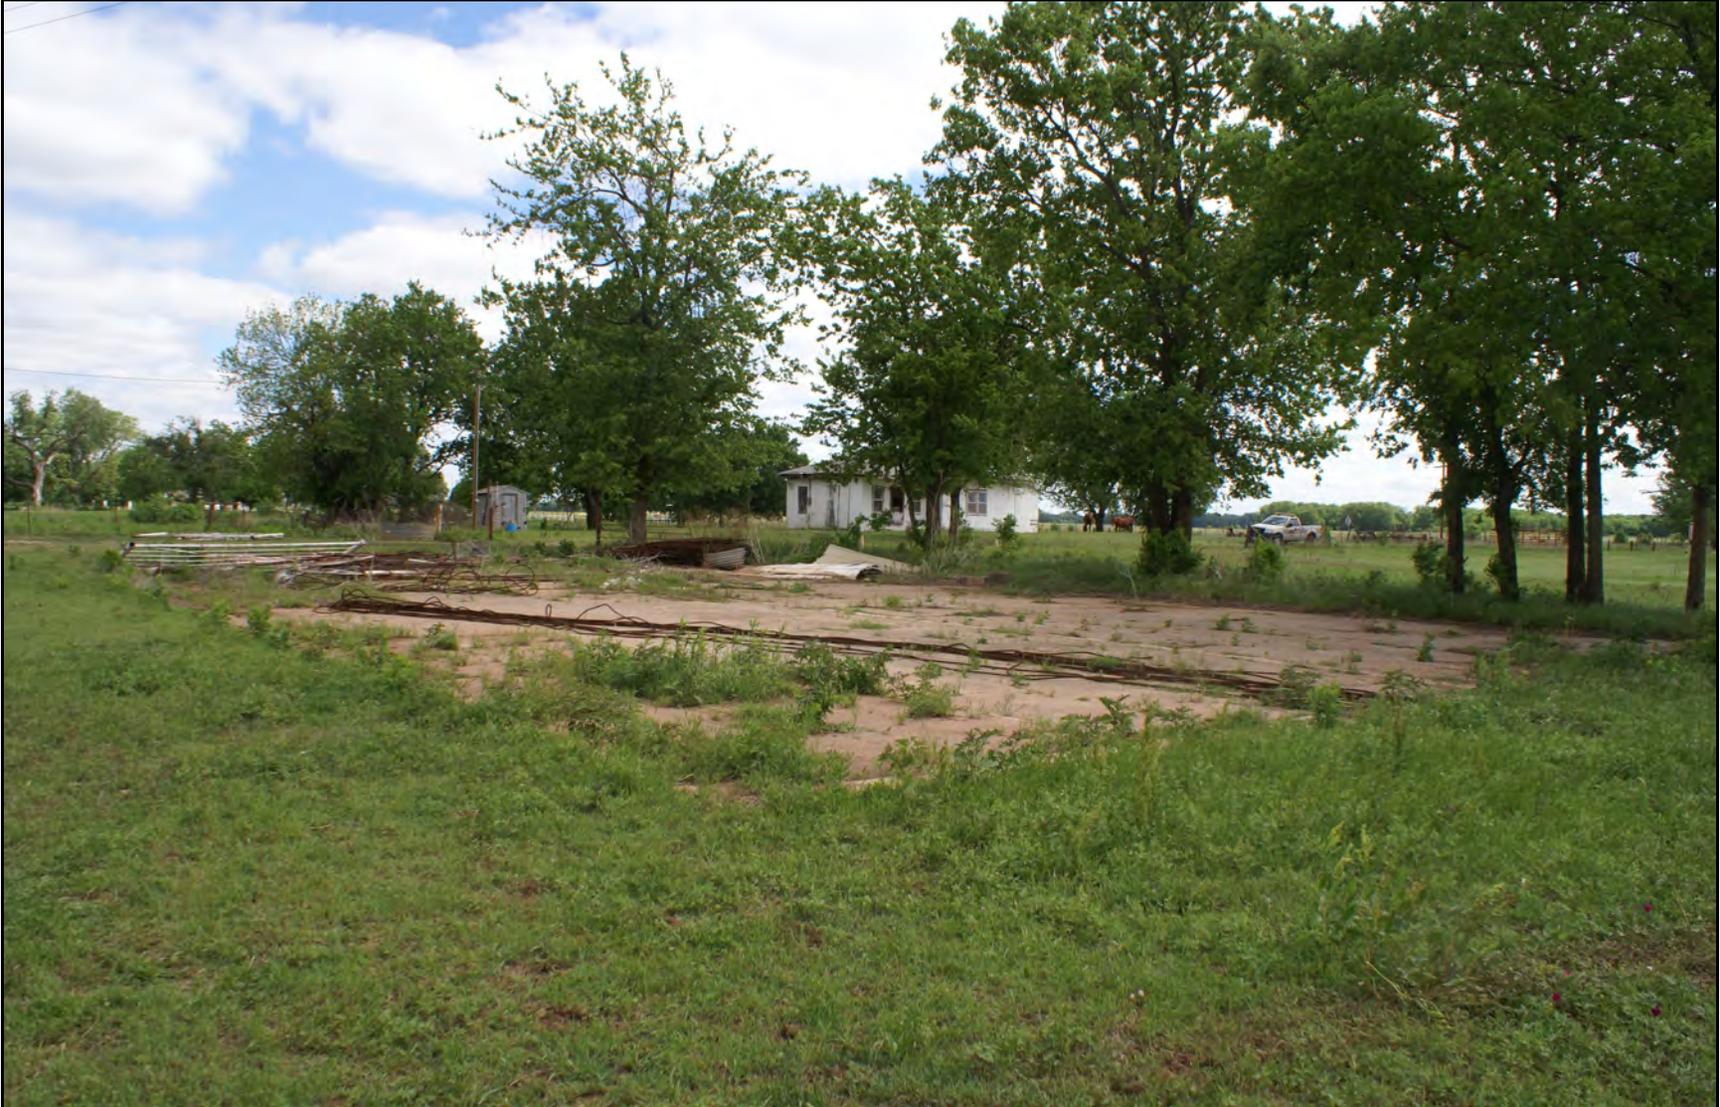
Figure A115

Overview of foundations slab of "elephant barn."
