# Fracture Critical Bridge Inspection Report

NBI Bridge No.: 04085

Route U.S. 281 over S. CANADIAN RIVER  
Canadian County

Re: Fracture Critical Bridge Inspection Report  
Structure No.: 0902 0000 X  
NBI No.: 04085  
US 281 over South Canadian River  
ODOT Field Division 4, Canadian County

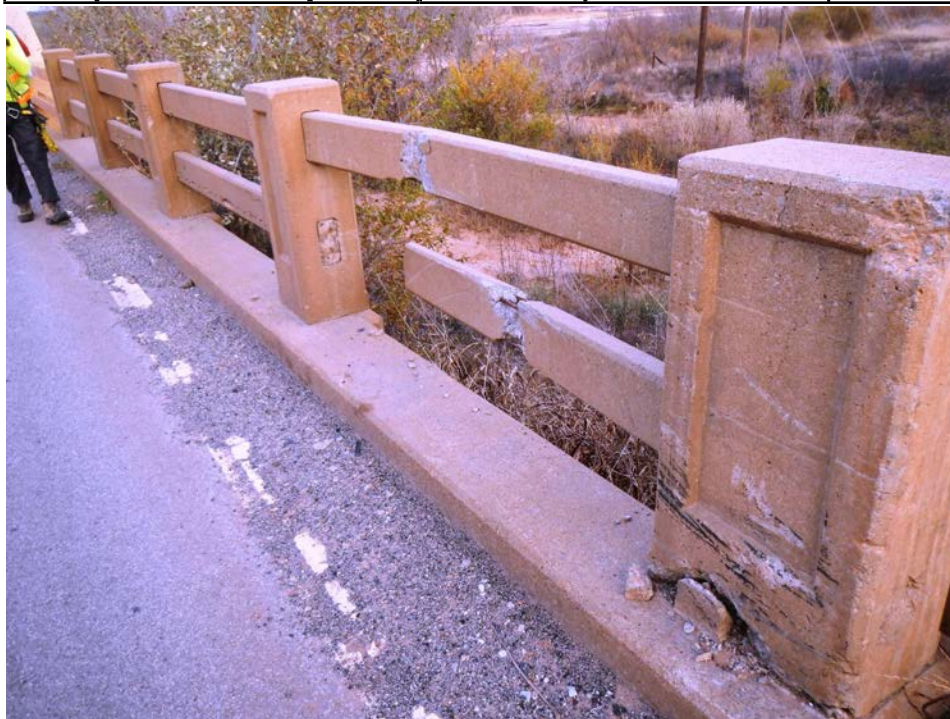
- **PX** – Collision damage exists to the concrete railing in spans 1 and 40. One section of the bottom rail has been severed in span 1 and is no longer functional (**photo 3**). The north most concrete post in span 40 is spalled and has cracked through at the base and the second post has spalling with exposed reinforcing steel (**photo 4**). Four of the concrete posts for the west rail in span 40 are leaning outward and the deck is cracked on the outside edge of the posts.

Photograph 3 - Looking northeast at the east railing in span 1. Note: collision damage to railing severing portion of railing making this panel no longer effective.

- Reinforce the damaged concrete bridge railing in spans 1 and 40. Consider installing approach railing with transitions and terminations compliant with current standards in both approach roadways.

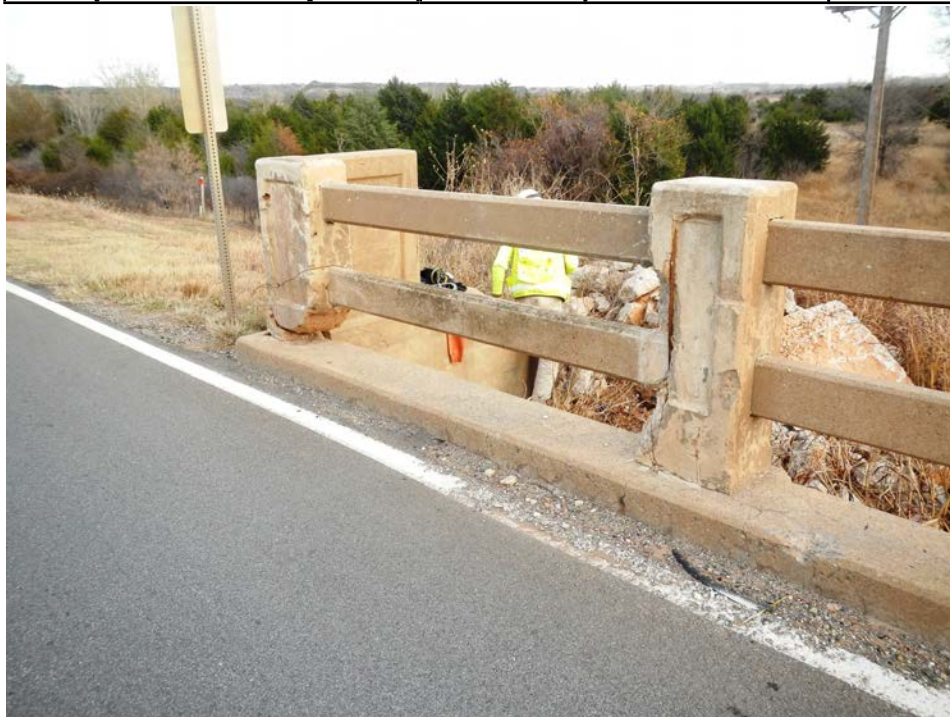
Photograph 4 - Looking northeast at the east railing in span 40. Note: the end two concrete railing posts have collision damage.

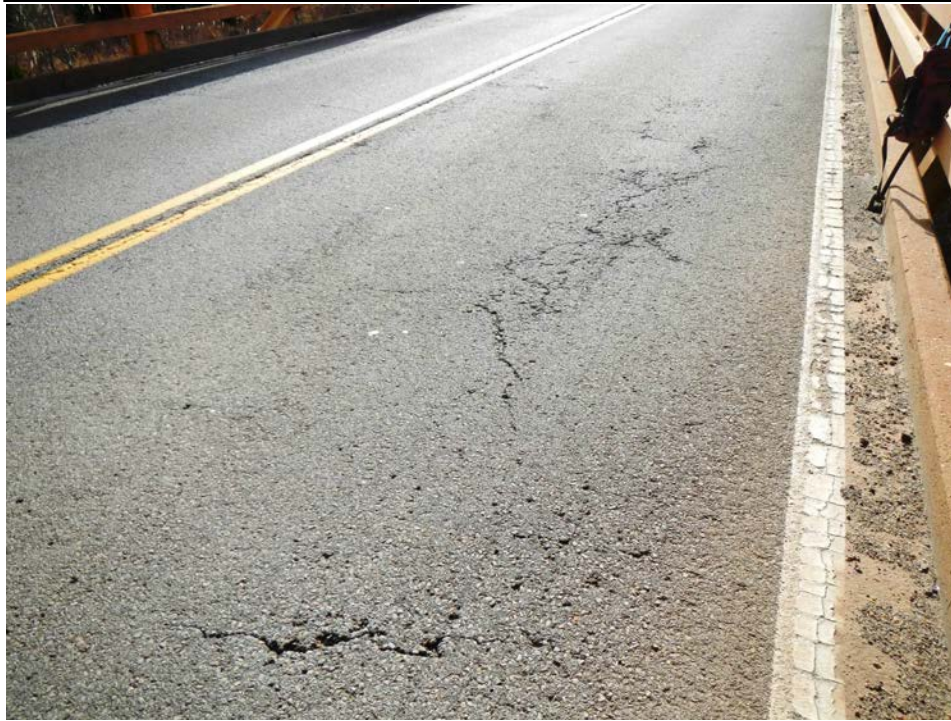
- **PX** – The asphalt wearing surface has unsealed longitudinal cracks throughout the spans (**photo 5**).
- **FX** – The deck appears to be growing from the center of each truss span as evidenced by the distress in the floor system at the end floor beams (cracking and web rotation of the floor beams, cracks in the stringer connection angles, and broken rivet heads at the stringer connection angles). These conditions were observed in nearly all of the truss spans. Growth of the approach pavement has also affected the beam spans (specifically the pier beams); however, the expansion joints are not closed, though many of the truss expansion bearings are at or near their limits of movement. Evidence of significant approach pavement growth was noted at the deck/abutment backwall interface (**photo 6**).

Photograph 5 - Looking southeast at the deck in the southbound lane in span 19. Note: unsealed longitudinal cracks in wearing surface.

- Seal cracks in the asphalt wearing surface throughout the bridge.
- Install elastomeric pads or steel shims at missing locations on the supplemental pier beams over piers 1 and 39.

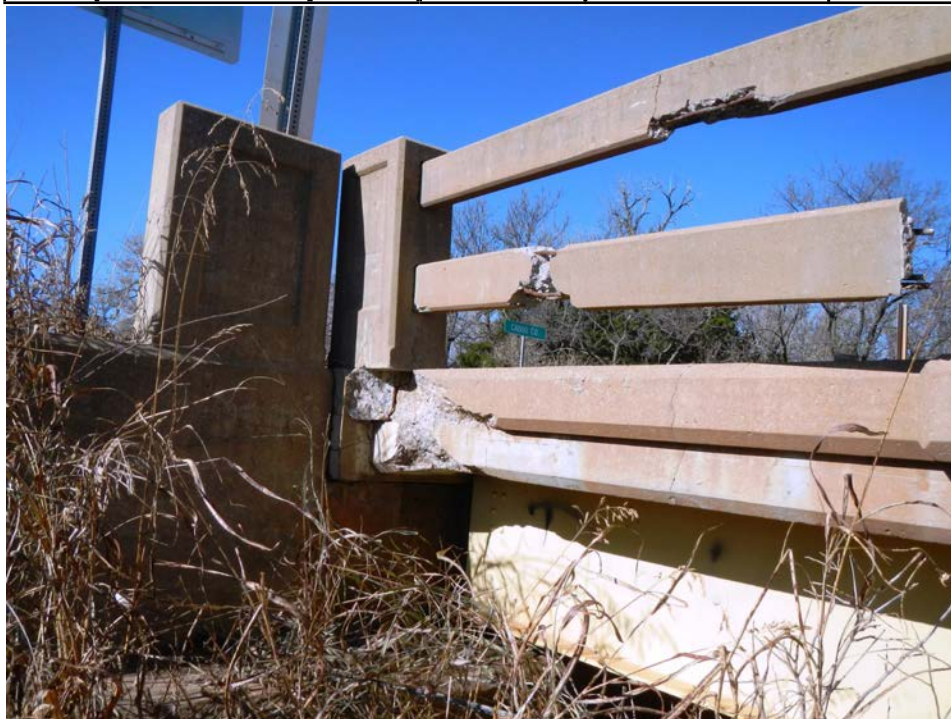
Photograph 6 - Looking southwest at span 1 intersection with the south abutment. Note: span 1 has moved 3 1/4 inches north with respect to the face of the abutment backwall.

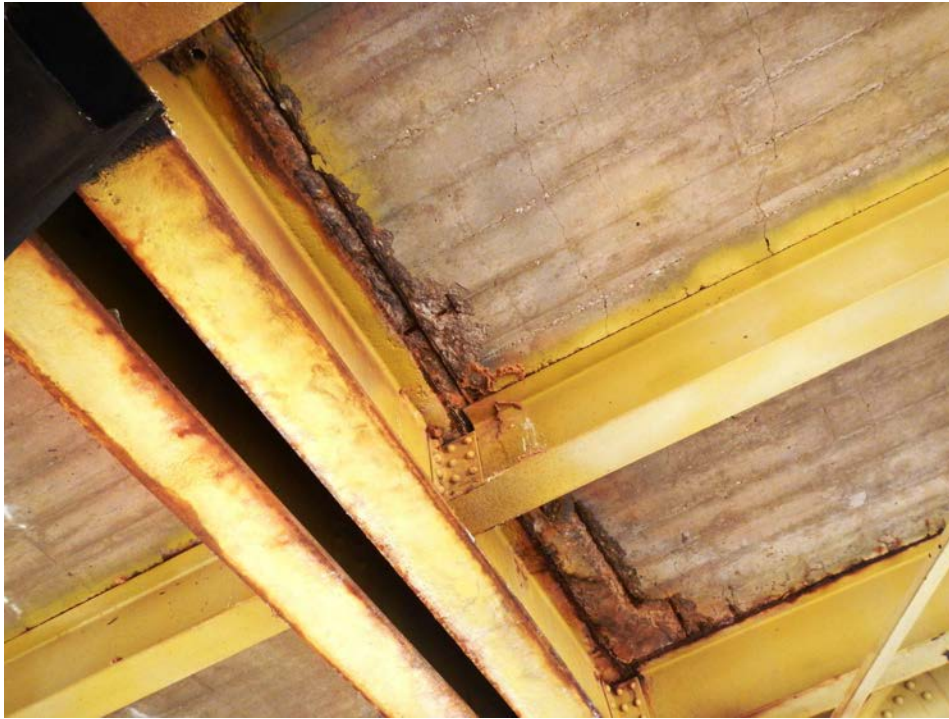
- **FX** – Spalls exposing corroded reinforcing steel are common in the underside of the deck at the expansion joints (**photo 7**). The spalls appear to be the result of deck drainage leaking through cracks in the deck adjacent to the joint.

Photograph 7 - Looking southwest at the deck soffit in span 5 at floor beam 0. Note: spalls with exposed corroded reinforcing steel exist in the deck underside full length of the floor beam.

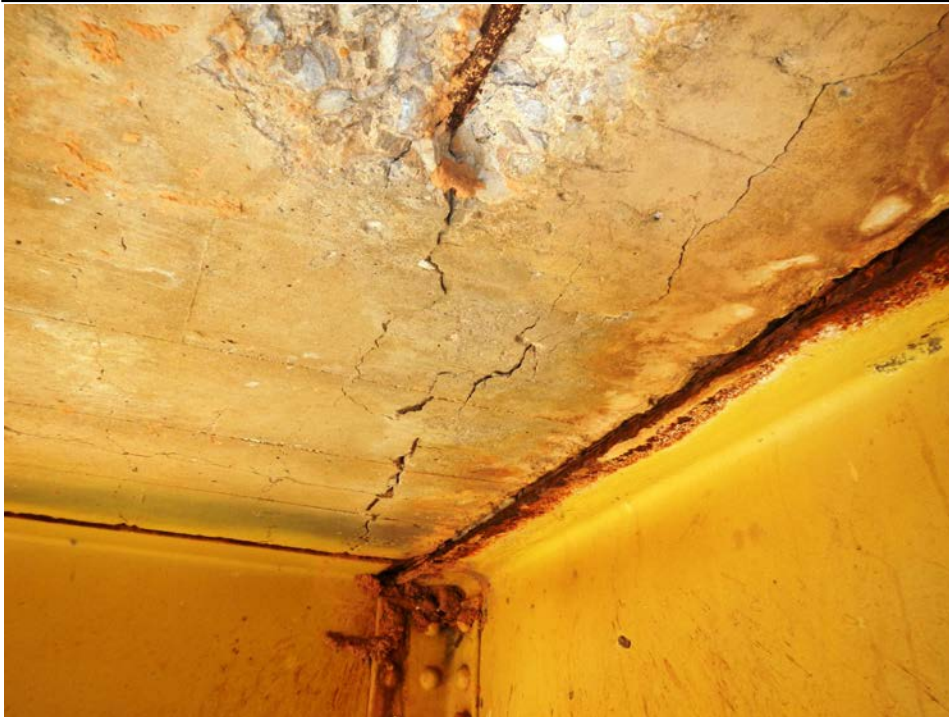
- The deck is lifting adjacent to the floor beams due to pack rust on the top flange of the stringers and floor beams (**photo 8**). This condition is worse at the end floor beams and is the result of deck drainage leaking through the expansion and deck joints. A transverse crack is common in the underside of the deck between 4 and 6 feet from the expansion joints as a result of the lifting deck. The riding surface is relatively smooth across the bridge in spite of the lifting at the floor beams.

Photograph 8 - Looking west at the deck in span 4 at floor beam 5. Note: pack rust between the deck and the floor beams is lifting the deck and causing cracks and spalls in the soffit.

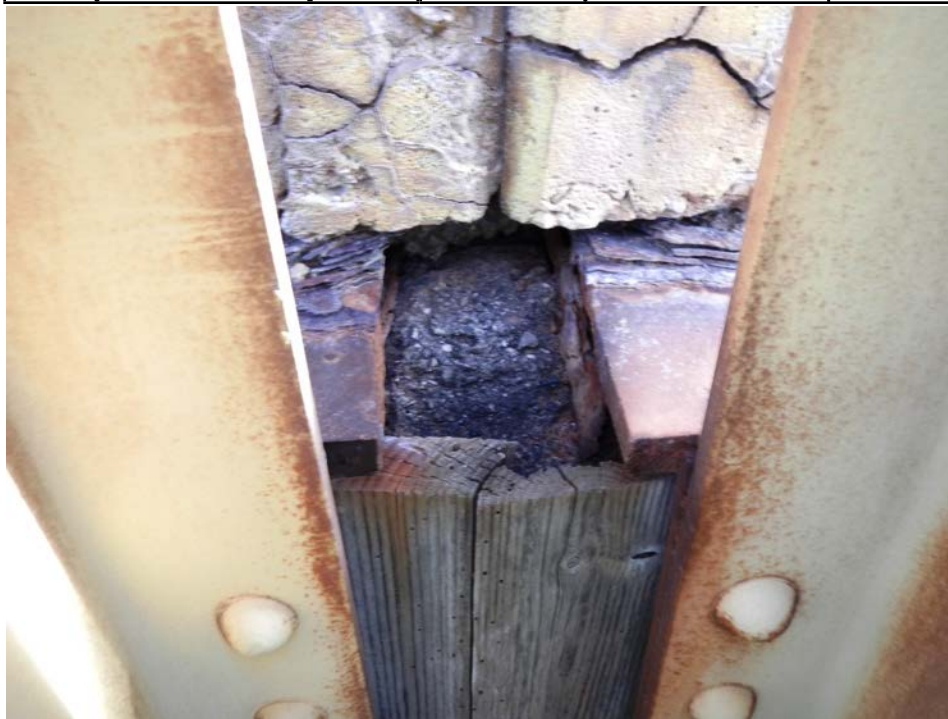
- The void between floor beam 5, span 20, and floor beam 0, span 21, over pier 20 has been completely filled with asphalt from the top of the floor beam bottom flanges to the underside of the deck (**photo 9**). The asphalt retains moisture which accelerates corrosion and section loss on the floor beams.

Photograph 9 - Looking east between floor beam 5 of span 20 and floor beam 0 of span 21. Note: the void between the floor beams is completely filled with asphalt.

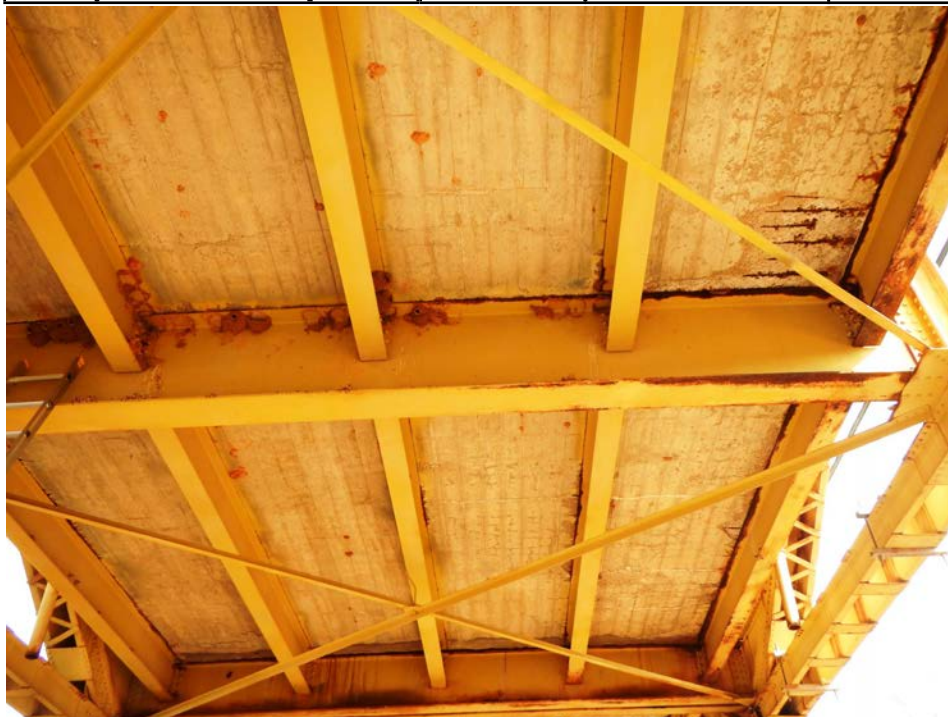
- The underside of the deck exhibits transverse cracks with light efflorescence. Spalls and deteriorated concrete exist in exterior stringer bays at isolated locations (**photo 10**). Full

Photograph 10 - Looking north at the deck soffit in span 29. Note: typical areas of spalls with exposed reinforcing steel in the deck soffit.

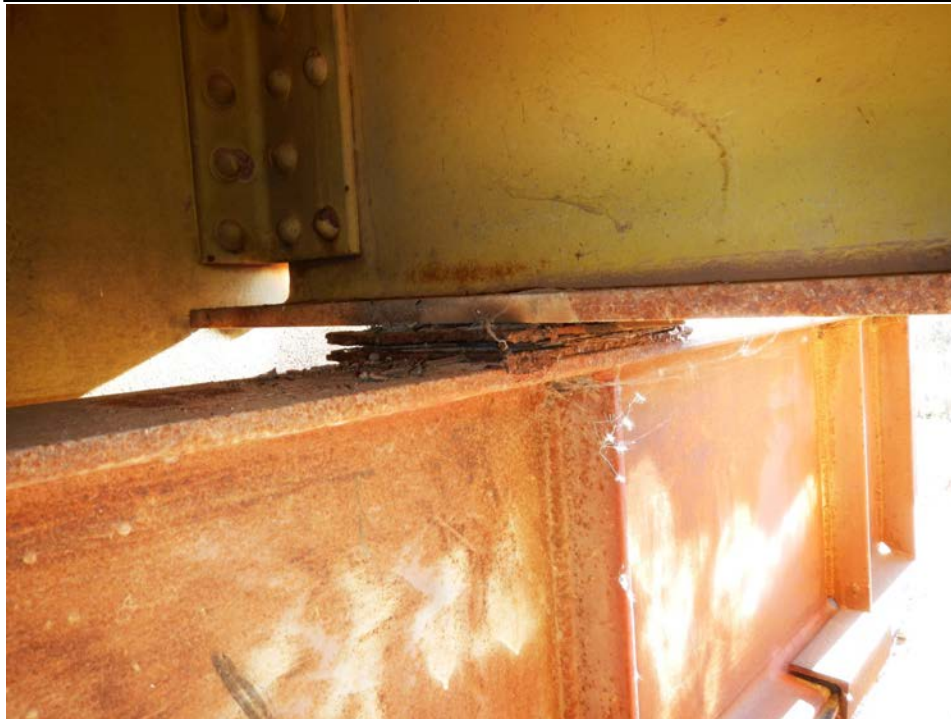
- **PX** – The connection angles for the beams to pier beam 39 are deformed due to the apparent pavement growth. The elastomeric bearings that were installed between each approach span beam and the supplemental pier beam are rotated and twisted. The bearing pad under beam 3 is no longer in place. At pier beam 1, bearings are missing at beams 1 through 4 over the supplemental pier beam and the steel bearing at beam 5 is heavily pack rusted (**photo 11**).

Photograph 11 - Looking northeast at beam 5 in span 1 at pier 1. Note: heavy pack rust between bearing plates under beam 5.

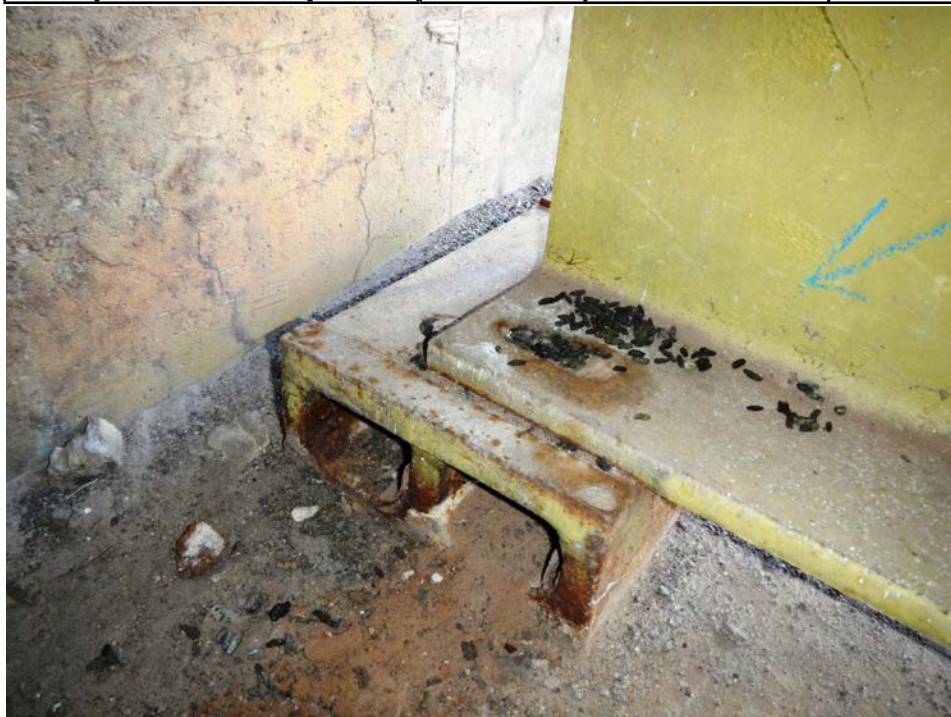
- Patches of surface corrosion exists on the top flanges of exterior beams and on the end 1-3 feet of the beams.
- Exterior beams at both abutments have sheared anchor bolts at the bearings (the interior beam anchor bolts do not extend into the abutment seat concrete). This most likely is a result of pavement pressure from the approach roadway pushing the bridge deck; up to 3 1/4 inches of movement to the north was noted at the south abutment (**photo 12**). The beam bearings at the north abutment are pushed to the south up to 2 1/4 inches also due to pavement pressure.

Photograph 12 - Looking southwest at beam 1 at the south abutment. Note: the anchor bolts at beam 1 are sheared.

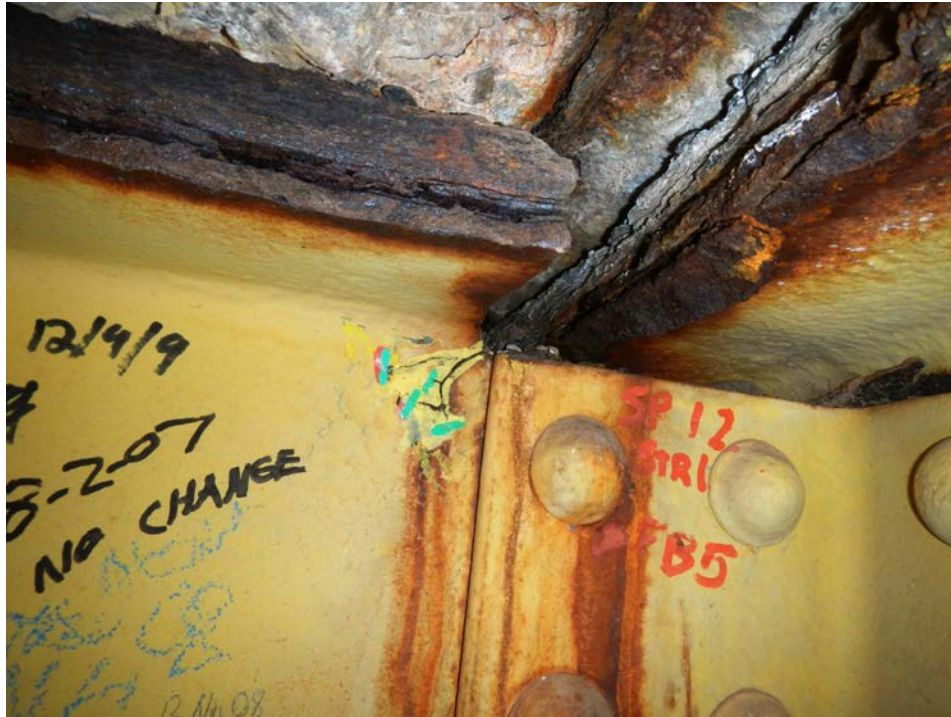
- **PX** – Cracks were observed in the web of numerous stringers at the top flange cope (see **Appendix A** for locations and lengths) (**photos 13 and 14**). The cracks exist at the stringer connections to the end floor beams and exterior stringer connections to the interior floor beams. A few new cope cracks were found and some cracks have grown 1/8 inch to 1/4 inch since the last inspection. A definitive cause for the cracks could not be determined during the inspection; however, the force of an expanding deck and differential movements between the deck and floor beam during flexure of the floor beams are a

Photograph 13 - Looking northwest at stringer 1, south face of floor beam 5 in span 12. Note: 1 1/2-inch long crack in the web of the stringer at the top flange cope.

- During future inspections, compare lengths of cracks in stringer and floor beam webs with Appendix table values. Drill crack tips that grow significantly.

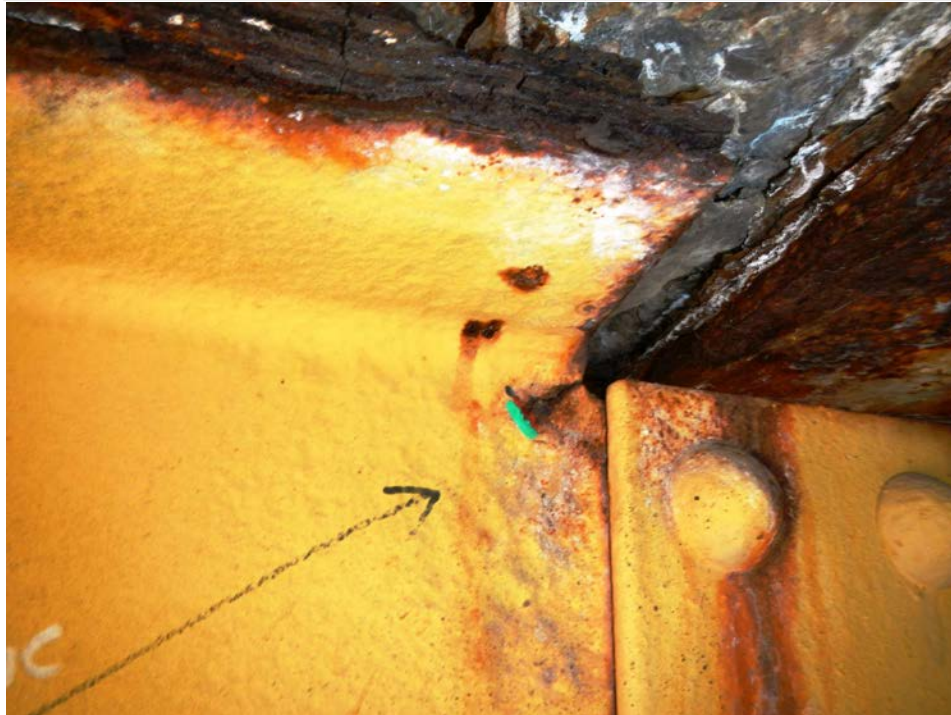
Photograph 14 - Looking east at stringer 5, north face of floor beam 0 in span 20. Note: 7/8-inch long crack in the stringer web at the top flange cope.

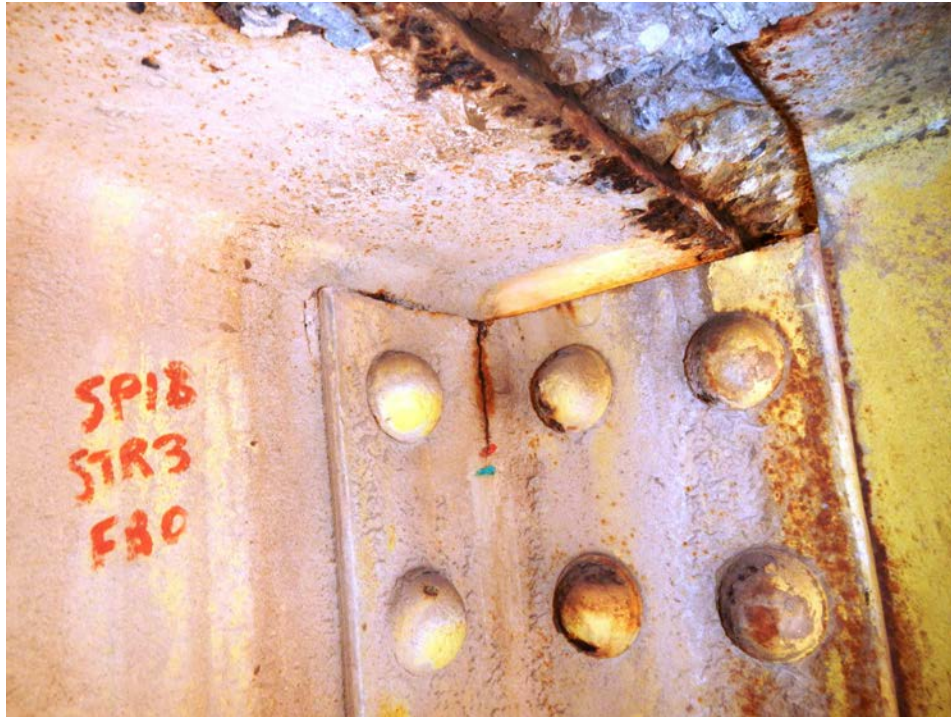
- **PX** – Cracks in the stringer connection angles (see **Appendix B** for locations and lengths) and broken rivets (see **Appendix C** for locations) were observed at numerous locations at the end floor beams (**photos 15 and 16**). The conditions were generally worse at the odd number floor beams where the expansion bearings/joints exist. The vertical cracks start at the top of the connection angle, propagating down through the angle leg adjacent to the floor beam web at the fillet. A few new connection angle cracks were found and some cracks have grown 1/8-inch to 1/4-inch since the last inspection. These cracks typically have a horizontal offset as if the floor beam web is being pushed away from the stringer. Broken rivets were always between the connection angle and the floor beam web and nearly always the top rivet of the connection angle (**photo 17**). Typically the rivet shank is being pulled through the connection angle where the rivet heads have broken away. These conditions appear to be the result of the deck pushing against the ends of the floor beams. It is speculated that the joints above the fixed bearings are closed, causing all expansion to occur at the expansion floor beams. The fixed joints are paved over and this theory could not be confirmed visually.

Photograph 15 - Looking southwest at stringer 3, north face of floor beam 0 in span 18. Note: 2 3/4-inch long vertical crack in the east connection angle.

- Repair cracks in stringer connection angles by adding seat brackets below stringer.
- Repair section loss in stringer and floor beam webs where corrosion holes and/or heavy section loss exists with welded plates and/or angles.

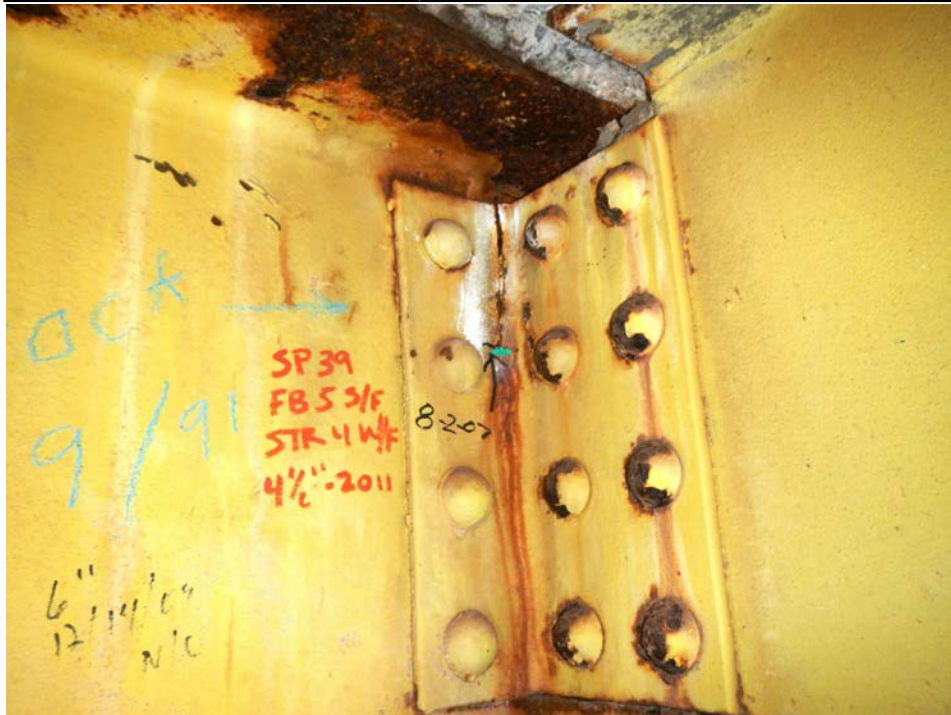
Photograph 16 - Looking northeast at stringer 4 on the south face of floor beam 5 in span 39. Note: 4 5/8-inch long vertical crack in the west connection angle.

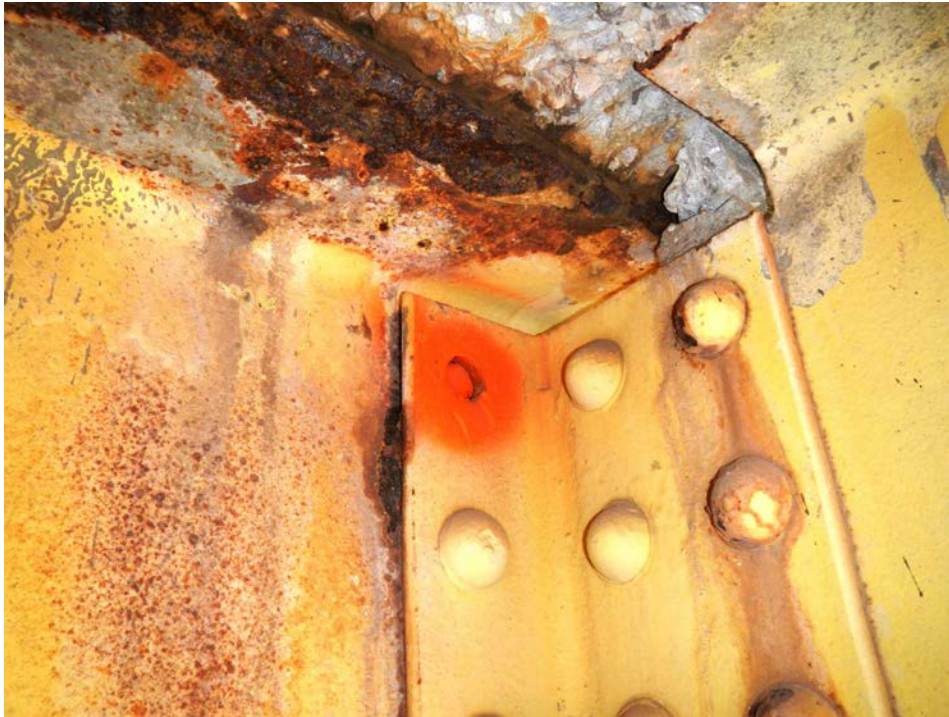
Photograph 17 - Looking southwest at stringer 2, north face of floor beam 0 in span 18. Note: popped rivet head with shank no longer in shear plane at stringer connection to floor beam.

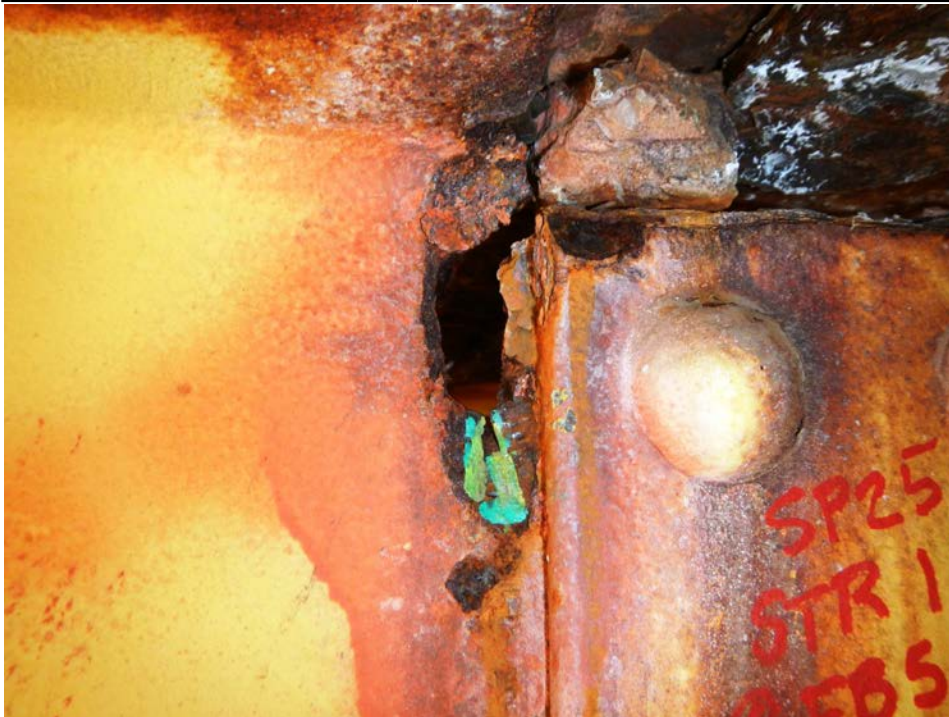
- **PX** – Section loss, including corrosion holes, exists through the exterior stringers web at the end floor beams at numerous locations (see **Appendix D** for locations and sizes) (**photos 18 and 19**). The deterioration is typically worst at stringer 5 and is due to deck drainage passing through the joints. Numerous through holes also have cracks extending from the holes due to very thin remaining web thickness adjacent to the holes.

Photograph 18 - Looking west at stringer 1, south face of floor beam 5 in span 25. Note: 2-inch vertical by 5/8-inch horizontal corrosion hole in the stringer web at the top flange cope with a 5/8-inch long vertical crack.

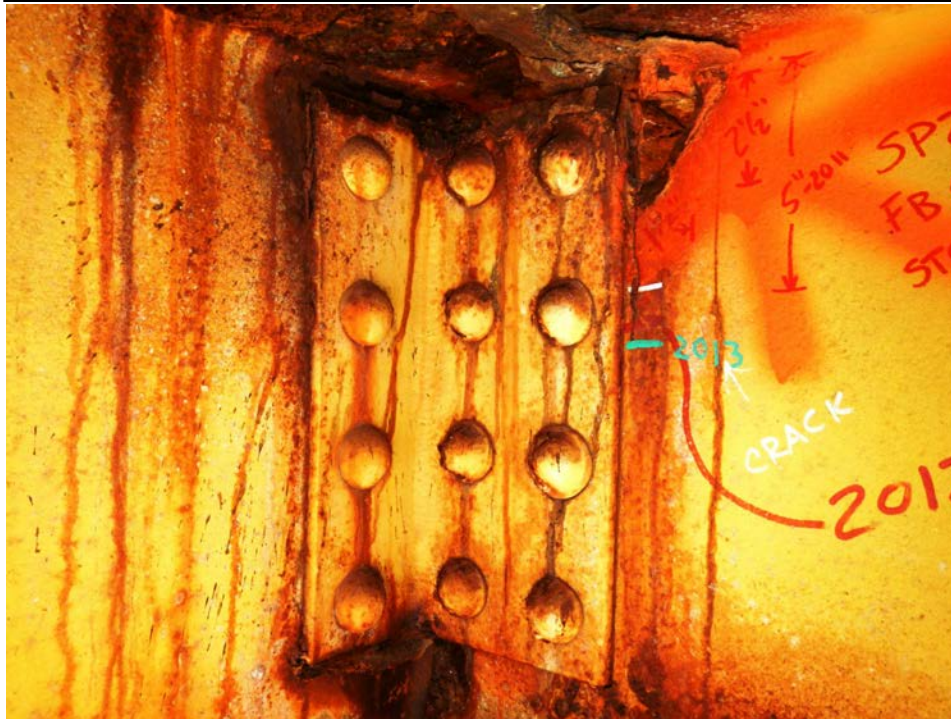
Photograph 19 - Looking east at stringer 5, south face of floor beam 5 in span 21. Note: 2 1/2-inch vertical by 1 1/2-inch horizontal corrosion hole in the stringer web at the top flange cope with a 3 7/8-inch long vertical crack.

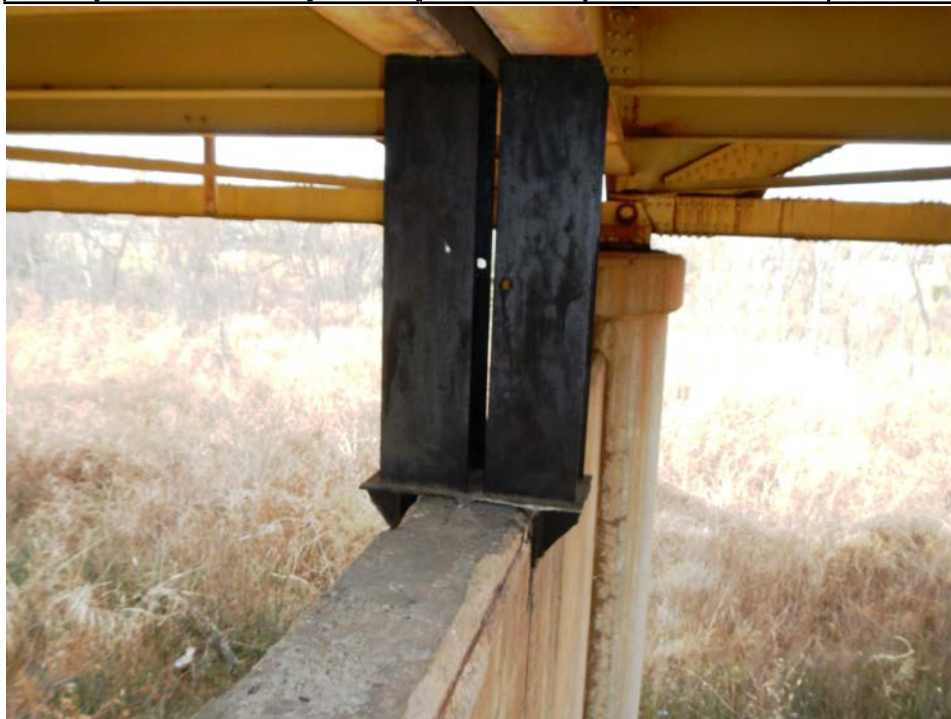
- **CX** – The end floor beams for the truss spans are twisted producing a sweep of the bottom flange away from the joint at most of the piers (see **Appendix E** for locations and dimensions) (**photo 20**). The bottom flange sweep ranges from 3/16 inch to 7/8 inch. All of the end floor beams with previously noted sweep have been recently retrofitted with the addition of stiff leg columns at/near midspan of the floor beams except at pier 38. At pier 38, both floor beam 5, span 38, and floor beam 0, span 39 have 3/8-inch sweep away from the joint with no stiff leg installed (**photo 21**). The floor beam top flange is bent towards the joint causing the bottom flange to have a sweep in the opposite direction. The floor beam distortion appears to be caused by the deck pushing against the top flanges of the floor beam and pack rust development at the joint armor pushing down and eccentrically on the floor beam top flange.

Photograph 20 - Looking west at pier 22. Note: typical stiff leg retrofit to address floor beam sweeps.

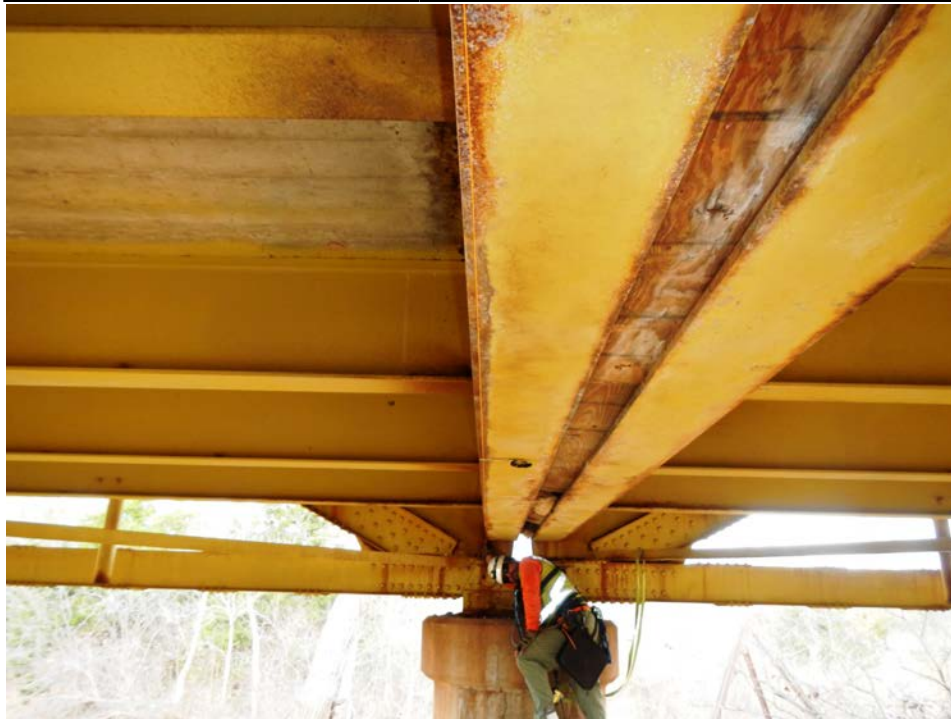
Photograph 21 - Looking west along the floor beams at pier 38. Note: 3/8-inch sweep in the floor beam with no stiff leg retrofit.

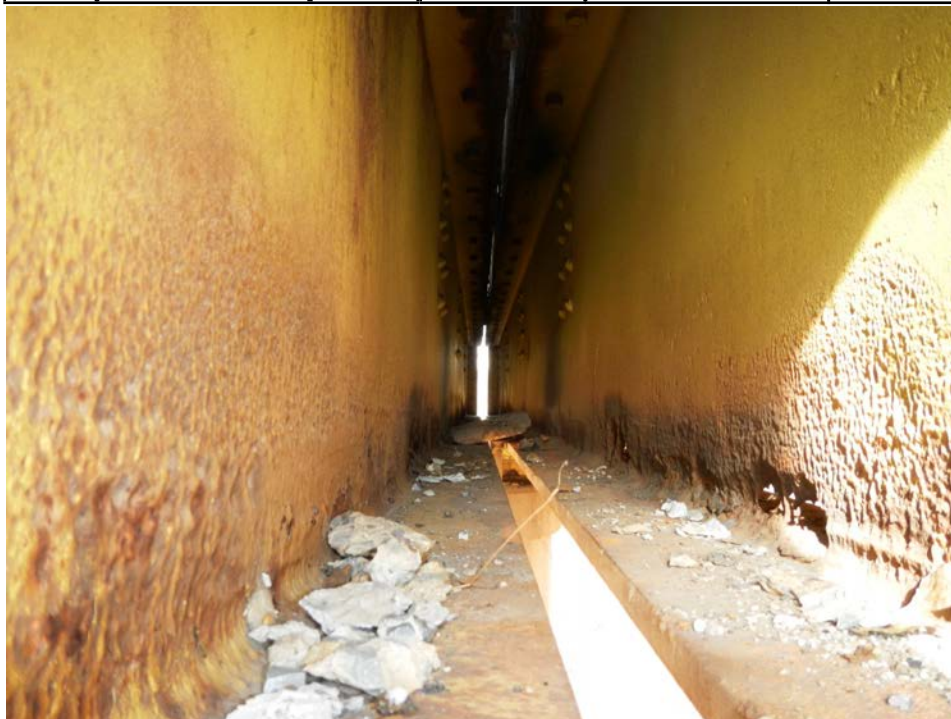
- **PX** – Active section loss is common on the floor beams under the expansion joints. Corrosion holes were observed through the web of the floor beams at several locations (see **Appendix F** for locations and dimensions) (**photo 22**). Corrosion holes were also noted through the web at the top flange cope of the interior floor beams at numerous locations (see **Appendix F** for locations and dimensions) (**photo 23**).

Photograph 22 - Looking west between the end floor beams at pier 37. Note: active section loss in floor beam webs under joints.

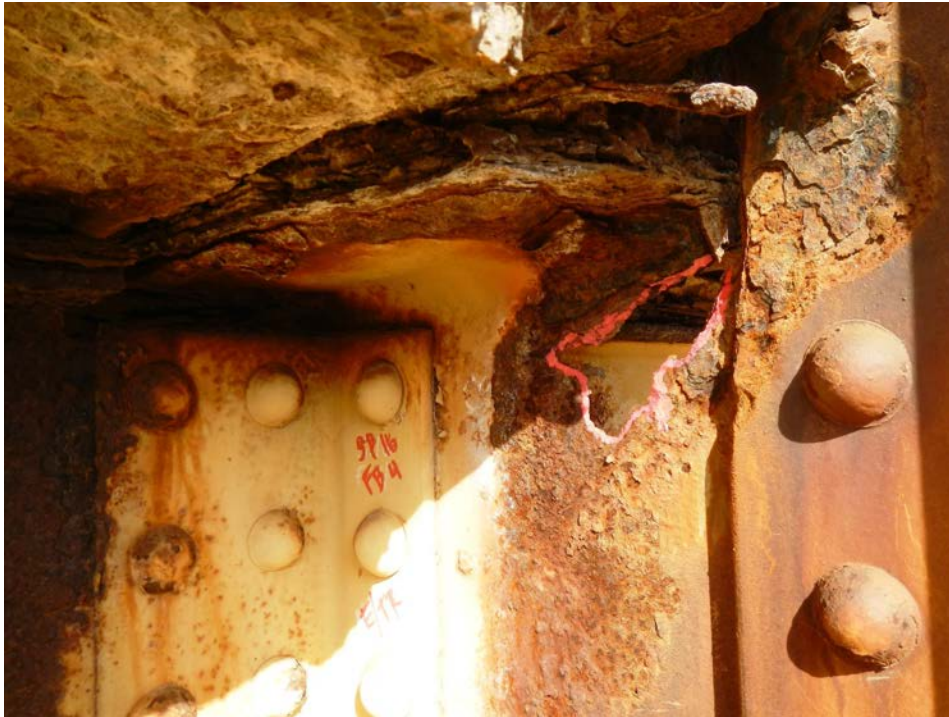
Photograph 23 - Looking northeast at floor beam 4, span 16 at the east truss connection. Note: 3 1/2-inch vertical by 4 1/4-inch horizontal corrosion hole through the floor beam web at the connection to the truss.

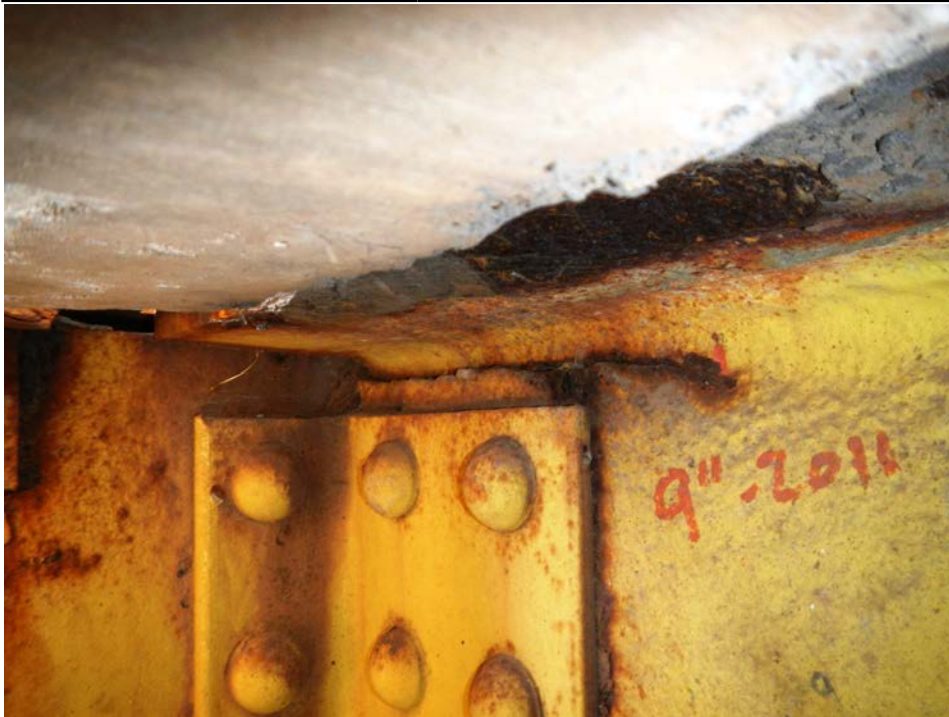
Photograph 24 - Looking southeast at floor beam 0, span 38 at the east truss connection. Note: 9-inch long horizontal crack in the floor beam web with at 3/8-inch lateral offset.

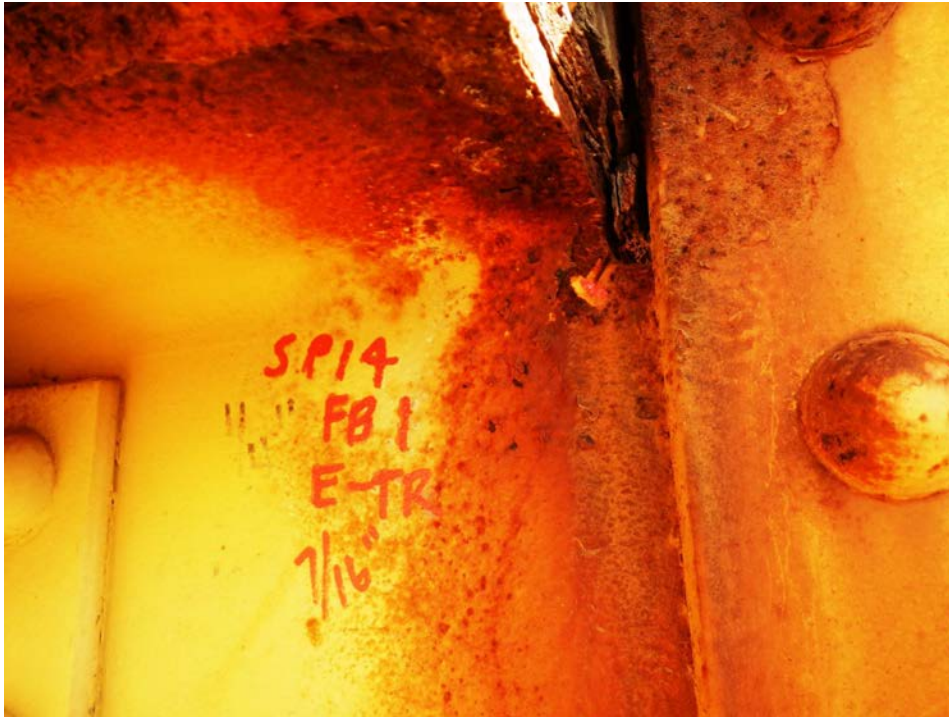
Photograph 25 - Looking north at floor beam 1, span 14 at the east truss connection. Note: 7/16-inch crack in the floor beam web at the connection to the east truss.

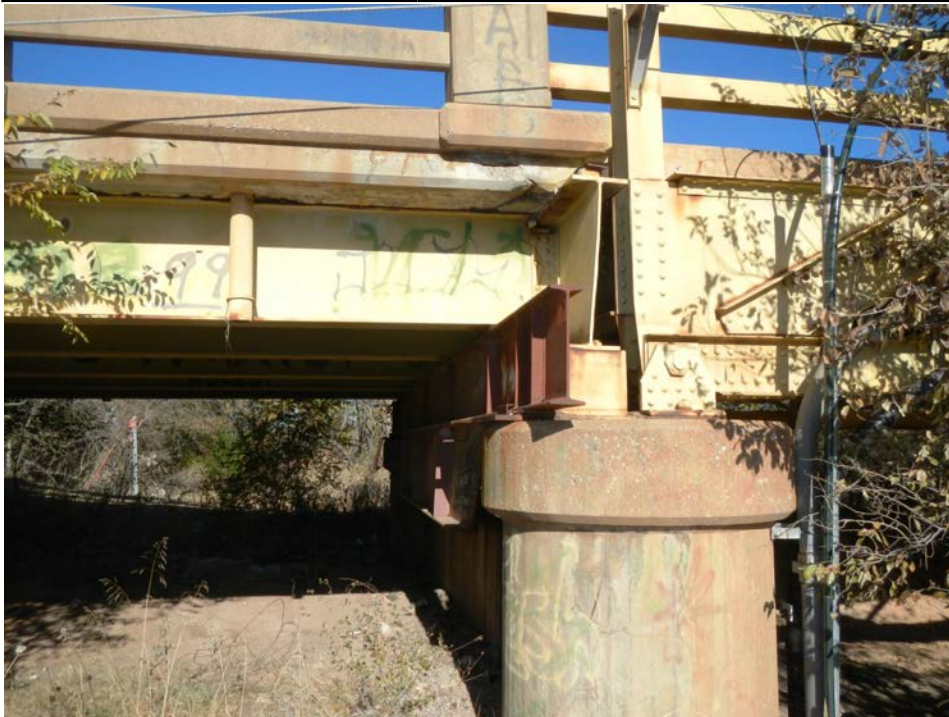
Photograph 26 - Looking west at the pier beam at pier 1. Note: severe rotation of pier beam with supplemental pier beam installed.

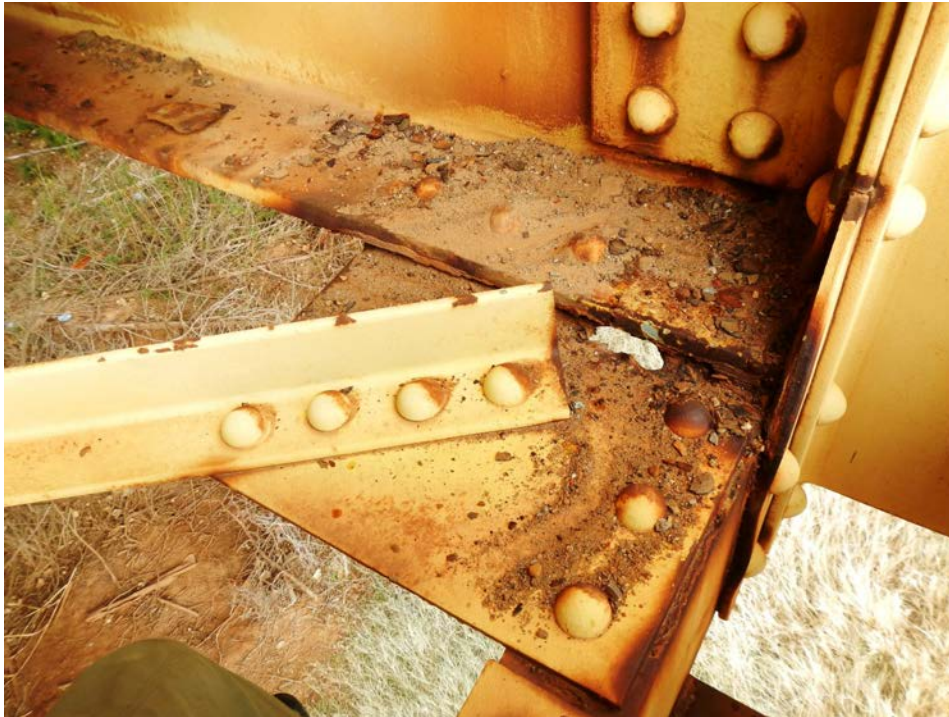
Photograph 27 - Looking northwest at the floor system bracing gusset plate adjacent to floor beam 1 and the east truss in span 37. Note: typical through holes in lower lateral bracing gusset plate.

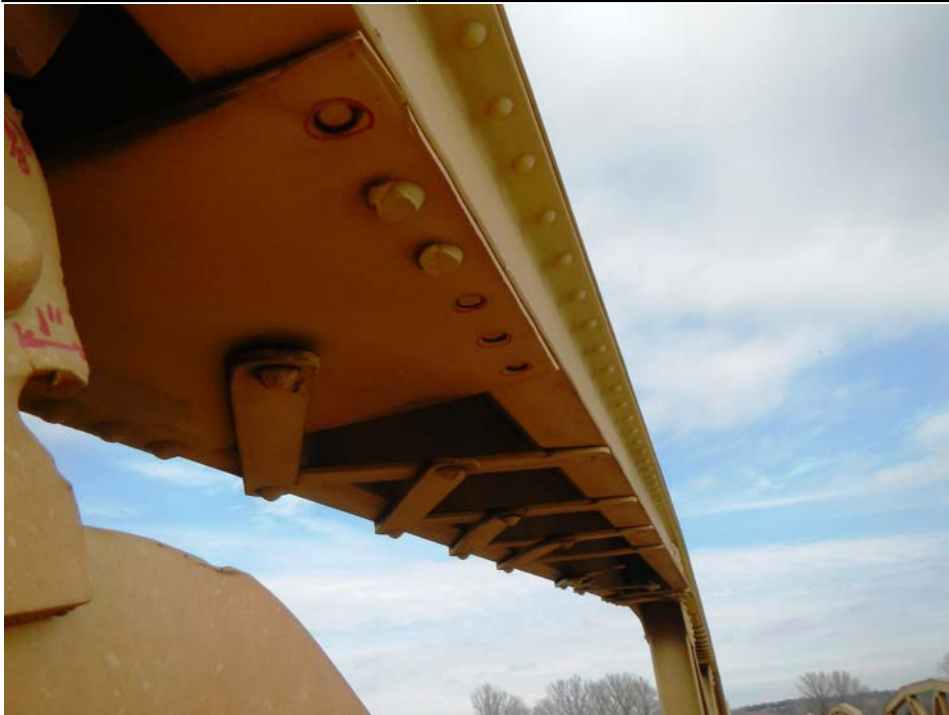
Photograph 28 - Looking north at west U1U2, span 31. Note: multiple sheared rivets for the bottom lacing due to impact damage.

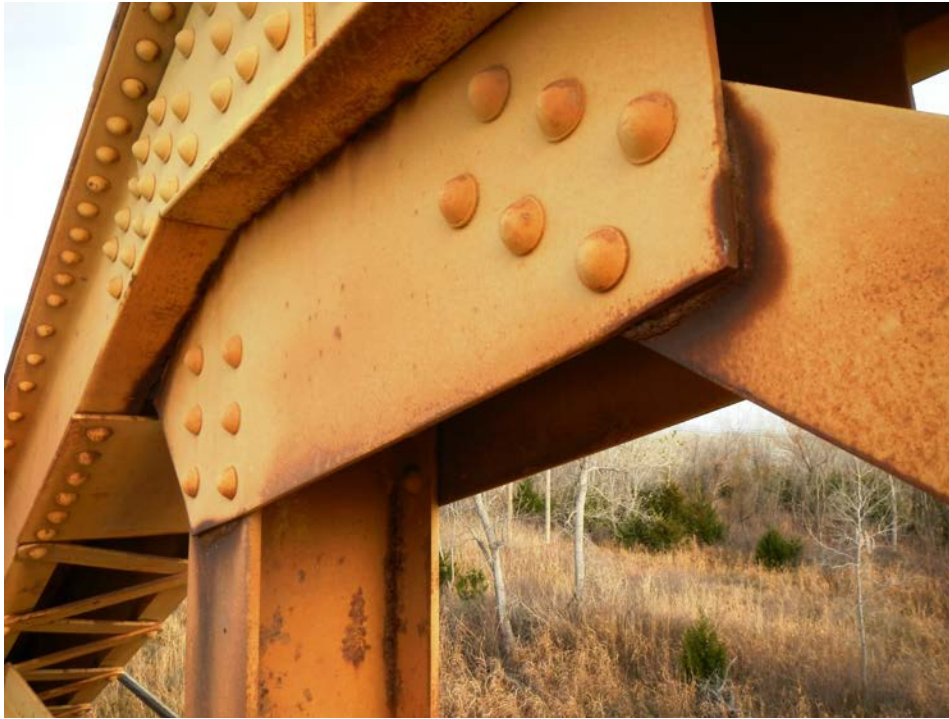
Photograph 29 - Looking northeast at a typical upper chord end gusset plate. Note: common 3/8-inch thick pack rust between the gusset plate and truss web member.

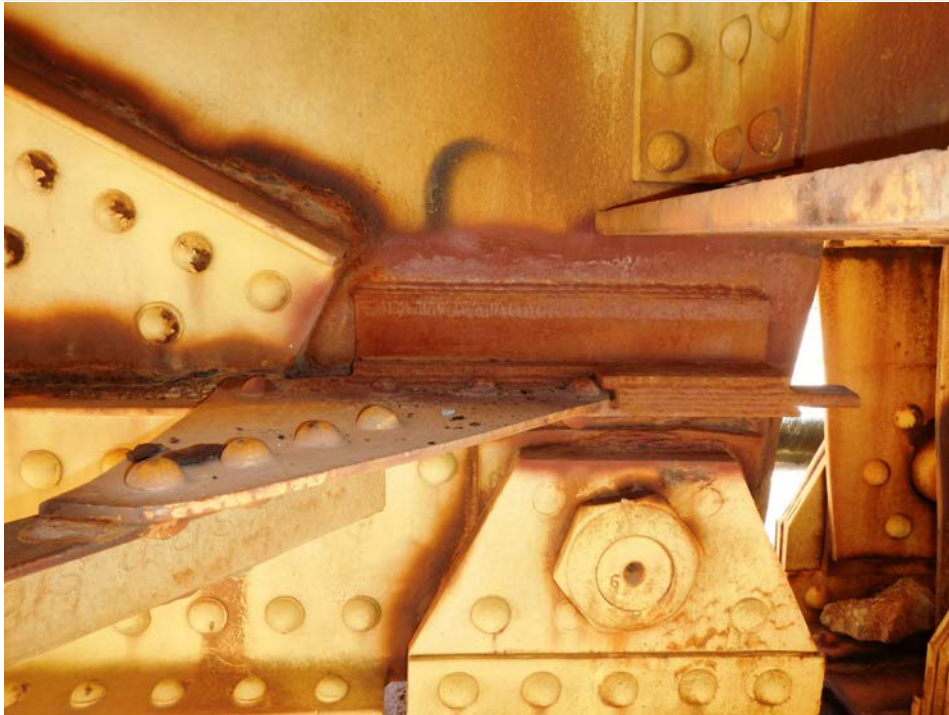
Photograph 30 - Looking east at east L0, span 8. Note: 5 1/2-inch long crack in L0 gusset plate at the top of the lower chord repaired with welded angle and plates.
