# Fracture Critical Bridge Inspection Report

NBI Bridge No.: 04085

Route U.S. 281 over S. CANADIAN RIVER  
Canadian County

Re: Fracture Critical Bridge Inspection Report  
Structure No.: 0902 0000 X  
NBI No.: 04085  
US 281 over South Canadian River  
ODOT Field Division 4, Canadian County

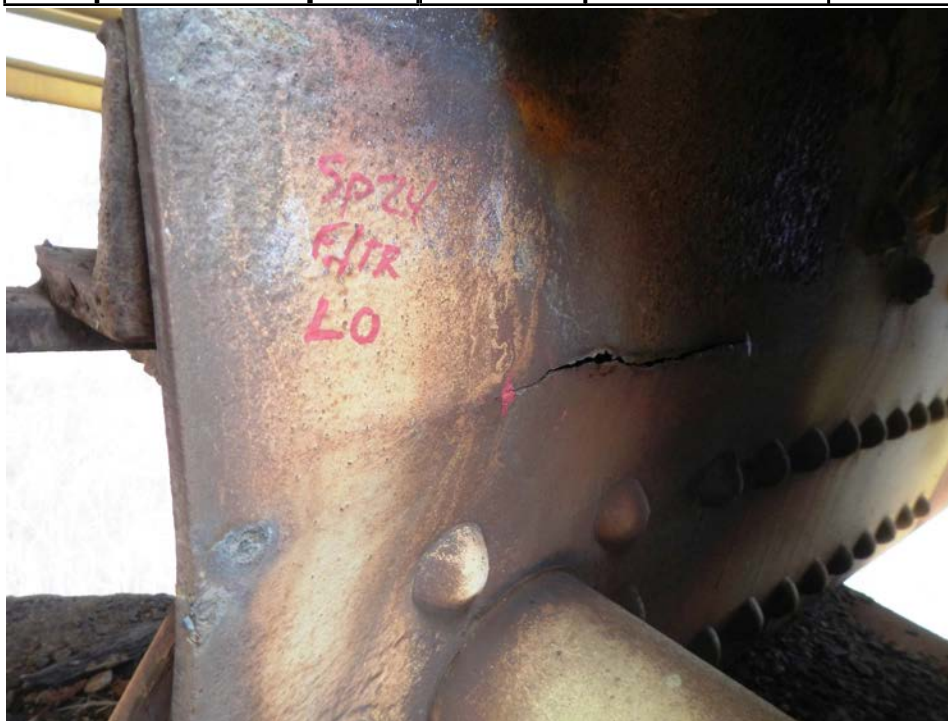
Photograph 31 - Looking northwest at east L0, span 24. Note: 8-inch long horizontal crack in the inboard gusset plate.

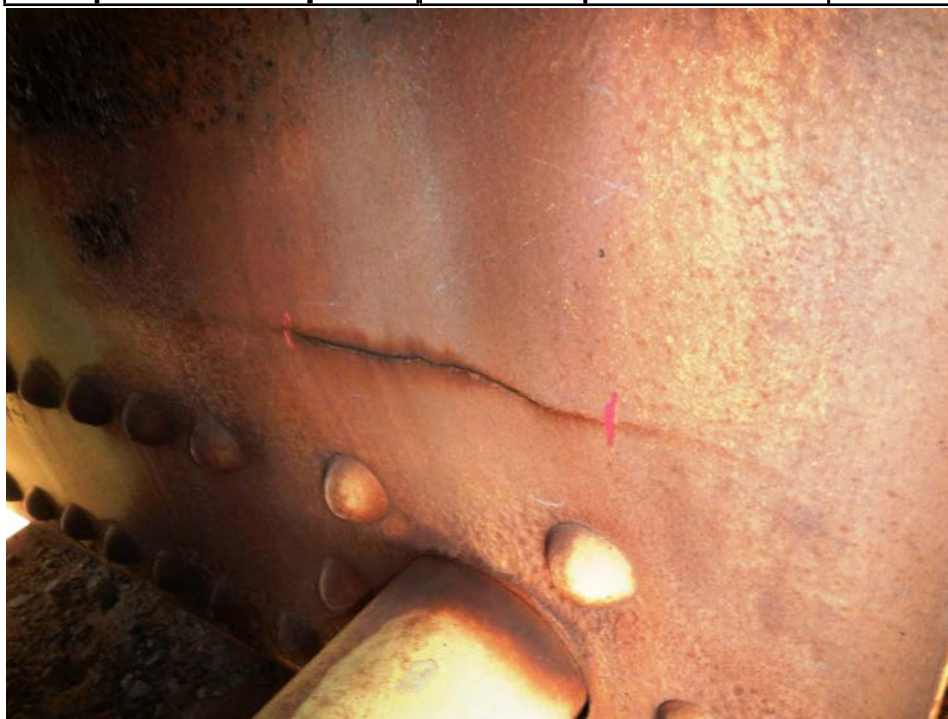
Photograph 32 - Looking southwest at east L5, span 29. Note: 6 1/4-inch long horizontal crack in the inboard gusset plate.

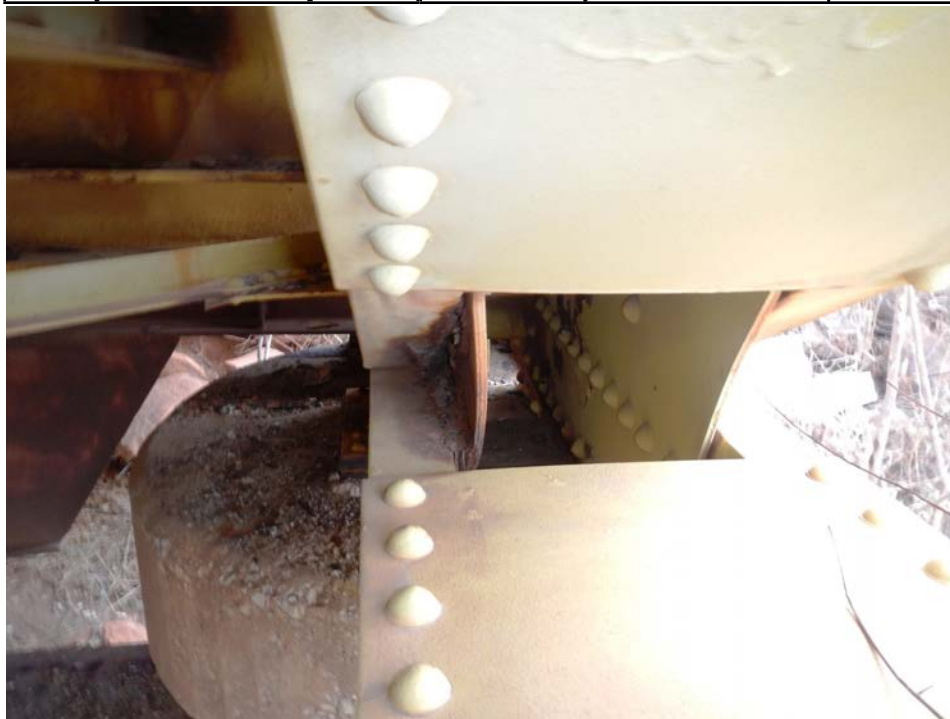
Photograph 33 - Looking north at east L5, span 39. Note: inboard gusset plate is bowing 1-inch due to pack rust.

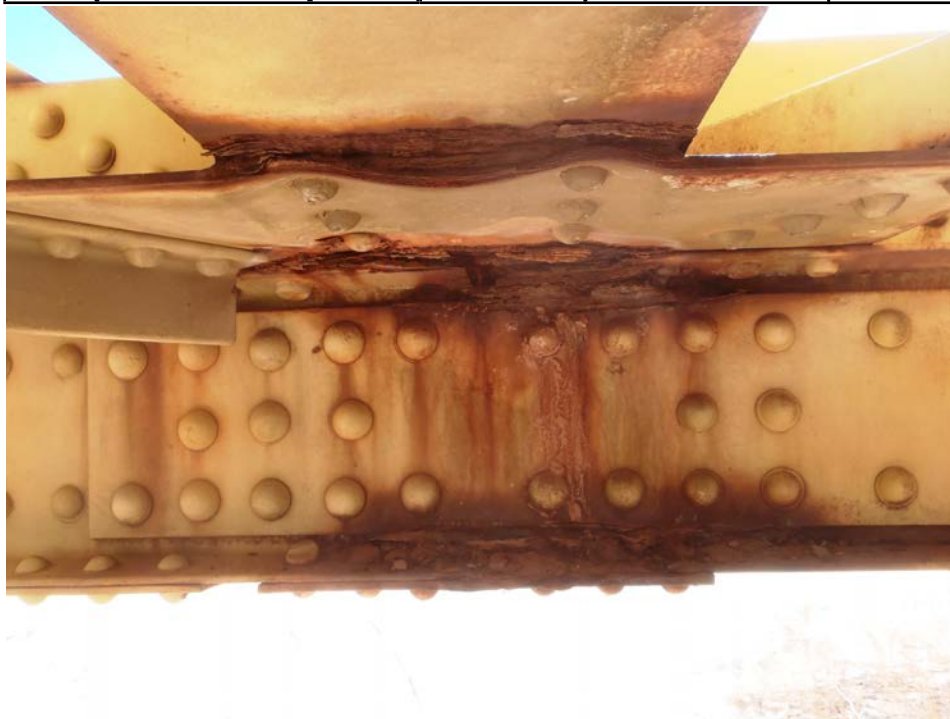
Photograph 34 - Looking east at the lower chord at east L2, span 2. Note: typical corrosion and section loss of the lower chord channels and splice plates under floor beams.

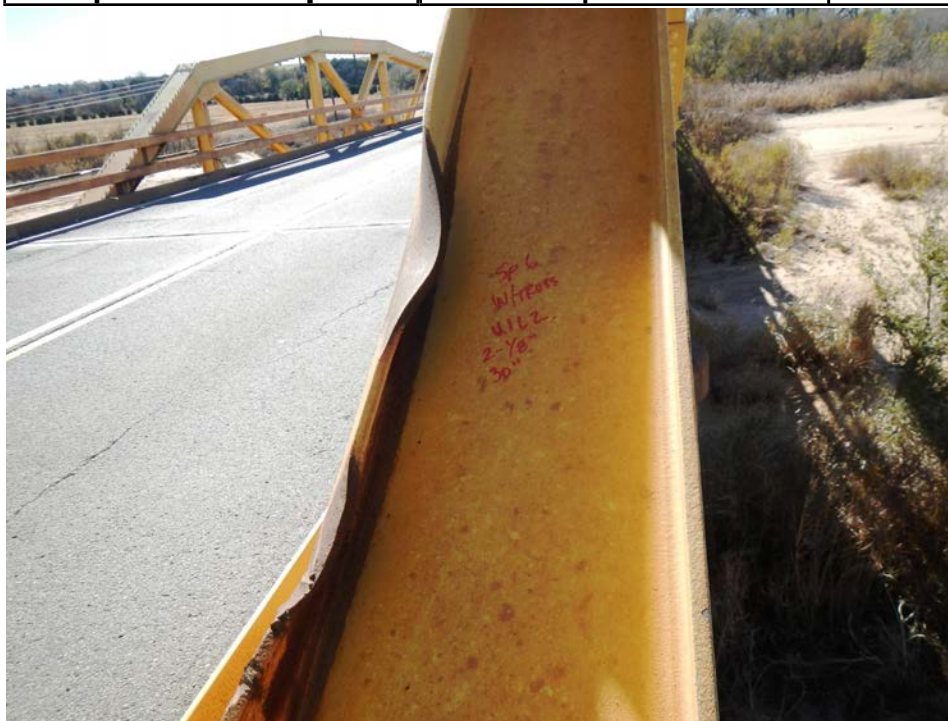
Photograph 35 - Looking south at west U1L2, span 6. Note: collision damage has bent the inboard flange of the diagonal 2 1/8 inches over a 30-inch length.

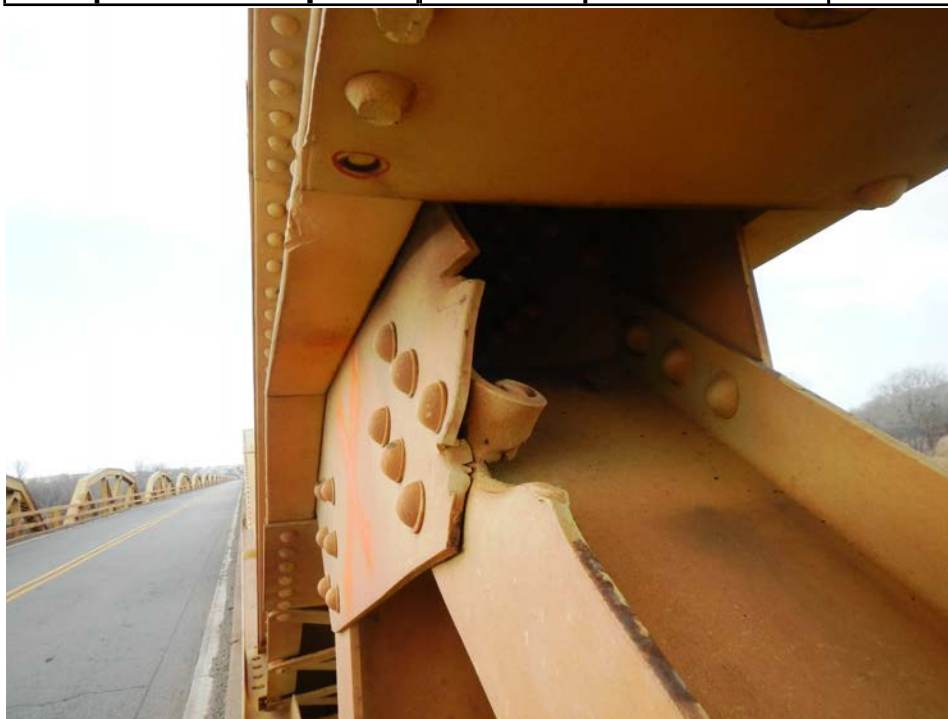
Photograph 36 - Looking south at west U1, span 31. Note: the inboard flange of U1L2 has a tear as a result of collision damage and the inboard gusset plate has two gouges.

- Replace sheared rivets in the vertical connection, upper chord, and end post with bolts near west U1 in spans 31 and 37.
- Grind out notches and cuts in inboard flange and gusset plate at west U1L2, span 31. Consider strengthening member if further distress is noted.

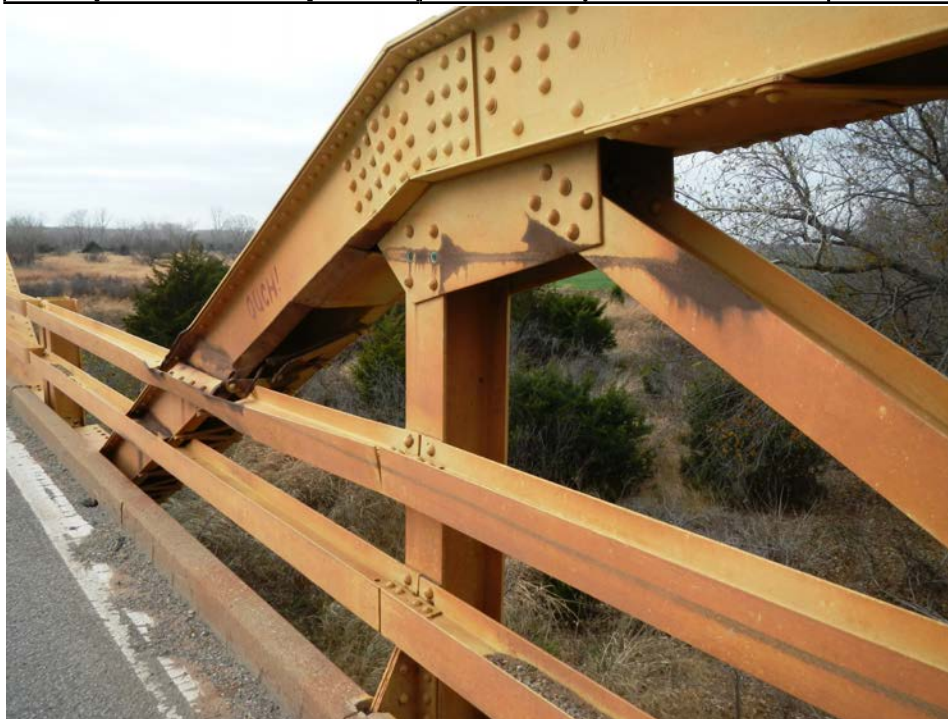
Photograph 37 - Looking southwest at west U1, span 37. Note: general view of impact damage to truss.

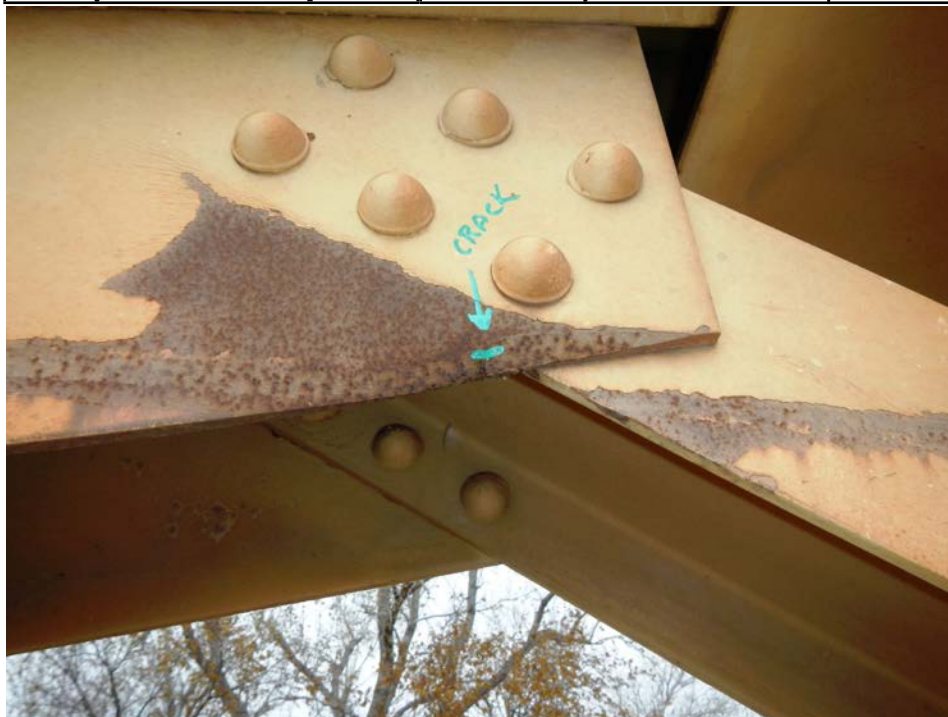
Photograph 38 - Looking west at the gusset plate at west U1, span 37. Note: 5/16-inch crack in the inboard gusset plate adjacent to U1L2.

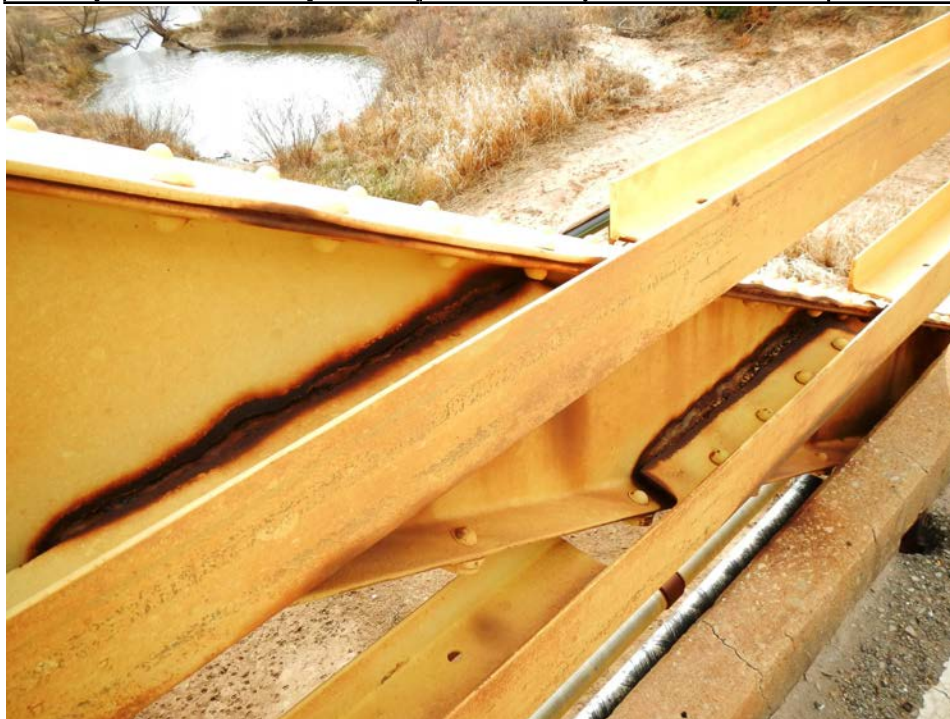
Photograph 39 - Looking southeast at east U1L0, span 34. Note: moderate pack rust between the bridge railing and the end post.

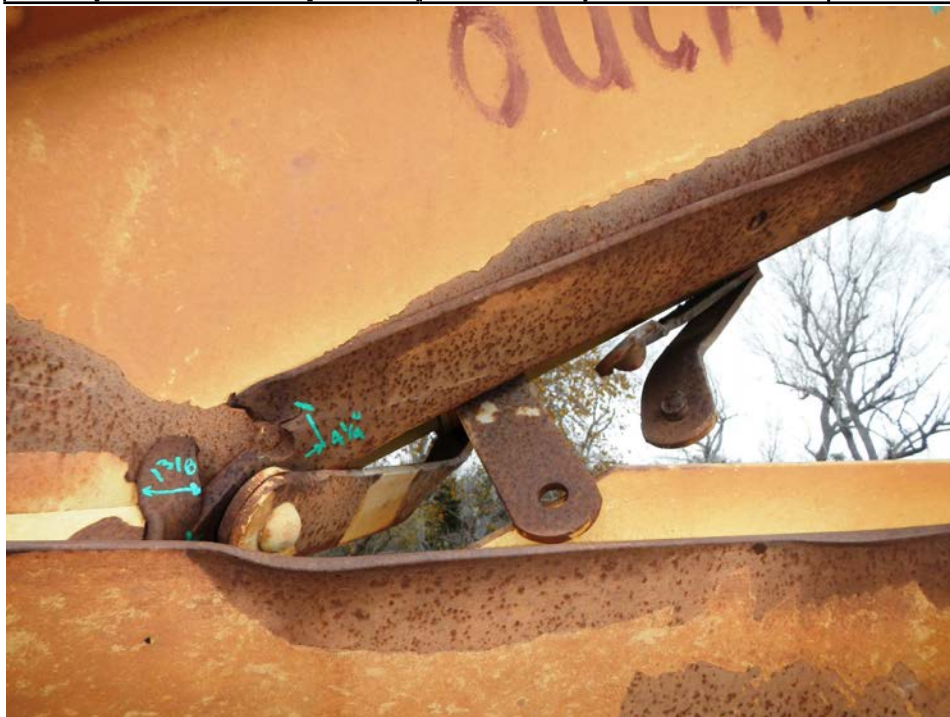
Photograph 40 - Looking west at the end post adjacent to the railing for west L0U1, span 37. Note: Three lacing bars detached on the bottom face of the end post.

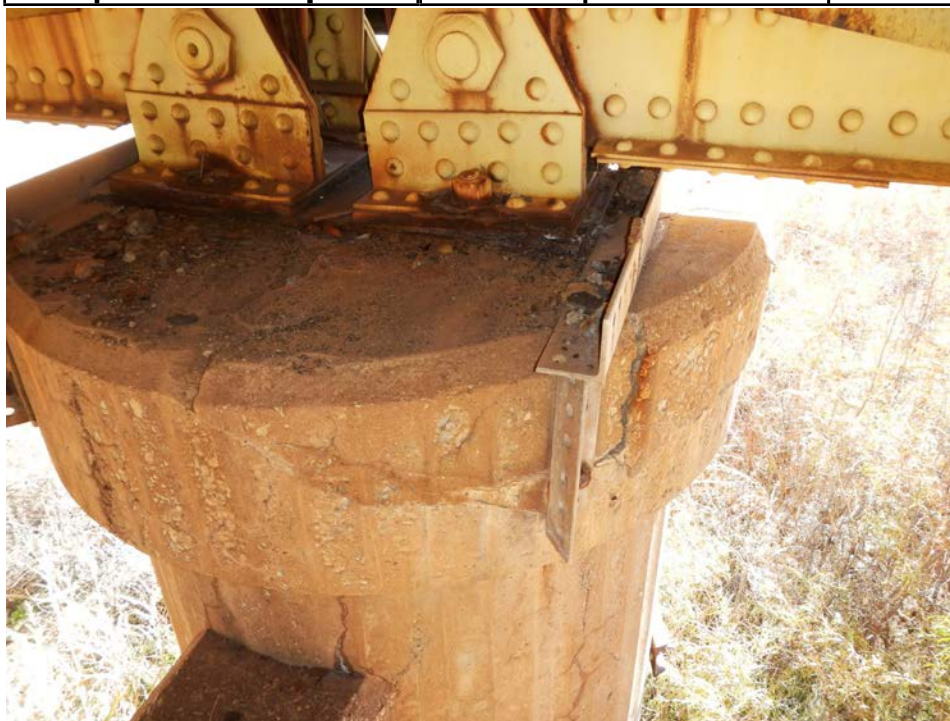
Photograph 41 - Looking east at the east column at pier 3. Note: 1-inch wide crack in the capital of the column.

- Monitor the cracking/spall at the east column capital, pier 3.
- Monitor the pack rust, pitting, and anchor bolts on truss bearings for further signs of distress throughout.

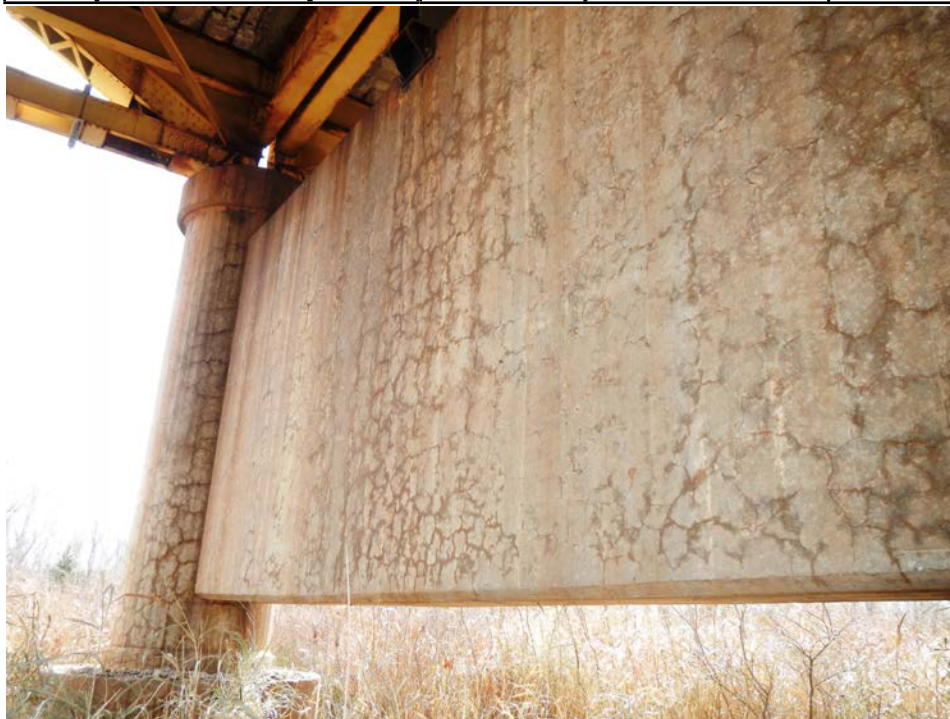
Photograph 42 - Looking southeast at the north face of pier 23. Note: vertical and horizontal cracks in the web wall.

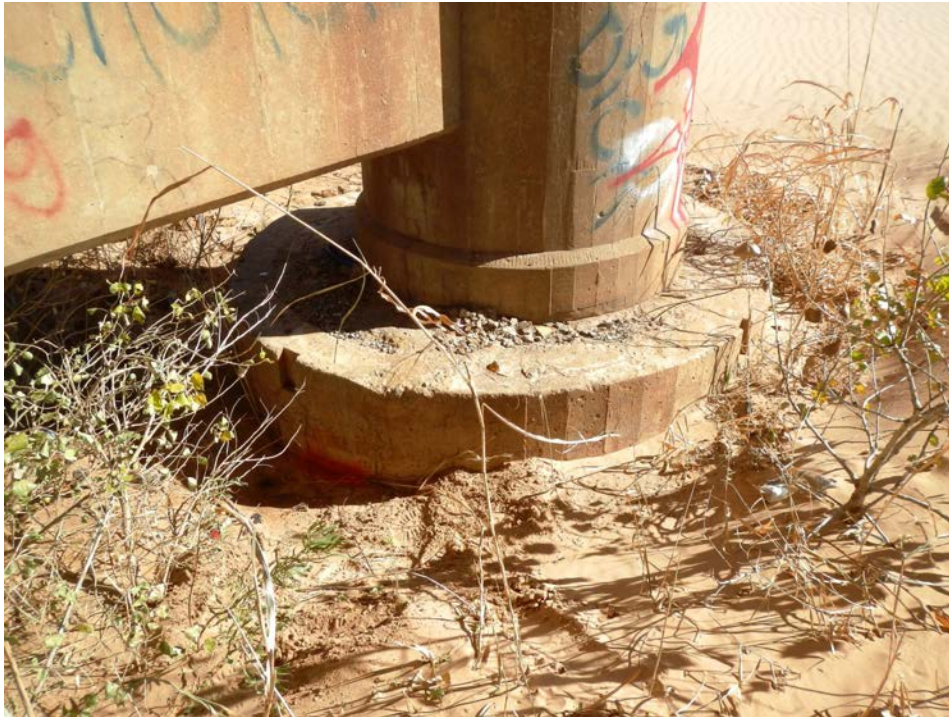
Photograph 43 - Looking northeast at the east pier column foundation for pier 7. Note: up to 18-inch deep scour exposing the top of the foundation.

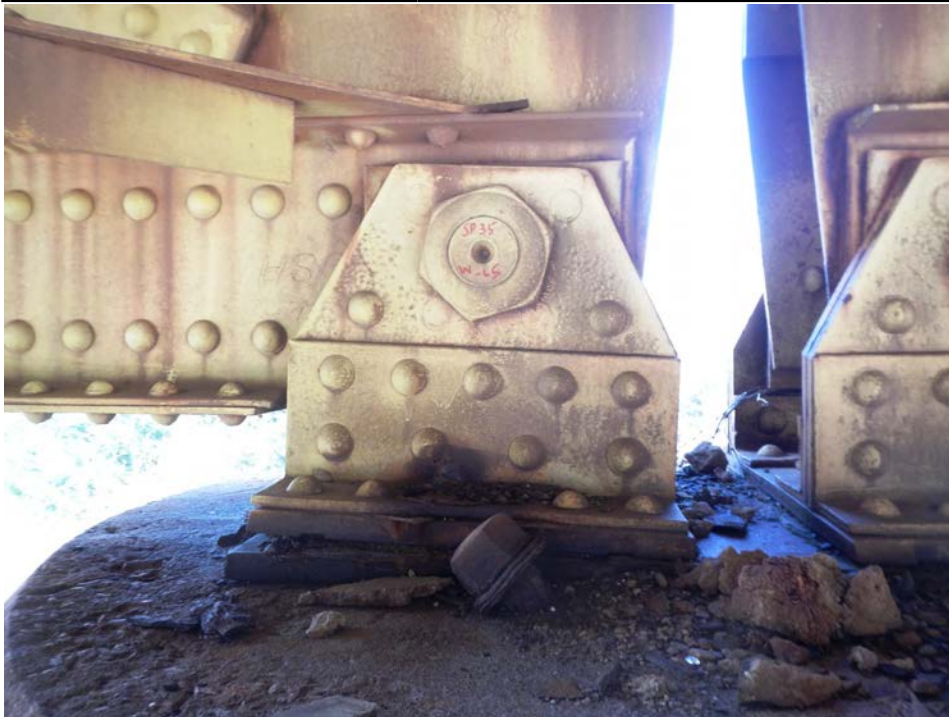
Photograph 44 - Looking west at the expansion bearing for span 35, west truss at pier 35. Note: the bearing is rocked 3/4-inches with pack rust between the sole plate and masonry plate, and the anchor bolt is broken.

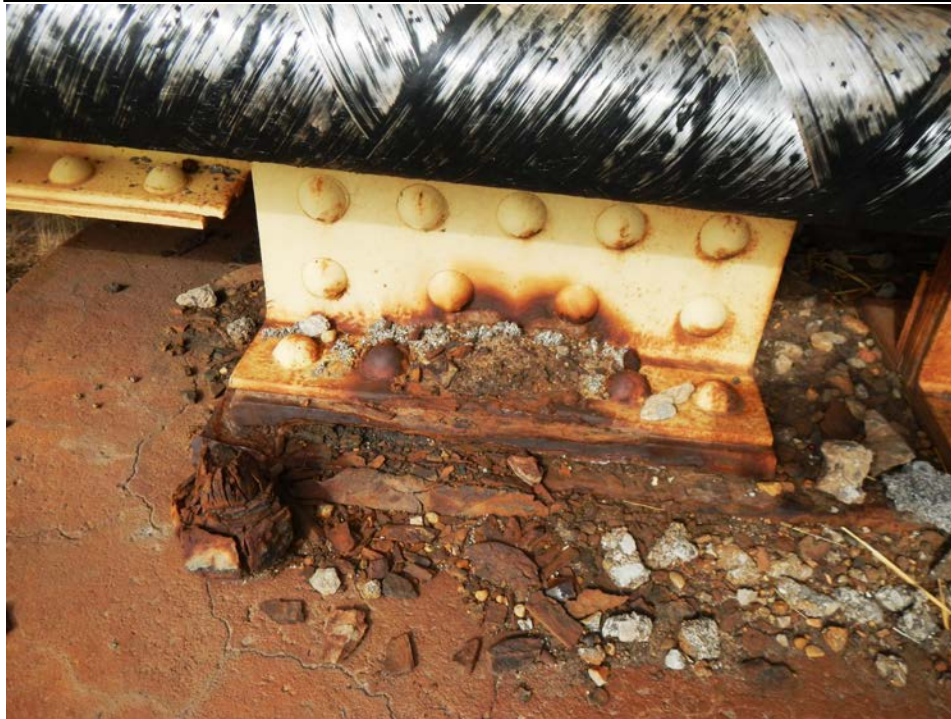
Photograph 45 - Looking west at the east truss bearing for span 27 at L5. Note: heavy laminating corrosion resulting in loss of anchor bolts.
