Other Special Bridge Inspection Report

NBI Bridge No.: 04085

Route U.S. 281 over S. CANADIAN RIVER
Canadian County

11/11/2014

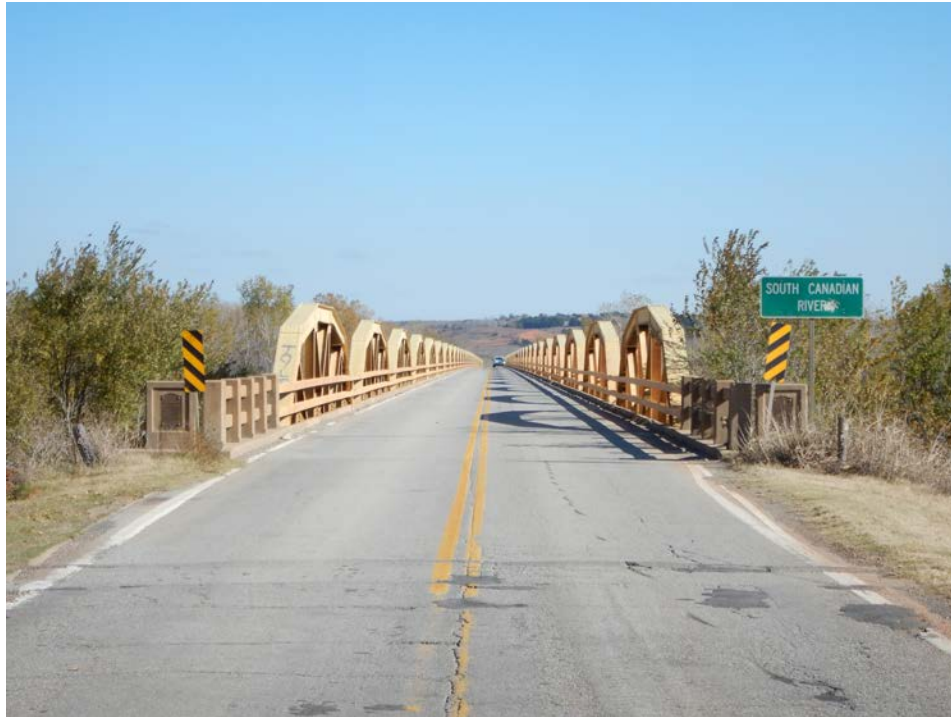
Photograph 1 - End view looking north

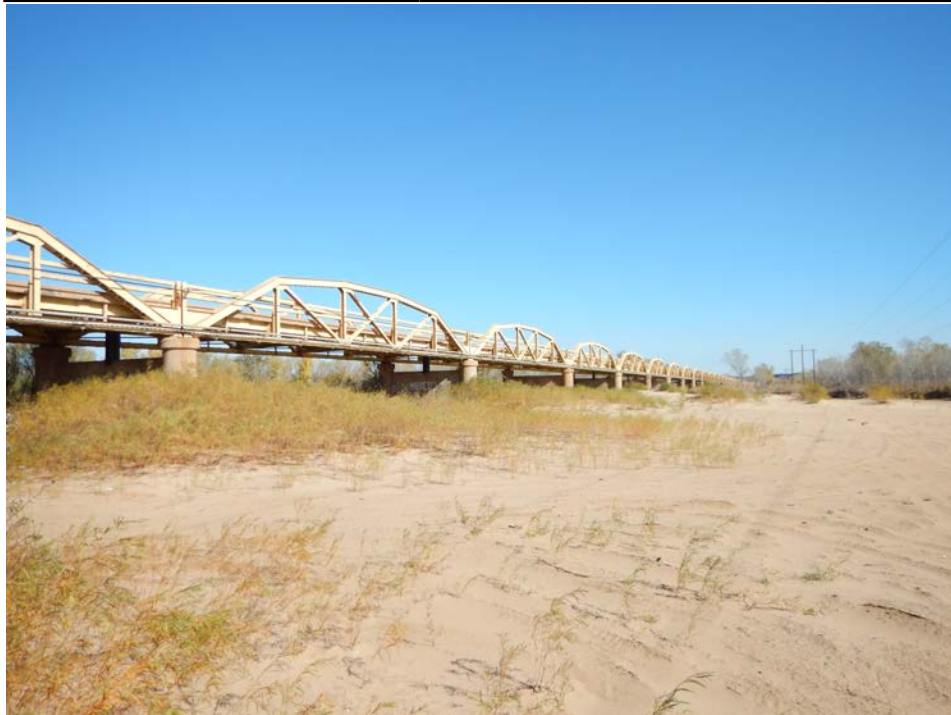
Photograph 2 - Elevation looking northwest

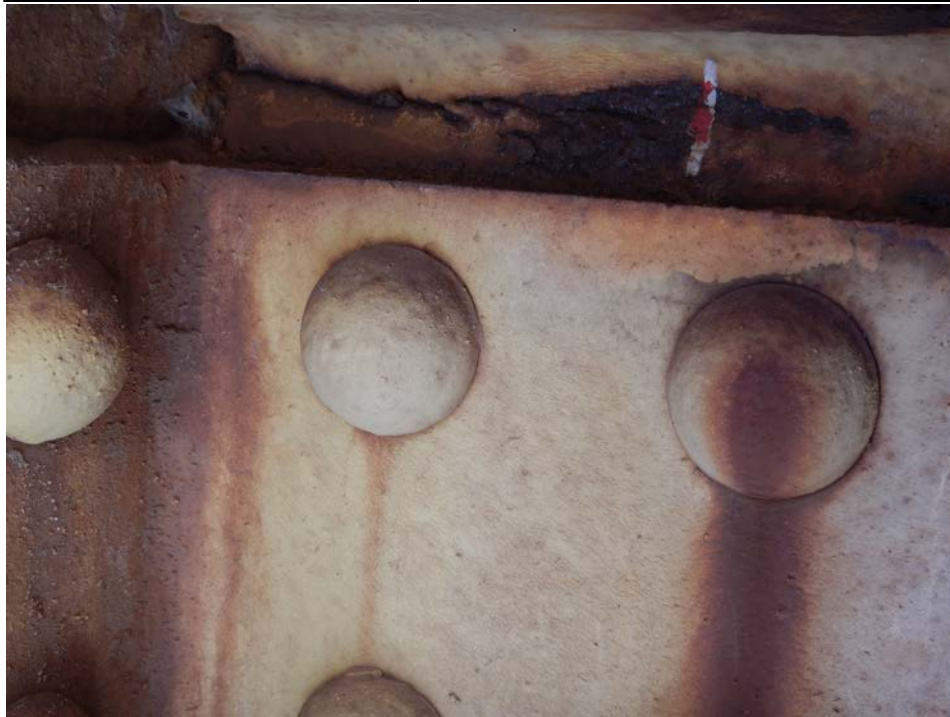
Photograph 3 - Looking southwest at span 24, floor beam 0 connection to east truss. Note: Crack has grown 1/16-inch and is now 4 1/16 inches.

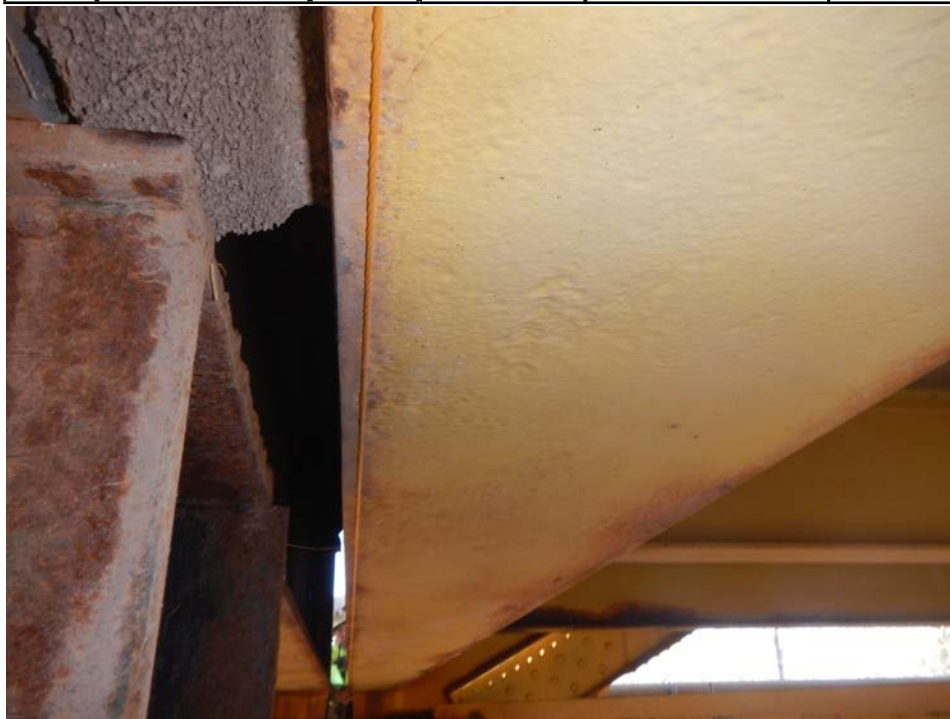
Photograph 4 - Looking east at span 25 floor beam 5, above pier 25. Note: 7/16-inch sweep without stiff leg.

We recommend that a stiff leg repair be installed at each of these floor beams.

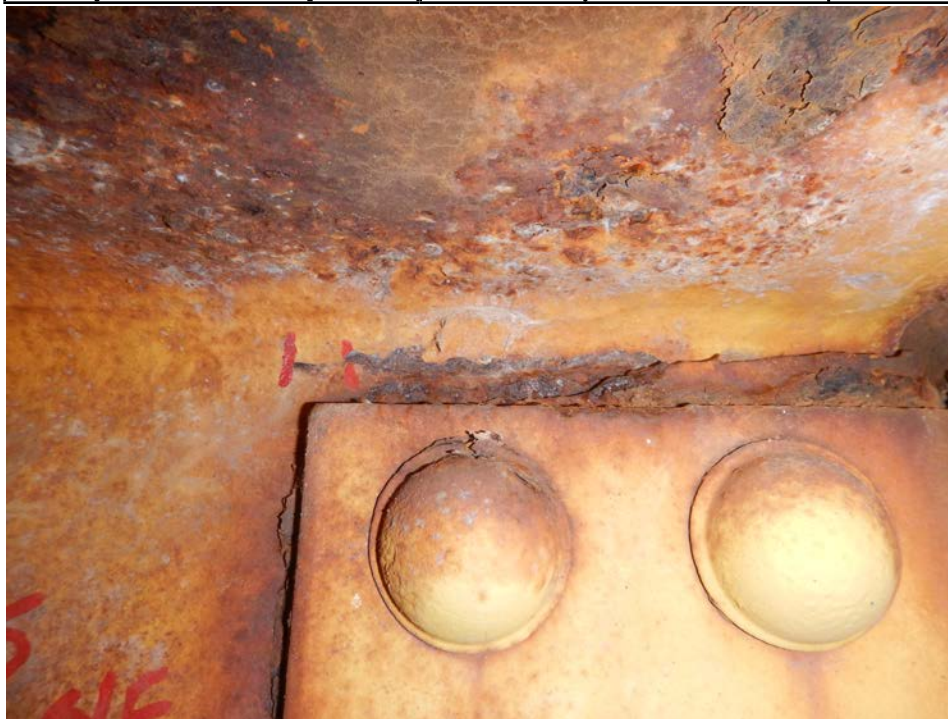
Photograph 5 - Looking north at span 25, floor beam 5 connection to east truss. Note: The crack at the connection to the east truss has grown 1/2-inch and is now 6 3/4 inches long.

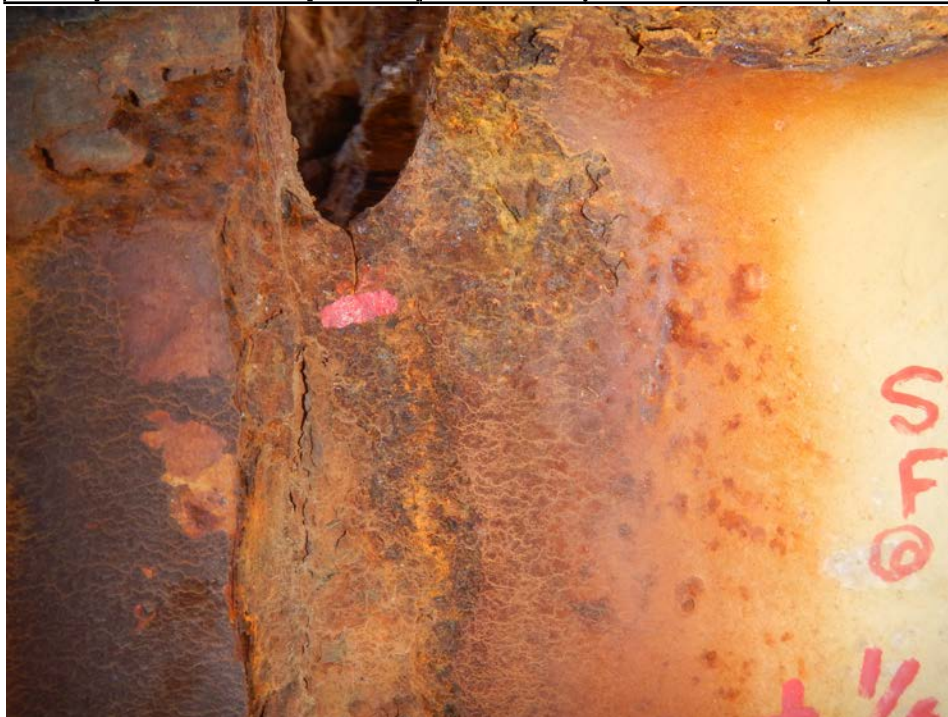
Photograph 6 - Looking north at span 30, floor beam 1 connection to the west truss. Note: Crack has grown 1/8-inch and is now 1/2 inch long.

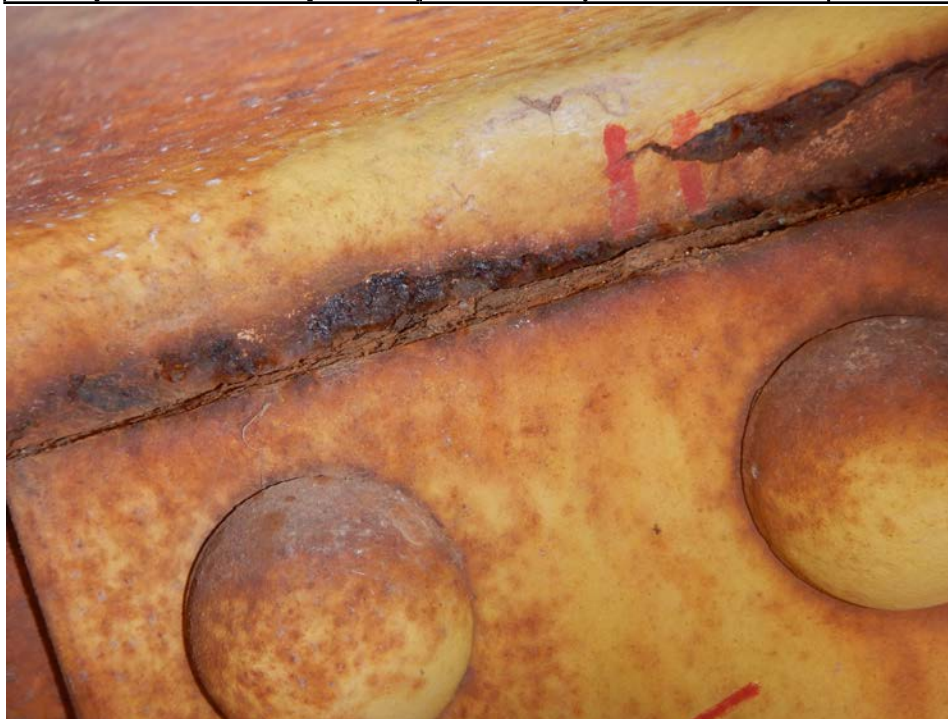
Photograph 7 - Looking north at span 35, floor beam 5 connection to the east truss. Note: The crack has grown 1/16-inch and is now 2 13/16 inches long.

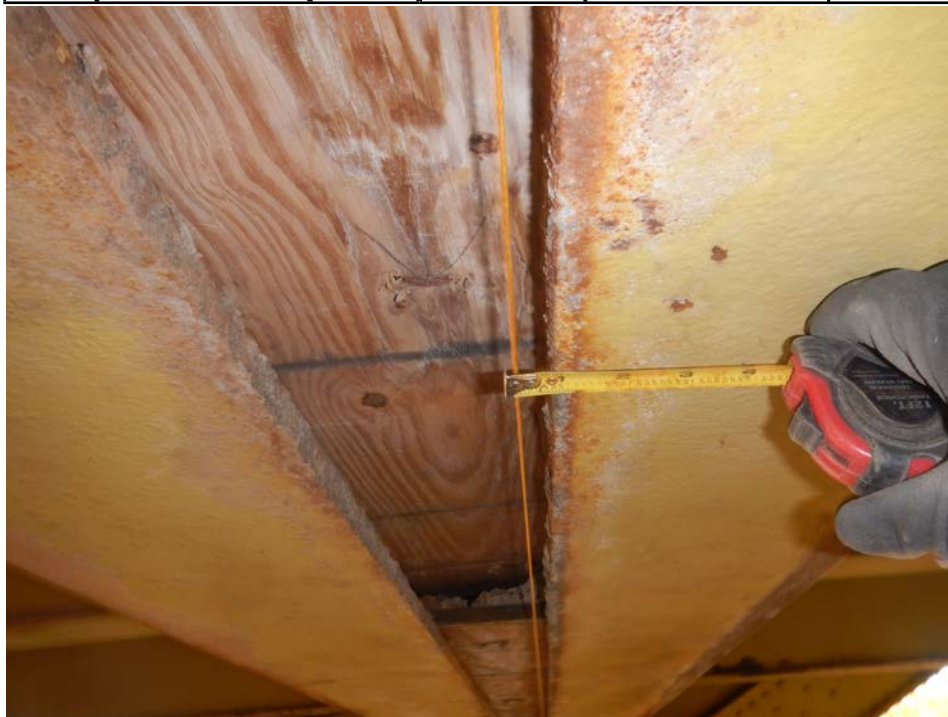
Photograph 8 - Looking east at span 38, floor beam 5 over pier 38. Note: 5/8-inch sweep to the south.

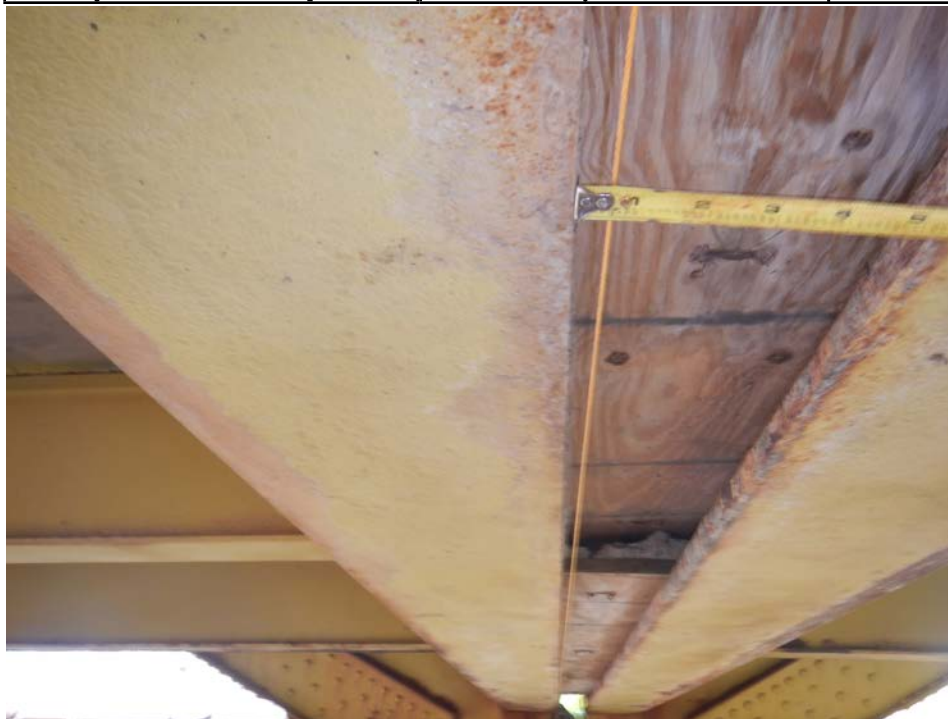
Photograph 9 - Looking east at span 39, floor beam 0 above pier 38. Note: 5/8-inch sweep to the north.

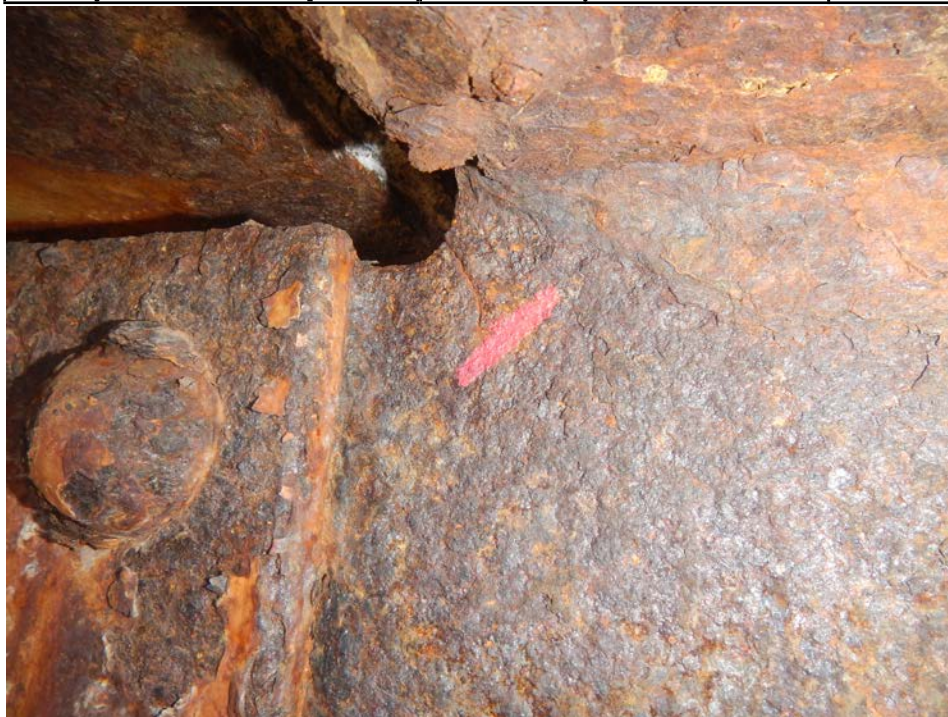
Photograph 10 - Looking northeast at span 27, stringer 1 at the south face of floor beam 1. Note: Crack has grown 1/2-inch and is now 7/8 inch long.

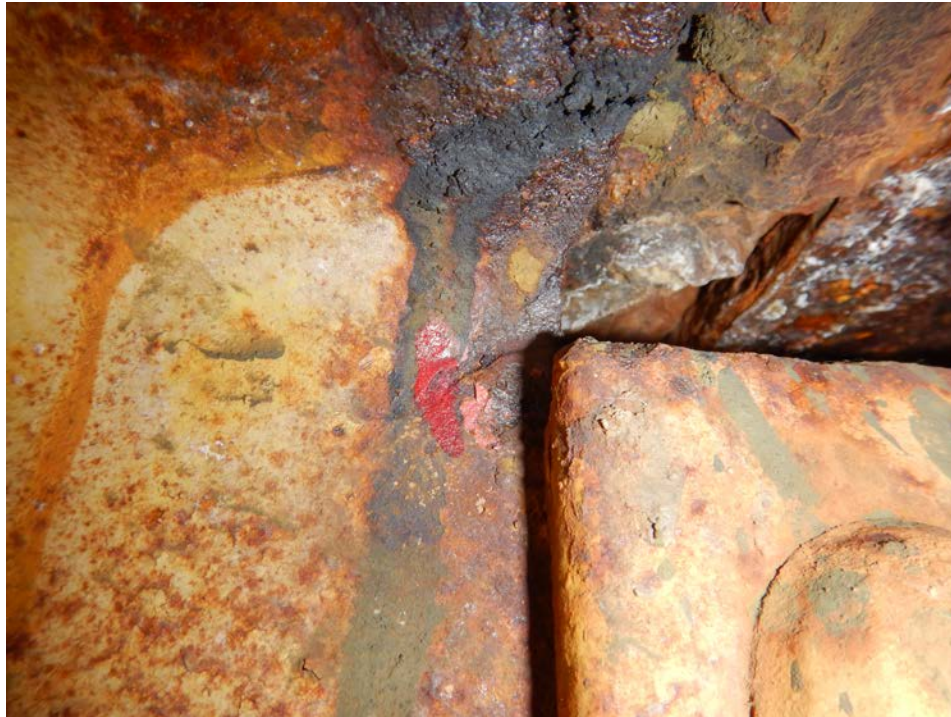
Photograph 11 - Looking east at span 32, stringer 5 at floor beam 0. Note: Stringer cope crack has grown 1/8-inch and is now 5/8 inch long.

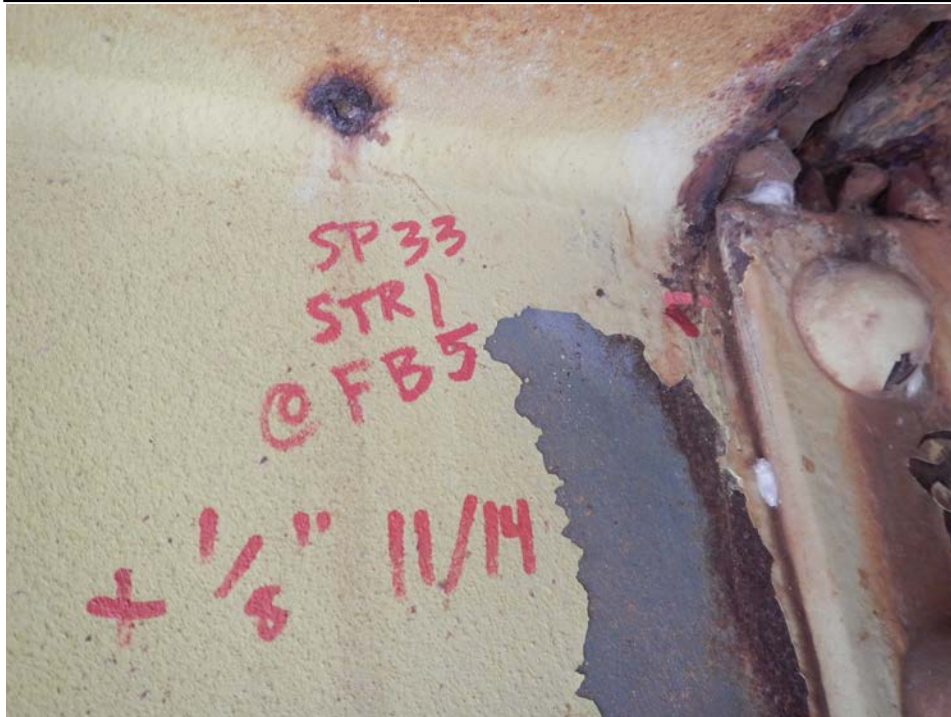
Photograph 12 - Looking northwest at span 33, stringer 1 connection to floor beam 5. Note: Stringer cope crack has grown 1/8-inch and is now 1 1/4 inch long.

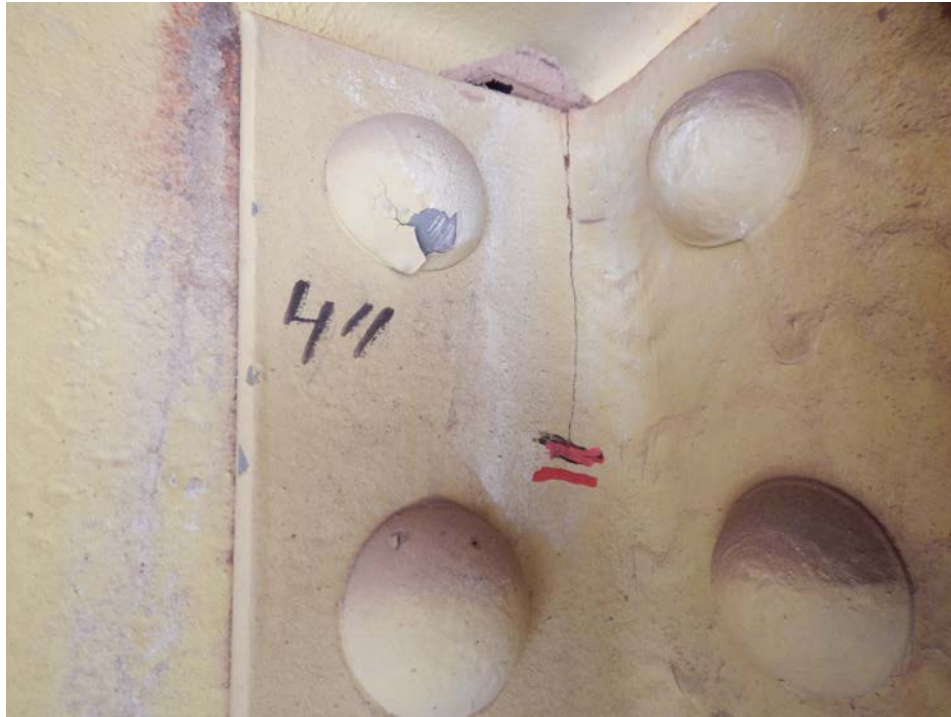
Photograph 13 - Looking southwest at span 36, stringer 4 connection to floor beam 0, east connection angle. Note: Stringer connection angle crack has grown 1/8-inch and is now 4 1/8 inches long.

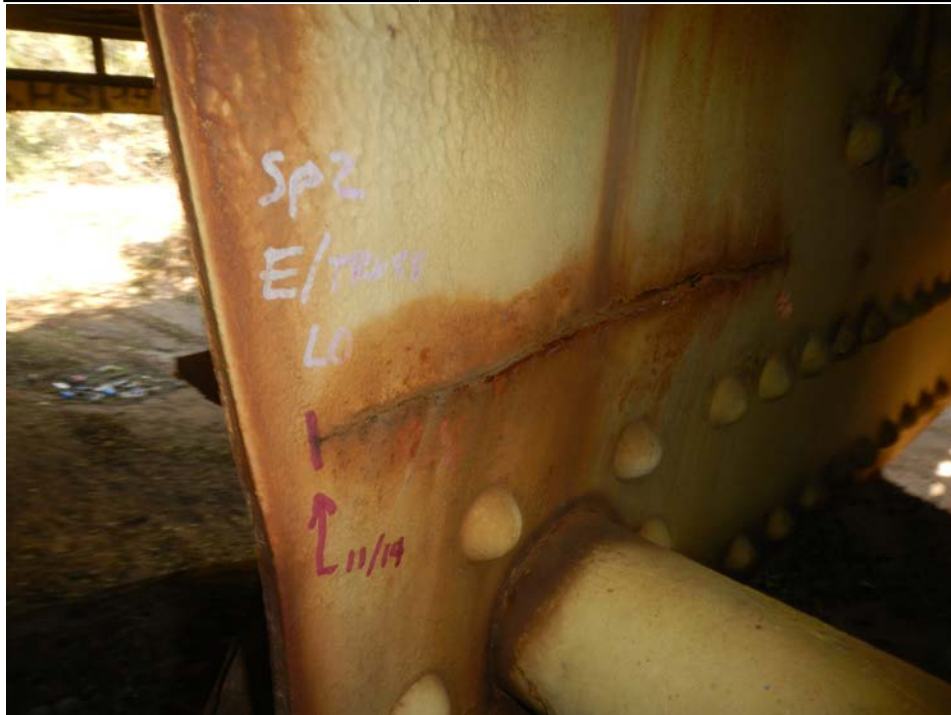
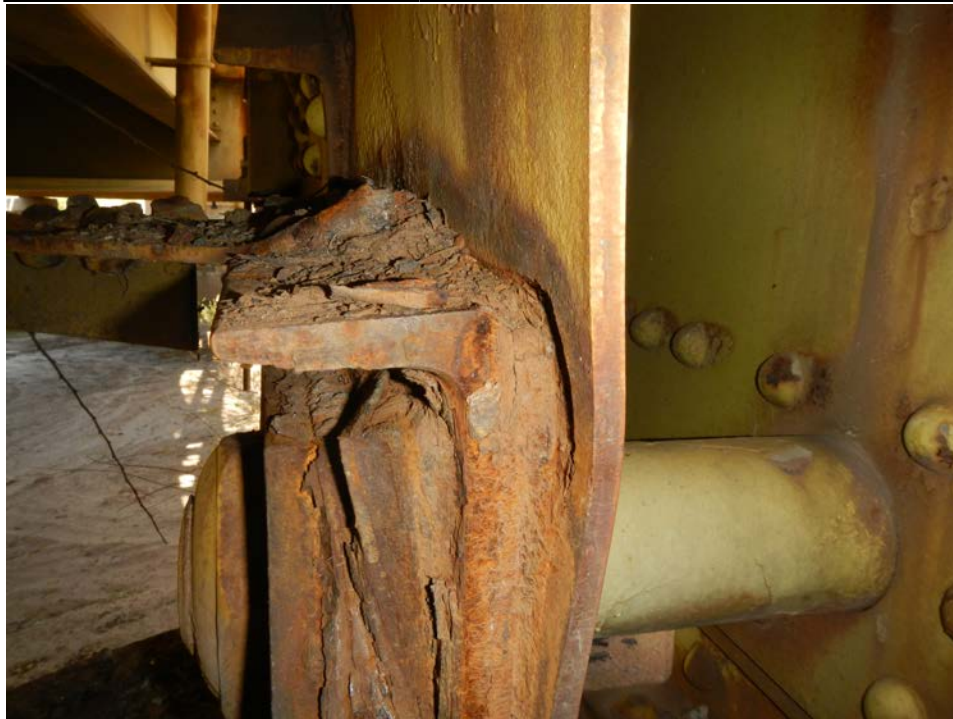
Photograph 14 - Looking northwest at span 2, L0, east truss, inboard gusset plate. Note: Crack has grown 5 7/8 inches since 2013 bringing the crack to 15 1/8 inches total length.

Photograph 15 - Looking north at span 2, L0, east truss, inboard gusset plate. Note: Crack has grown 5 7/8 inches since 2013 bringing the crack to 15 1/8 inches total length.

We are recommending that these gusset plates be repaired by welding an angle between the inboard face of the gusset plate and the top flange of the lower chord inboard channel (similar to other recent repairs). In addition to these cracks, similar cracks were also observed at:

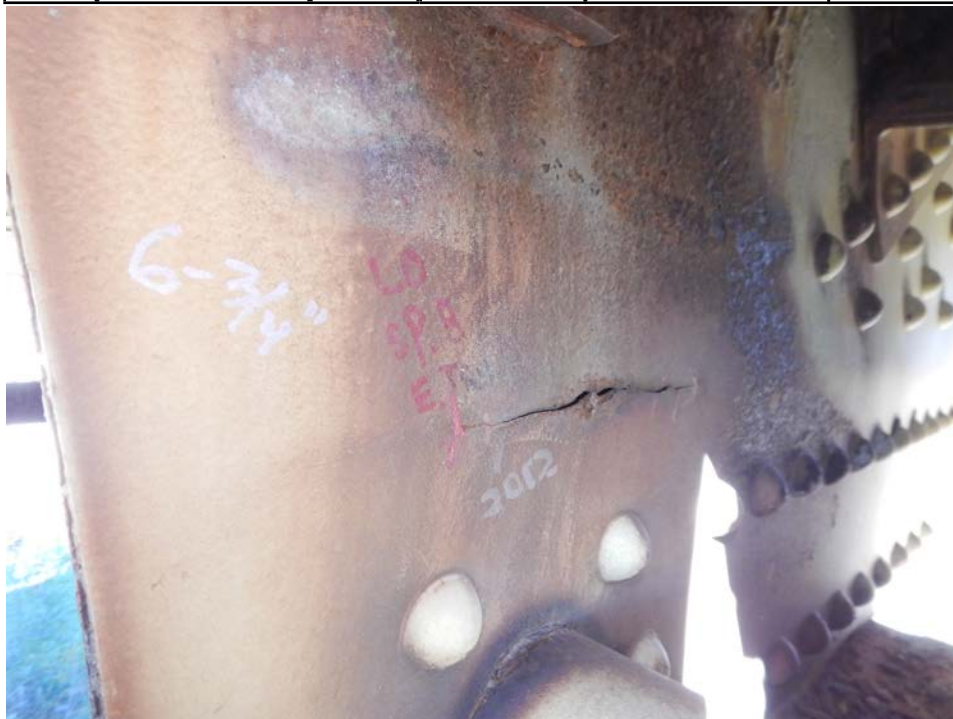
Photograph 16 - Looking west at span 8, east truss, L0 inboard gusset plate. Note: Crack has grown 1/2 inch and is now 7 1/4 inches long.

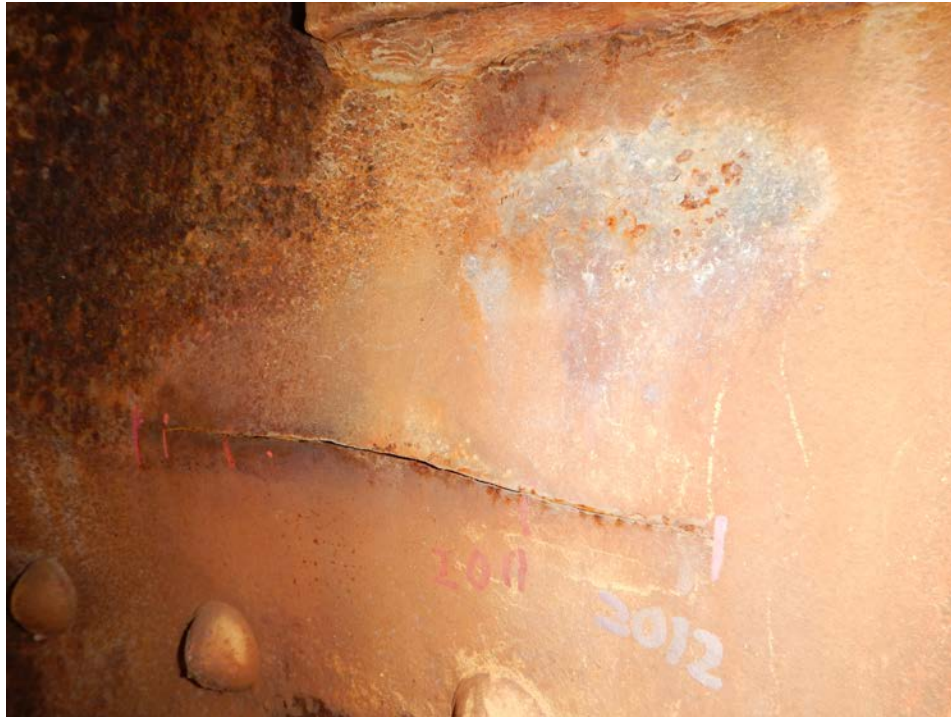
Photograph 17 - Looking southwest at span 17, east truss, L5 inboard gusset plate. Note: Crack has grown 3/4 inch and is now 9 inches long.

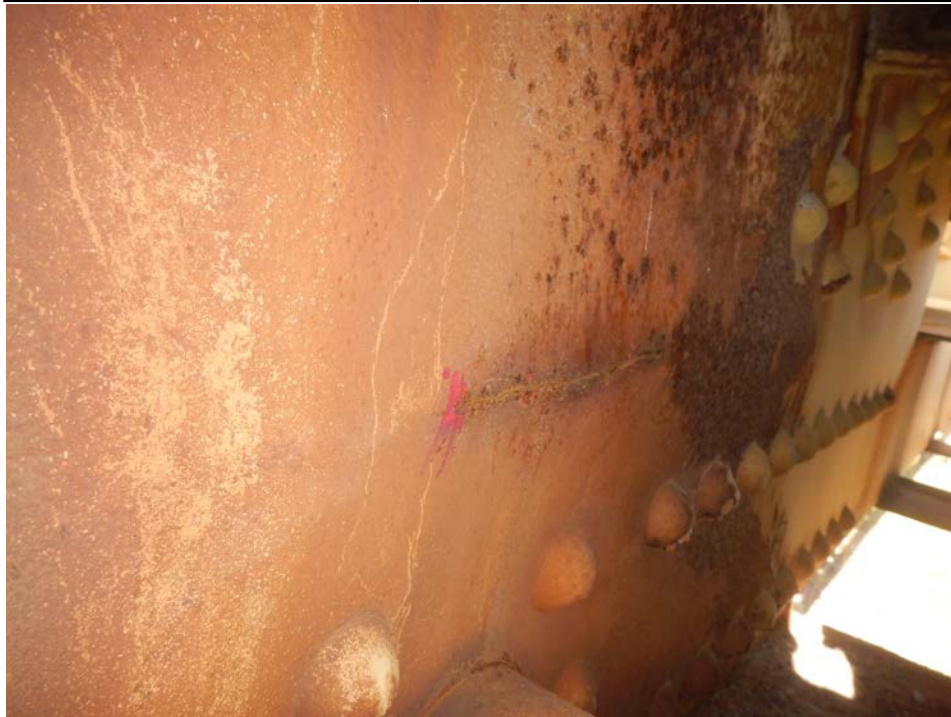
Photograph 18 - Looking northeast at span 20, east truss, L0 inboard gusset plate. Note: crack has grown 3 1/2 inches and is now 6 1/2 inches long.

Due to the rate of propagation, it is recommended that these cracks also be repaired.

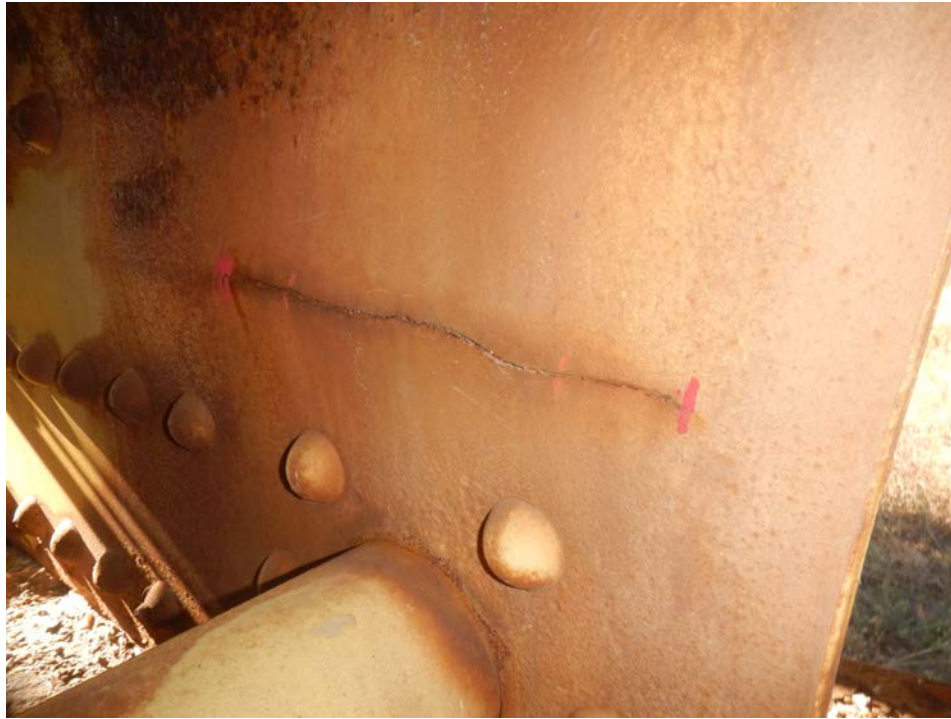
Photograph 19 - Looking southwest at span 29, east truss, L5 inboard gusset plate. Note: Crack has grown 3 3/4 inches to 10 inches.

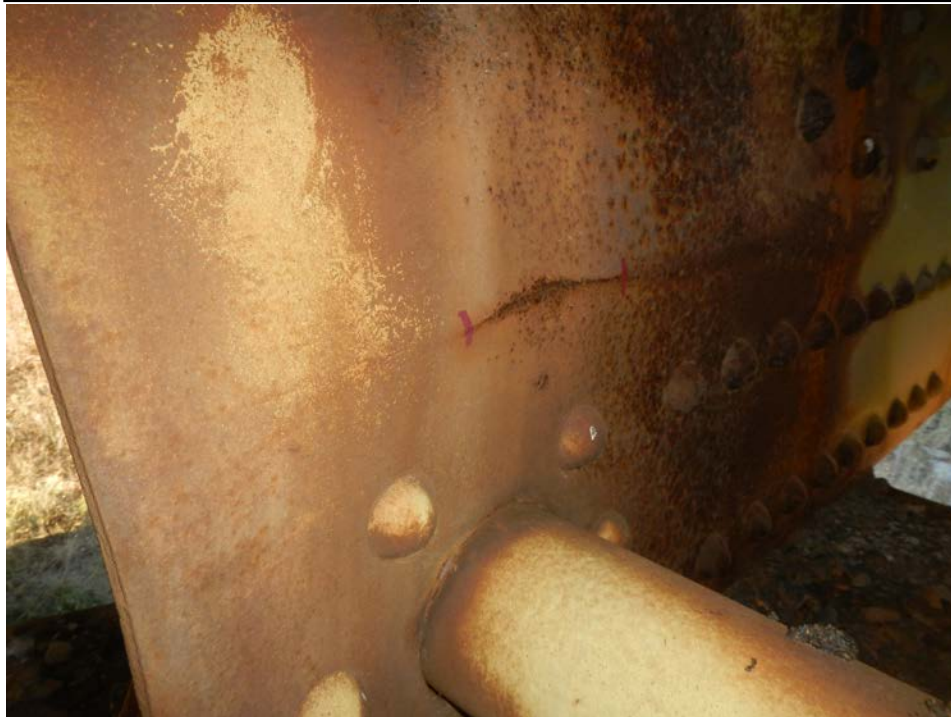
Photograph 20 - Looking northwest at span 30, east truss L0 inboard gusset plate. Note: New 4 3/4-inch long crack.

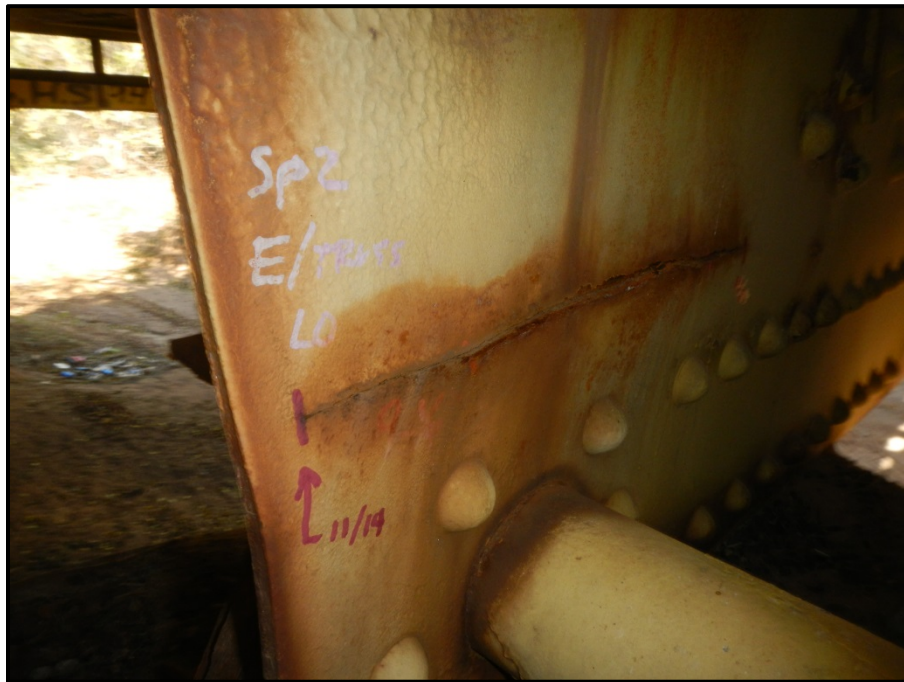
- Cracks in the truss gusset plate above the bearing:
 - Span 2, L0 east truss, inboard gusset (**photo 1**) – 15 1/8-inch long horizontal crack (crack has grown 5 7/8 inches since the 2013 inspection).
 - Span 29, L5 east truss, inboard gusset plate (**photo 2**) – 10-inch long horizontal crack (crack has grown 3 3/4 inches since the 2013 inspection).

Photo 1 – Looking northwest at span 2, L0 east truss, inboard gusset plate.
Note: 15 1/8-inch long horizontal crack above bearing pin.

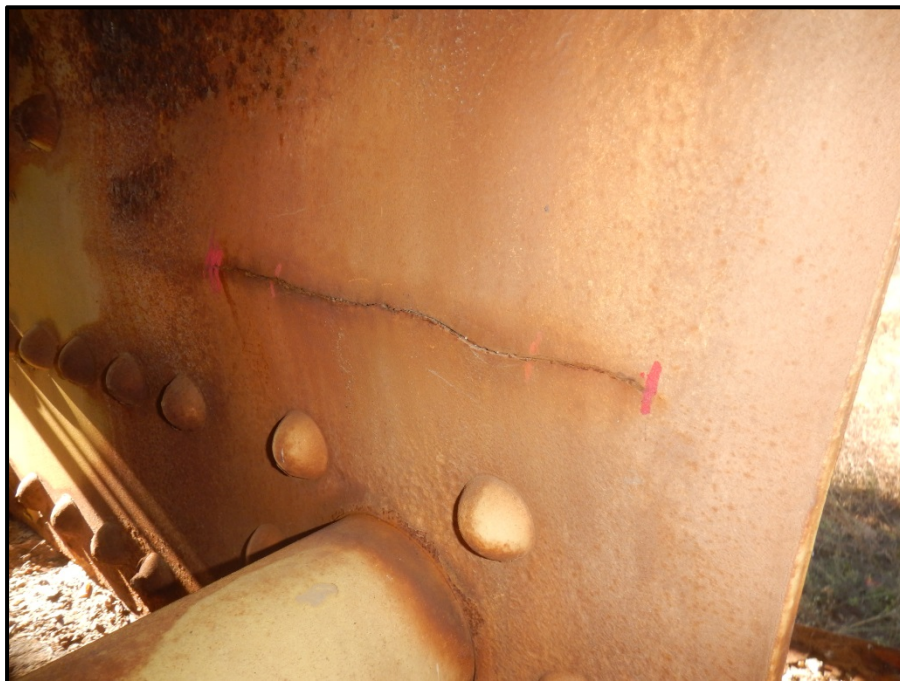
Photo 2 – Looking southwest at span 29, L5 east truss, inboard gusset plate.
Note: 10-inch long horizontal crack above bearing pin.

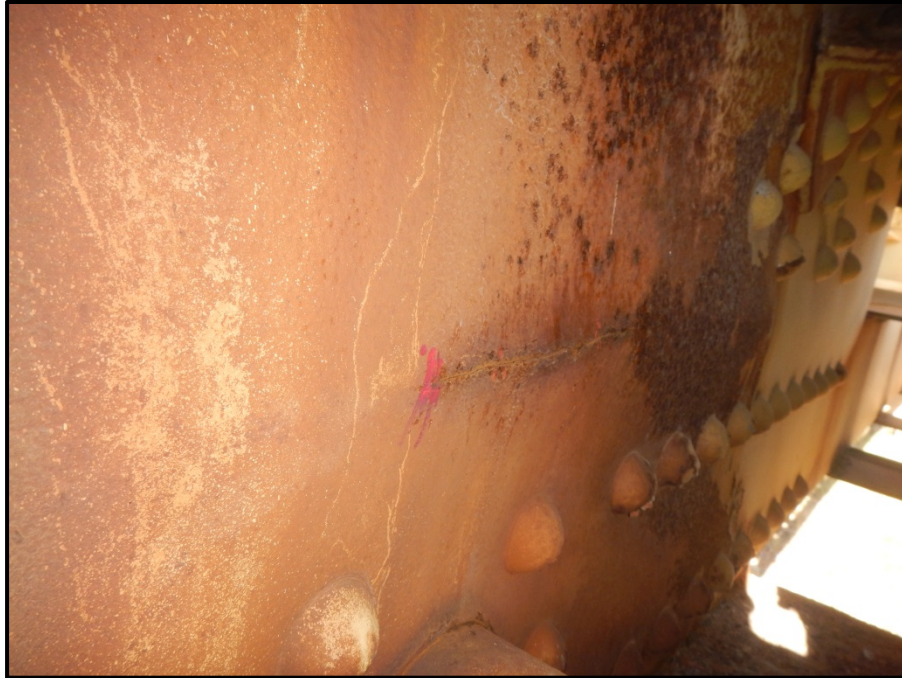
- Span 20, L0 east truss, inboard gusset plate (**photo 3**). This 6 3/4-inch long horizontal crack has grown 3 3/4 inches since the 2013 inspection.
- Span 30, L0 east truss, inboard gusset plate (**photo 4**). This 4 3/4" long horizontal crack was not previously noted. The crack is adjacent to that noted above in Span 29, L5 east truss.

Photo 3 – Looking northwest at span 20, L0 east truss, inboard gusset plate.
Note: 6 3/4-inch long horizontal crack above bearing pin.

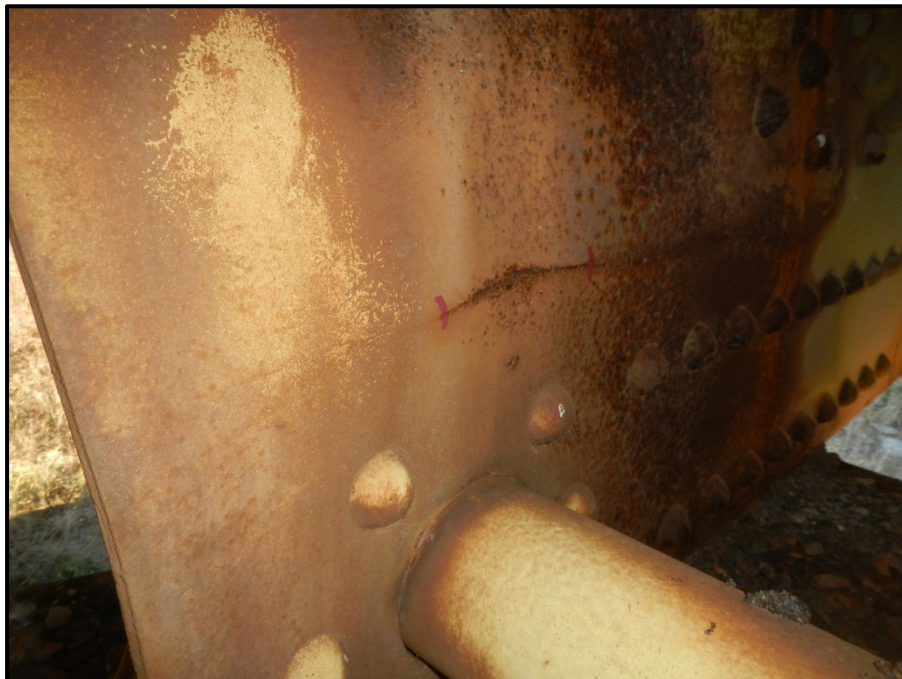
Photo 4 – Looking northwest at span 30, L0 east truss, inboard gusset plate.
Note: 4 3/4-inch long horizontal crack above bearing pin.

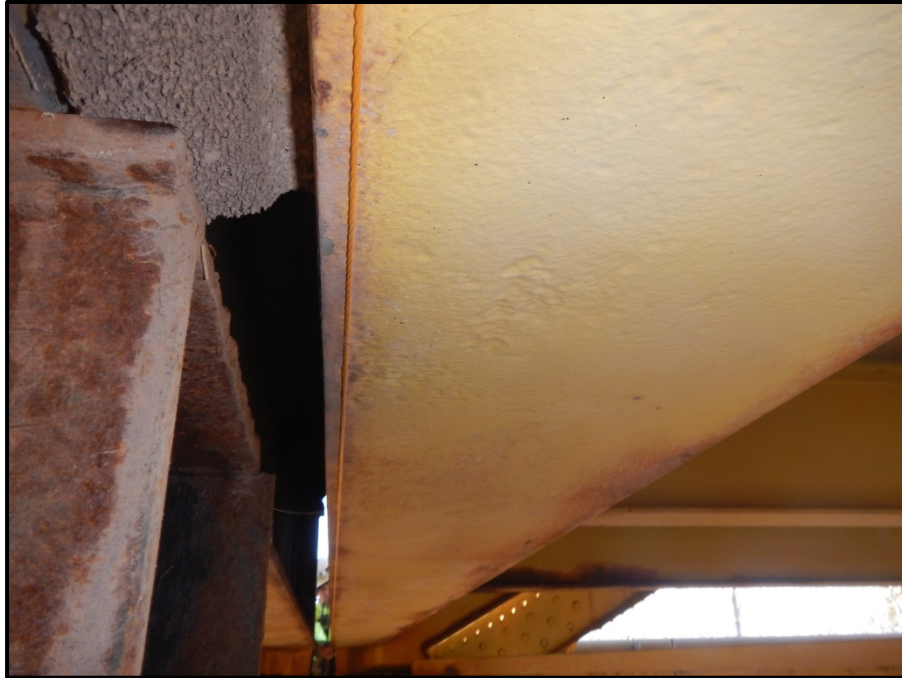
Photo 5 – Looking east along floor beam 5, span 25 over pier 25. Note: 7/16-inch sweep of bottom flange to the north.

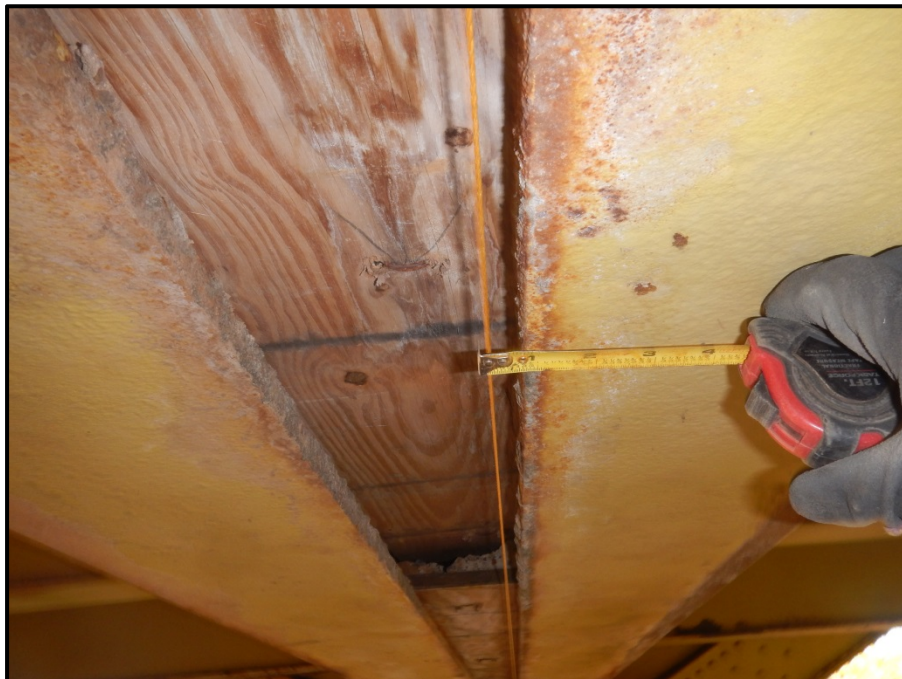
Photo 6 – Looking east along floor beam 5, span 38 over pier 38. Note: 5/8-inch sweep of bottom flange to the south.

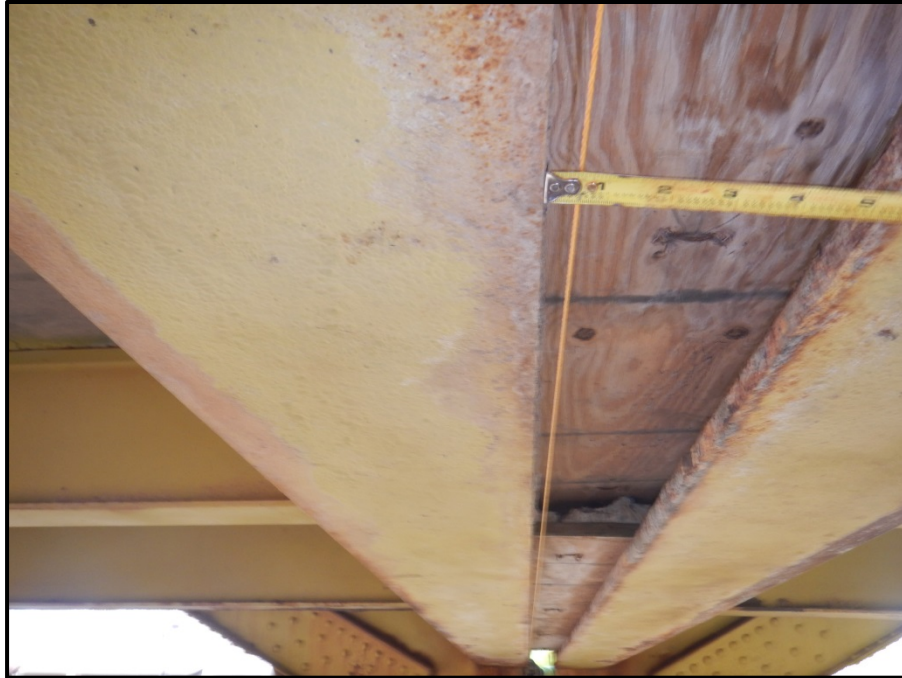
Photo 7 – Looking east along floor beam 0, span 39 over pier 38. Note: 5/8-inch sweep of bottom flange to the north.
