Consulting Party Meeting

SH-66 NB over Bird Creek
Rogers County, Oklahoma
JP 20899(09)

September 20, 2021

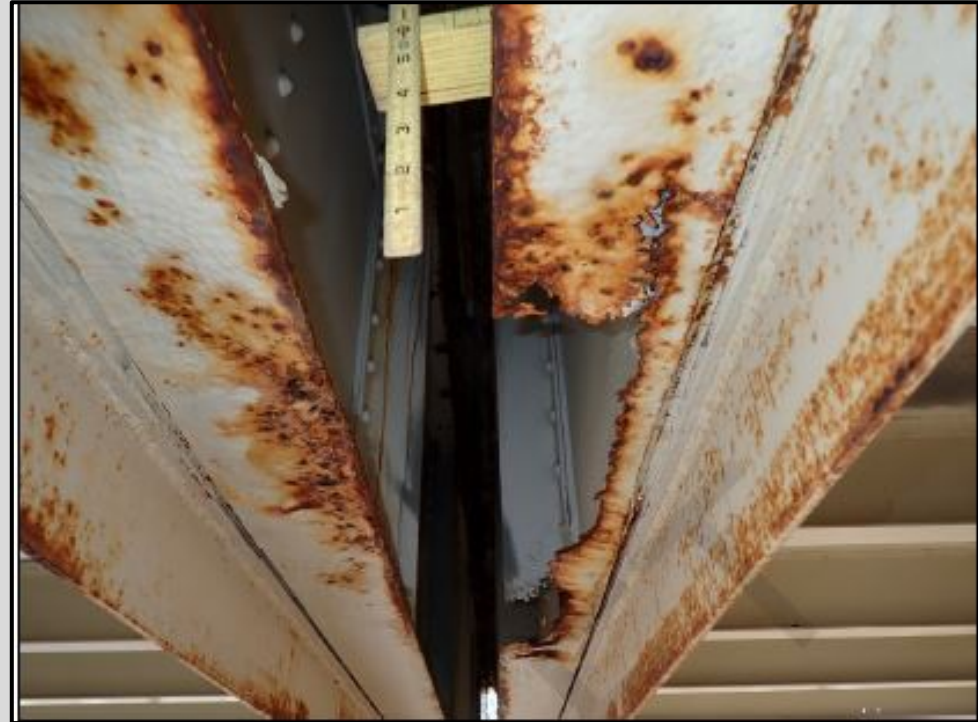
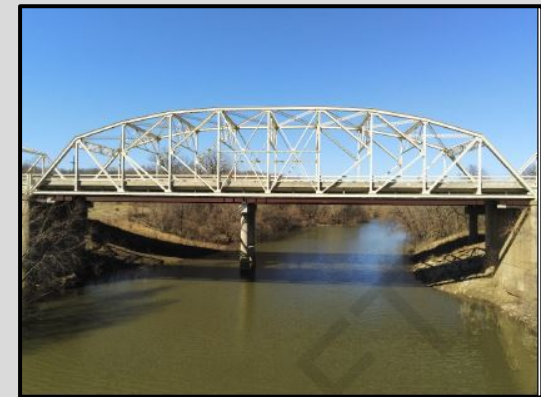
- Condition Ratings (December 2020)

- Deck = 5 (Fair)
- Superstructure = 4 (Poor)
- Substructure = 6 (Satisfactory)
- Sufficiency Rating= 49.4

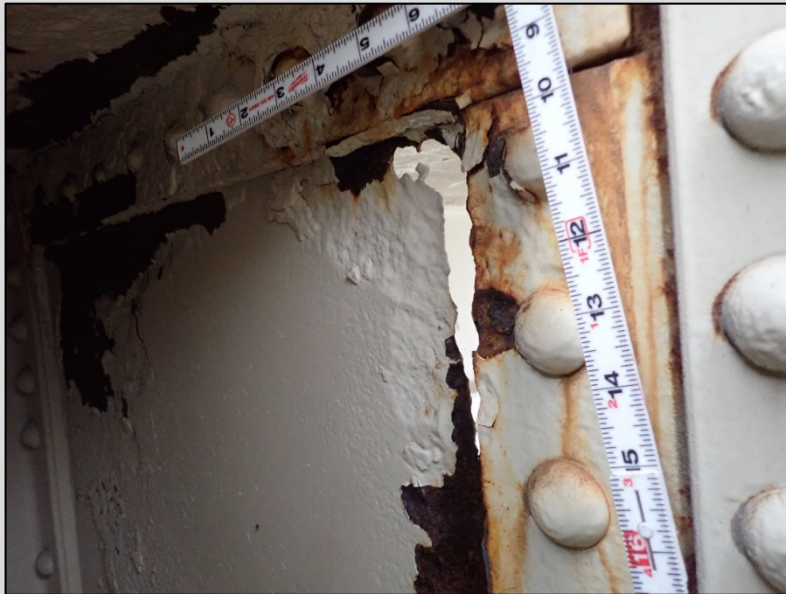
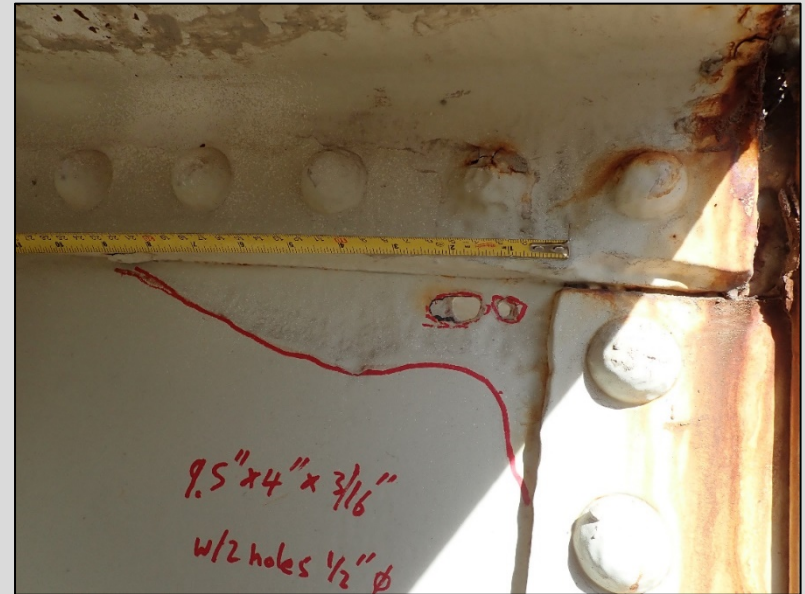
Alternative 1 – Do Nothing

- Minor maintenance only; no major rehabilitation
 - Periodic closures likely
 - Regular maintenance
 - Costly inspections

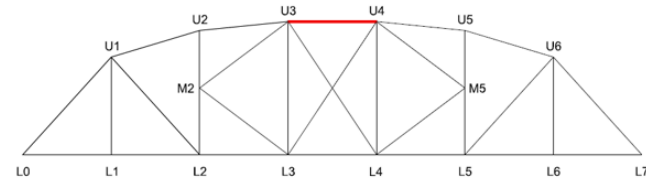
Figure 33: Overstressed Truss Members (Spans 1, 5, and 6) – Rehabilitation with Widening

- Alternative 2(a): Rehabilitation existing bridge; widen to provide 38-ft roadway
 - Replacement of deck, approach slabs, stringers, floor beams, and lateral bracing
 - Strengthening of various truss members
 - Remove and reset trusses and bearings
 - New bridge rails
 - Painting of all structural steel
 - Augmentation of both abutments and all five piers
 - Minor substructure repairs

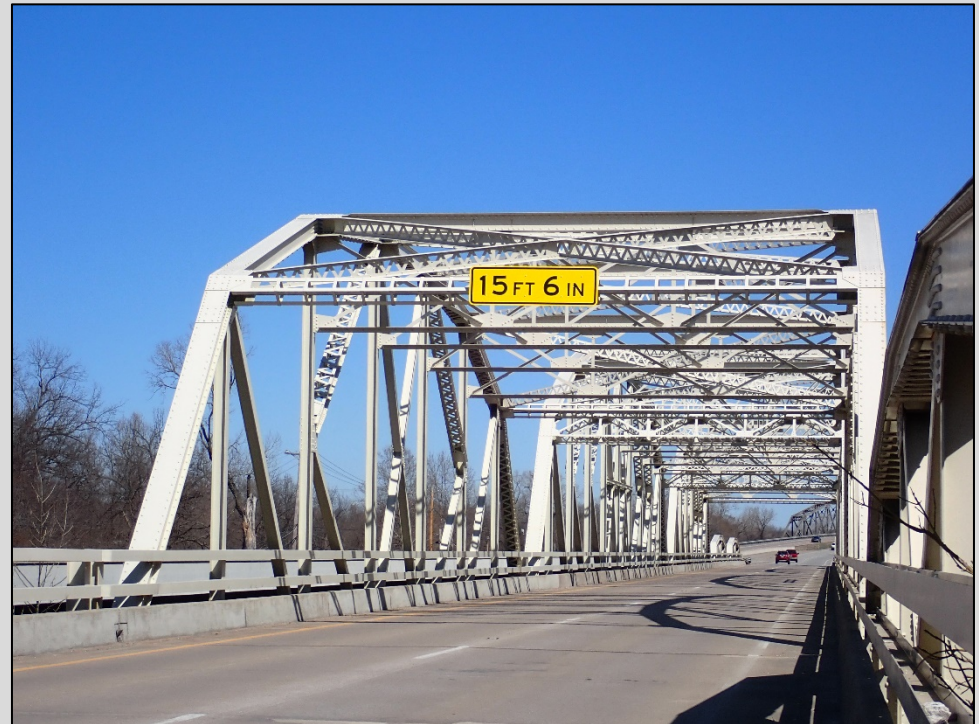
- Alternative 2(b): Rehabilitation of existing bridge; maintain current 30-ft roadway width
 - Replacement of deck, approach slabs, stringers, and floor beams
 - Remove and reset trusses and bearings
 - New bridge rails
 - Painting of all structural steel
 - Minor substructure repairs

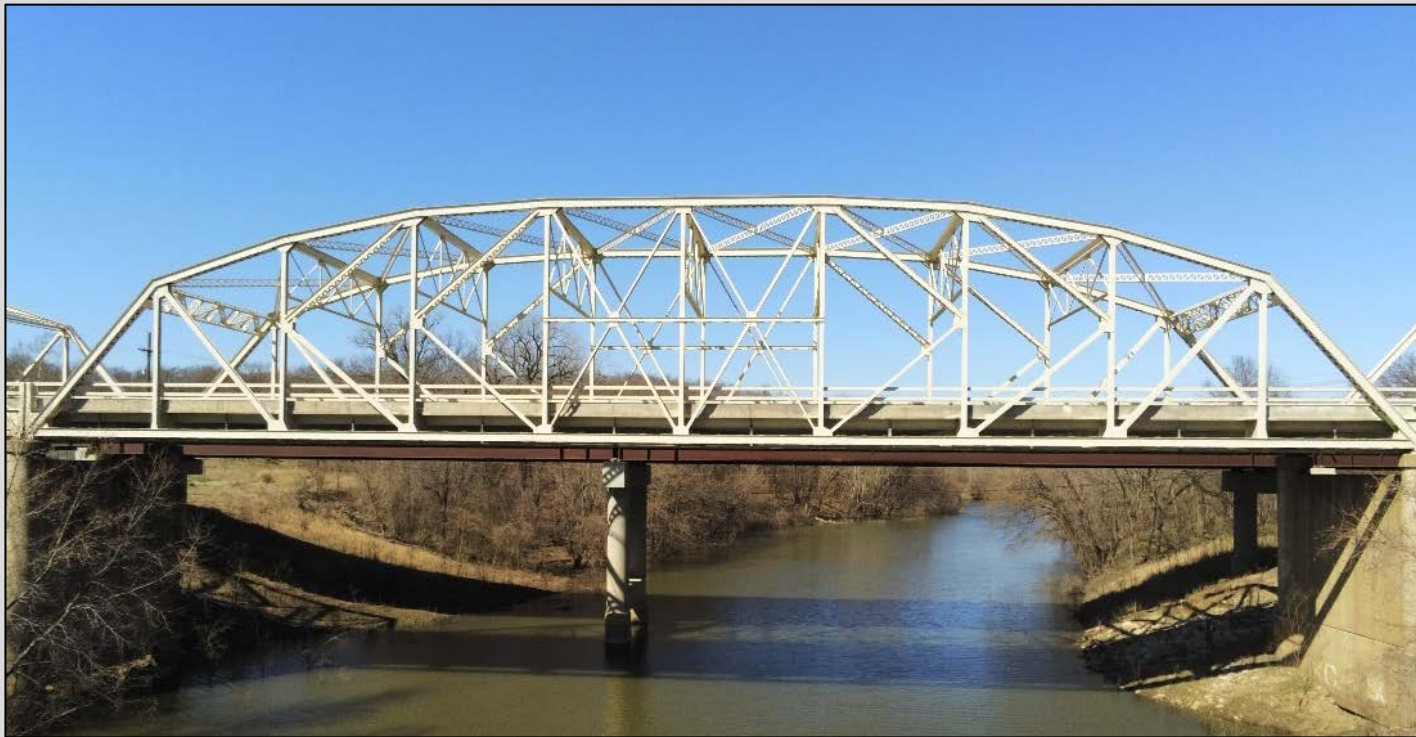
- Existing bridge remains in place as:
 - Non-functional monument
 - Non-vehicular pedestrian and/or bicycle facility
- Six offset alignments were evaluated in March 2011.

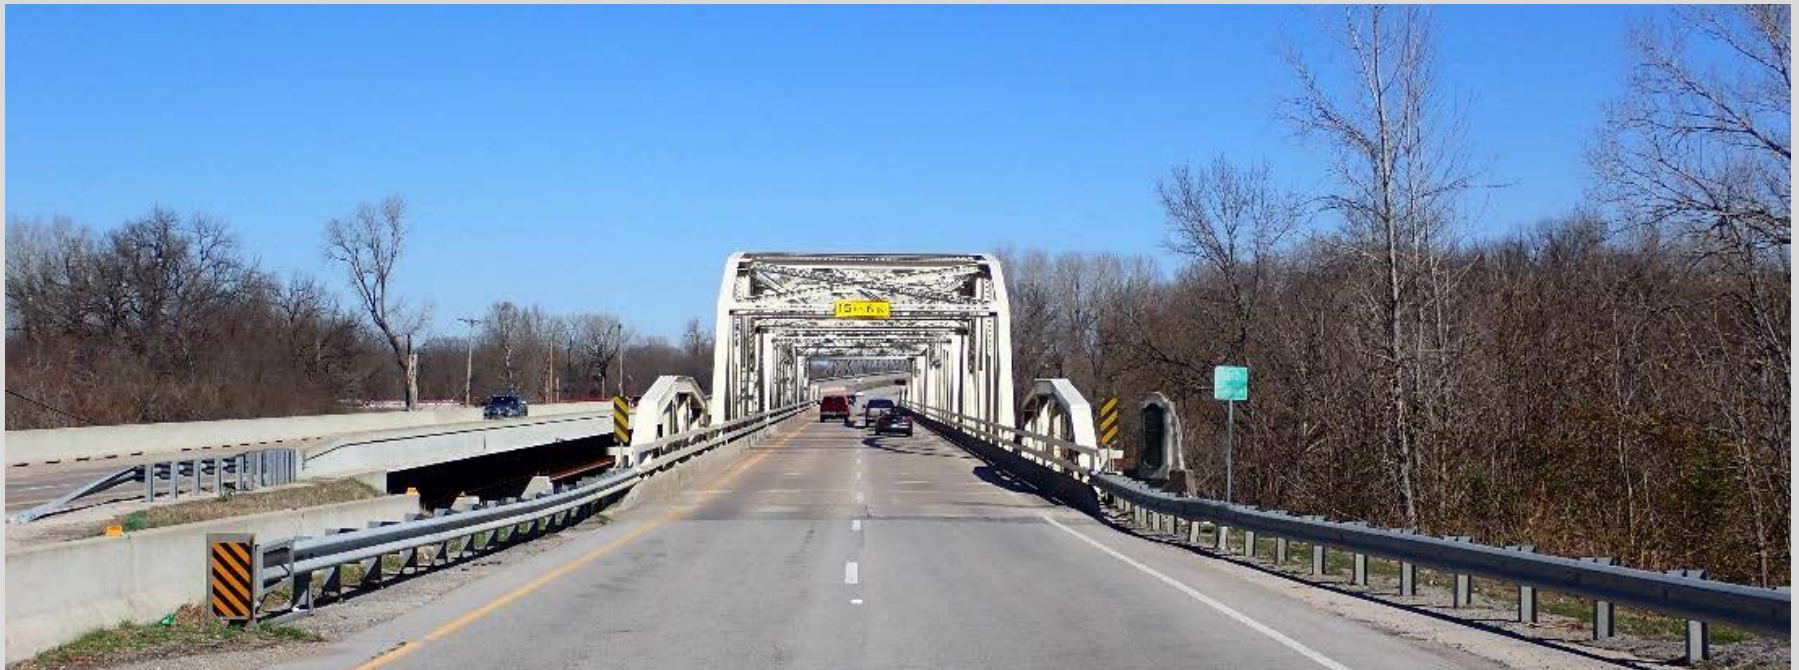
- Existing bridge removed
- Result in adverse effect and would require mitigation
