CUMBERLAND CUT MIXED TRUSS  
Spanning Lake Texoma/Cumberland Cut  
Marshall C.L. /Ft. Washita Vicinity  
Bryan County  
Oklahoma

PHOTOGRAPHS  
COPIES OF PLANS  
AND  
WRITTEN HISTORICAL AND DESCRIPTIVE DATA

## **HISTORIC AMERICAN ENGINEERING RECORD**

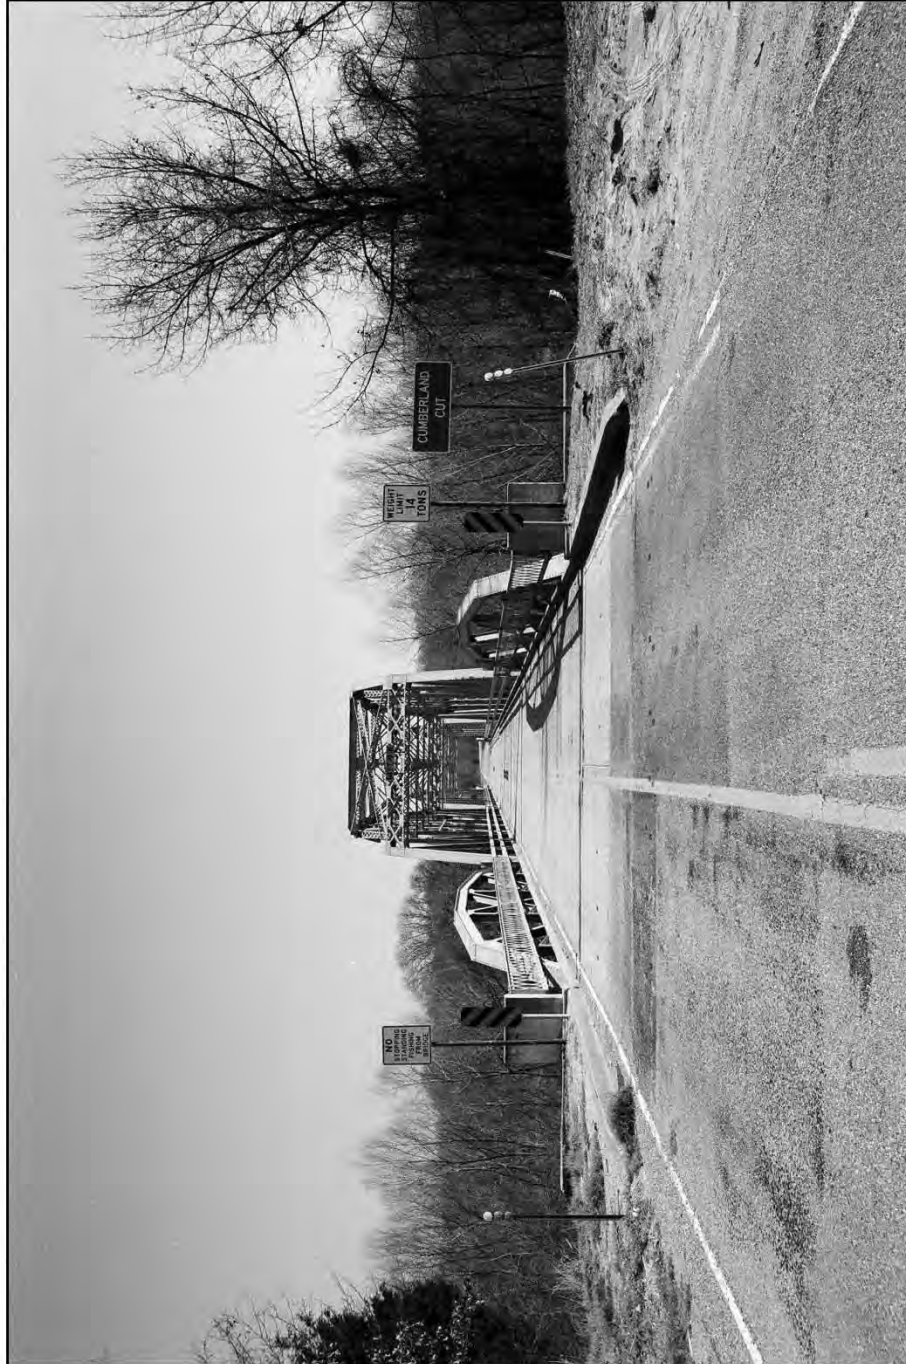
CUMBERLAND CUT MIXED TRUSS  
SEE INDEX TO PHOTOGRAPHS FOR CAPTION  
PHOTO 1

1. GENERAL SETTING VIEW, LOOKING NORTHEAST
2. SIDE VIEW, LOOKING NORTH
3. SOUTHWEST ABUTMENT, LOOKING SOUTHWEST
4. UNDERSIDE OF K-THROUGH TRUSS, LOOKING NORTHEAST
5. SIDE VIEW OF K-THROUGH TRUSS, LOOKING NORTH
6. SIDE VIEW OF PARKER-THROUGH TRUSS, LOOKING NORTH
7. SIDE VIEW, LOOKING WEST-SOUTHWEST
8. SIDE VIEW, LOOKING WEST-SOUTHWEST
9. UNDERSIDE OF PARKER-THROUGH TRUSS, LOOKING WEST-SOUTHWEST
10. SIDE VIEW, LOOKING SOUTH
11. SIDE VIEW, LOOKING EAST

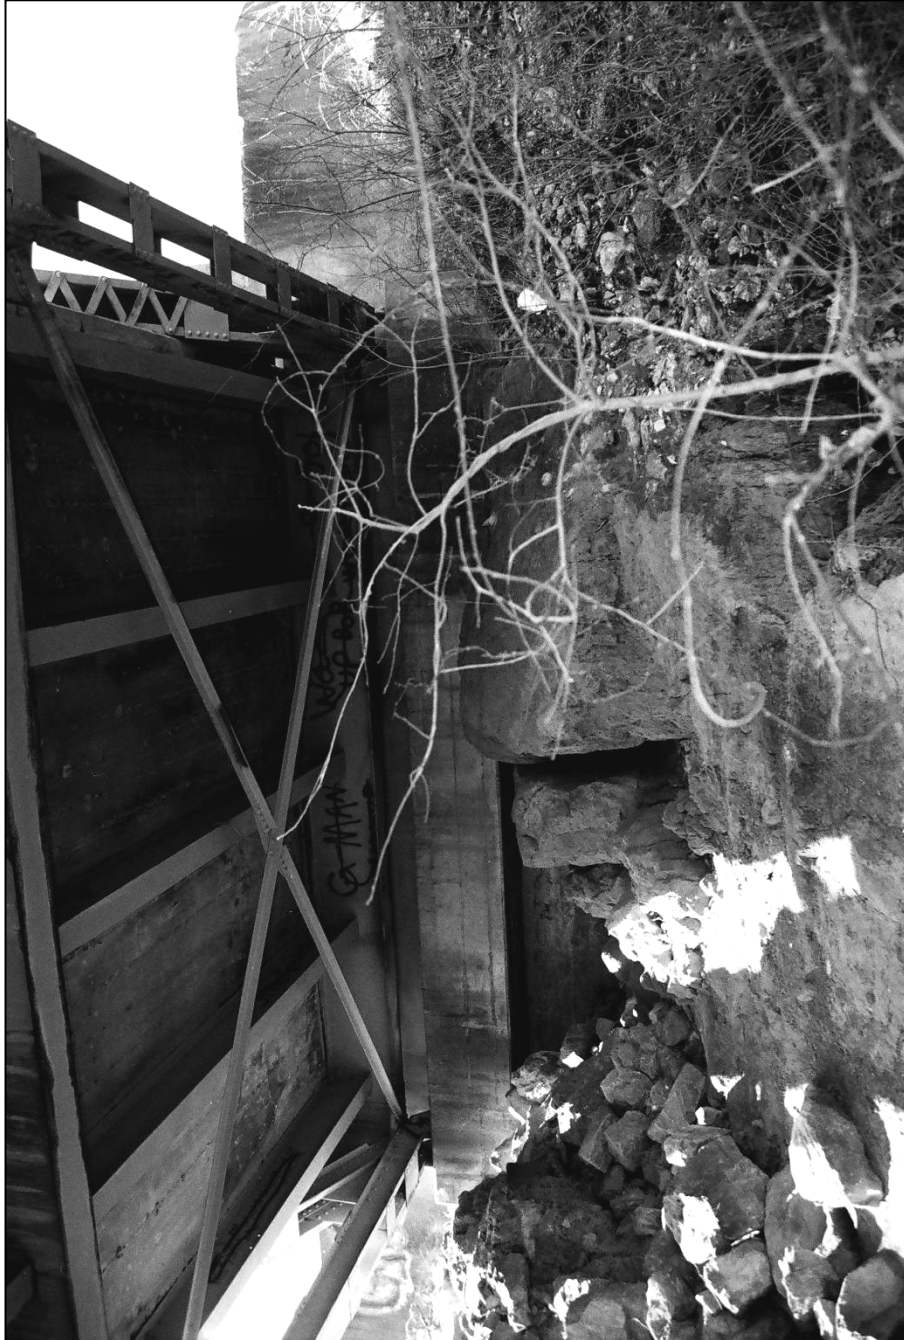
CUMBERLAND CUT MIXED TRUSS  
SEE INDEX TO PHOTOGRAPHS FOR CAPTION  
PHOTO 3

The bridge substructure consists of five square concrete piers with solid web walls. The piers are positioned at the end of each span. The concrete piers are uniform and appear to be original to the structure. Located at each end of the bridge are concrete abutments with straight wing walls and clipped corners.

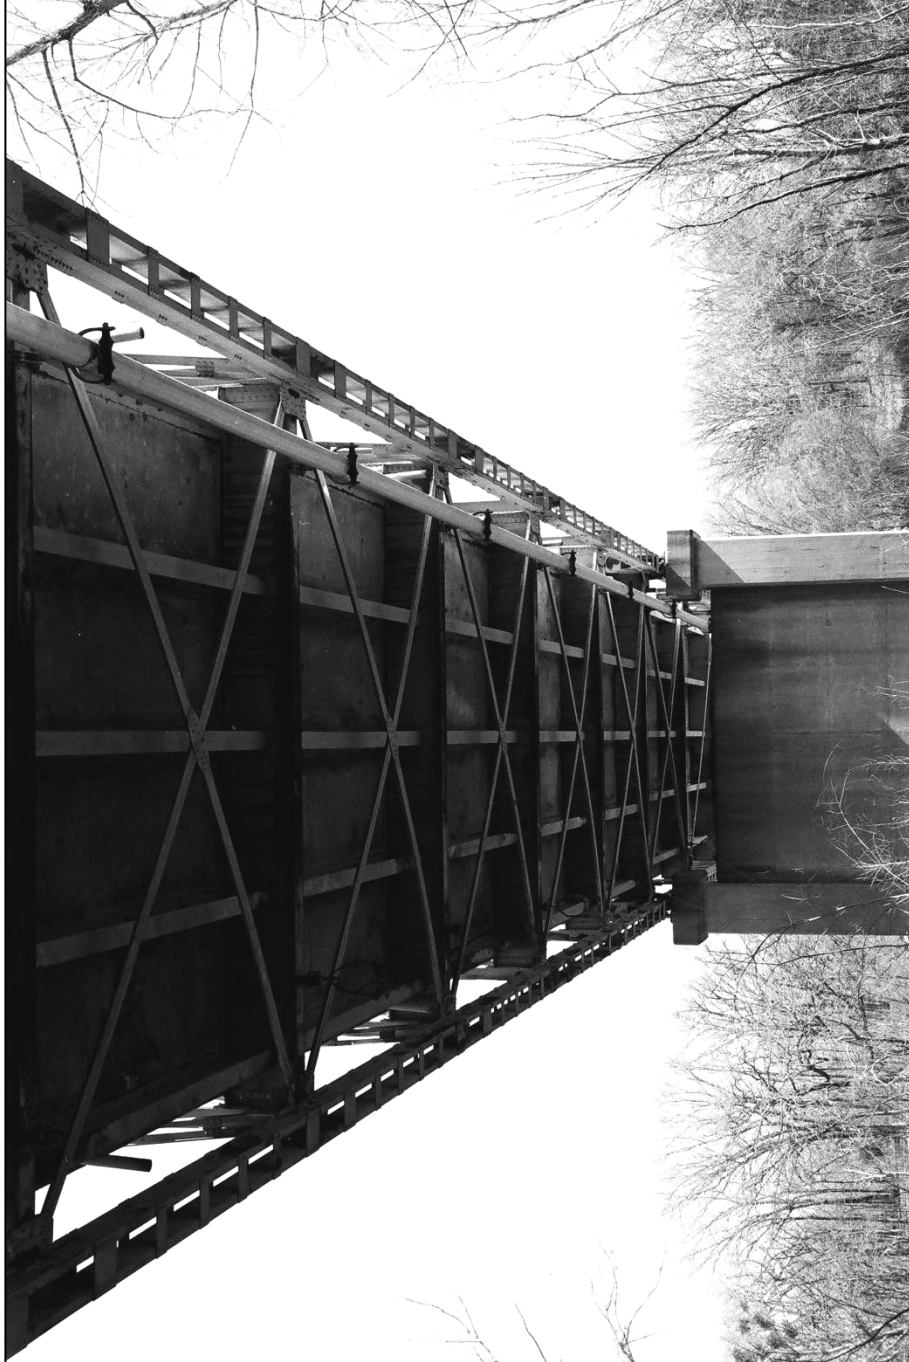
CUMBERLAND CUT MIXED TRUSS  
SEE INDEX TO PHOTOGRAPHS FOR CAPTION  
PHOTO 4

Southwest of the Parker-through truss is the K-through truss. This truss has similar features found on the adjacent Parker truss, but does not use any rods or pin connections. The walls of the K-through truss have eight panels and seven vertical built-up members. The two center panels exhibit diagonals that cross and form an X. These diagonals are made up of angles connected with stay plates. The panels flanking the two center panels have two small diagonal members that form an inward facing K-shape and provide the truss with its character-defining feature. The web connecting the truss walls at the top chord consists of six panels with lateral bracing and seven struts with lateral bracing. The lateral bracing throughout the web is made up of angles connected with stay plates. All of the members of this truss are riveted together with gusset plates located at each connection.

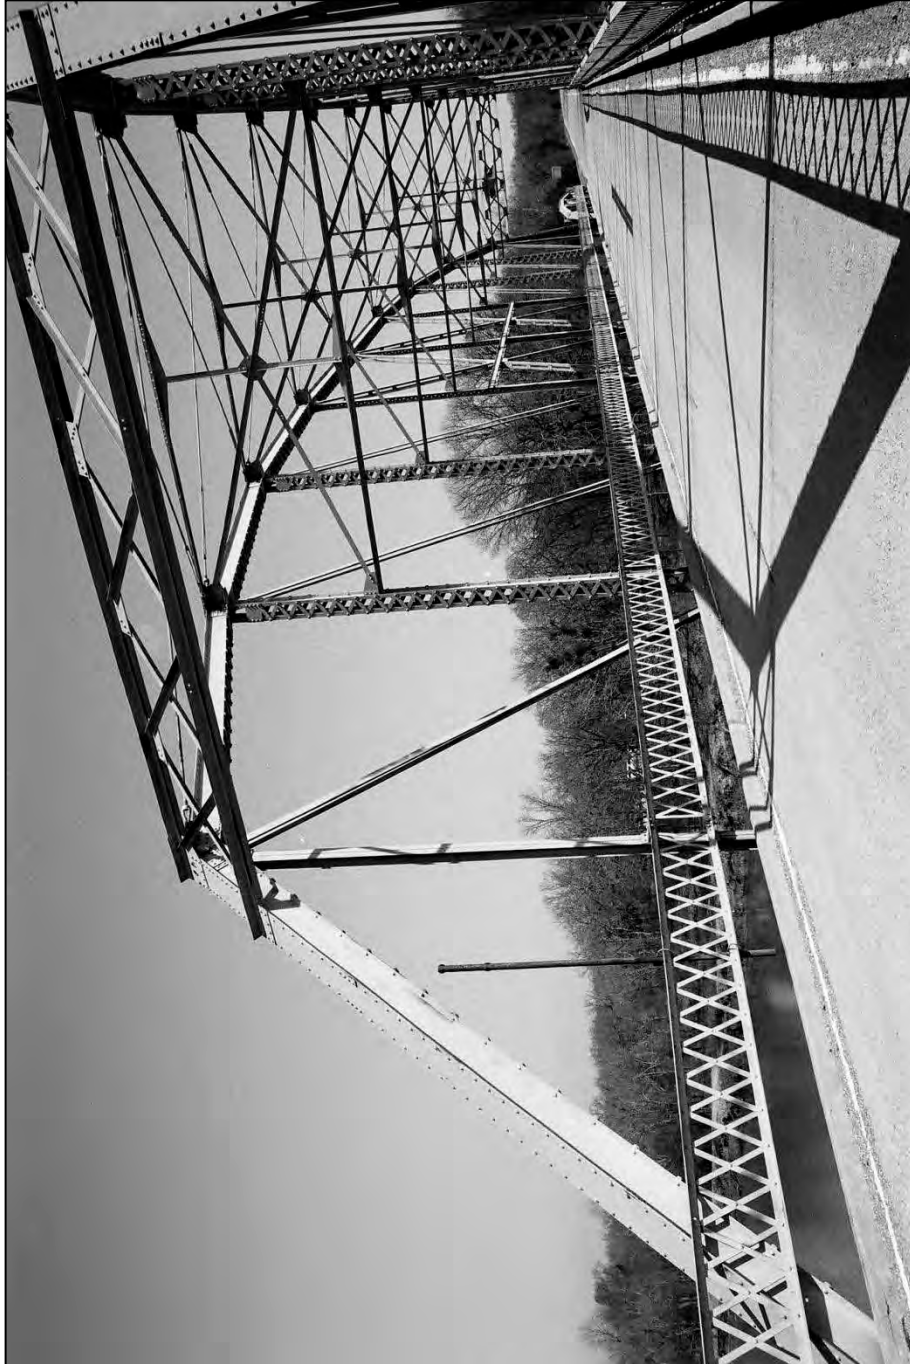
CUMBERLAND CUT MIXED TRUSS  
SEE INDEX TO PHOTOGRAPHS FOR CAPTION  
PHOTO 6

The Parker-through truss, located on the bridge’s northeast center span, has 10 inclined built-up members with V-lacing creating the design’s defining characteristic of an arched top chord.<sup>4</sup> The walls for this truss have 10 panels, nine vertical built-up members with V-lacing, and 10 diagonals. The diagonals in the two center panels cross to form an X and consist of angles connected with stay plates. The remaining diagonals consist of paired

rods angled inward and attached to the top and bottom chords using pin connections. All of the other members on the truss wall are riveted together with gusset plates located at the connection. The web connecting the truss walls at the top chord consists of eight panels with lateral bracing and nine struts with lateral bracing. The lateral bracing throughout the web is made up of rods with pin connections and angles with riveted connections.
