**US-281 at the South Canadian River
and Associated Roadway Section
Caddo, Canadian, Blaine Counties**

**Alternatives Analysis Report
November 2020**

Prepared For:
The Oklahoma Department of Transportation

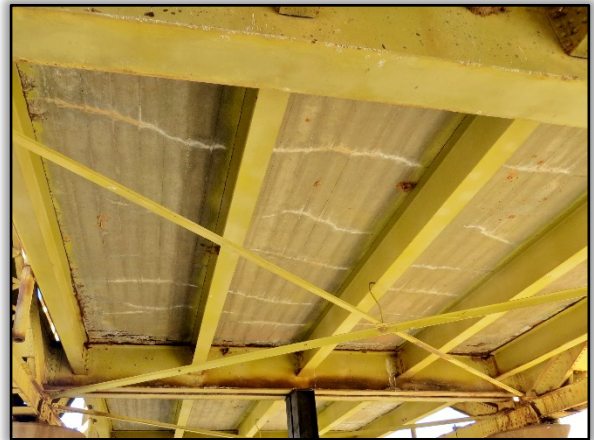
Figure 12. Transverse Cracking in Soffit

The 2013 FC-BIR noted several transverse cracks approximately four to six feet from expansion joints in the truss spans, likely caused by deck lifting. Spalls with exposed and corroded reinforcing steel were present on the underside of the deck near expansion joints (**Figure 10**). Cracks, minor spalling, staining, and concrete efflorescence were commonly found in exterior stringer bays and overhangs on the underside of the deck. The deck of each truss span exhibited expansion from the center of the span out (**Figure 11**). Expansion joints remained open, but the expansion bearings were near the limit of movement. End floor beams also showed evidence of deck growth with sweep, web rotation, and damages to the stringer connection angles. Transverse cracking in the soffit was visible on the underside of the bridge (**Figure 12**). There were several large sections of the concrete curb which had spalled and exposed reinforcing steel (**Figure 13 and Figure 14**).

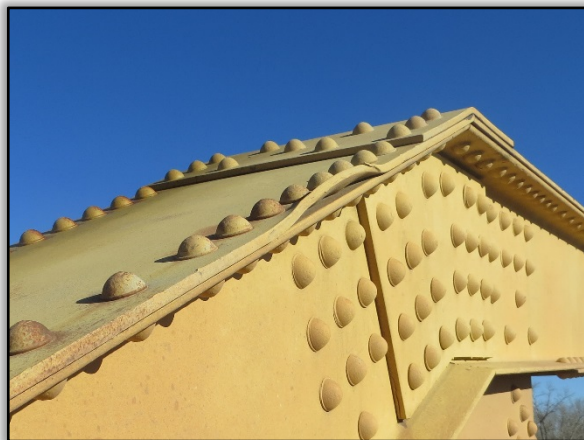
Figure 16. Typical Truss Upper Chord Collision Damage

The primary damage to the trusses above the deck was assumed to be due to vehicular collision. It was common for the top plates and flanges of the top chord of the trusses to be bent or wavy (**Figure 16**). In isolated locations, severe damage was observed, including torn flanges, detached lacing, sheared rivets, bent gusset plates, and corrosion at impact locations. Some of these larger damage areas are shown in **Figure 17** through **Figure 20** below. Typically, welds between the railing and truss members were corroded (**Figure 22**) and isolated locations had significant pack rust with possible section loss to the truss web. Pack rust was developing at gusset plate seams in several truss upper chords, causing gusset plates to bow slightly.

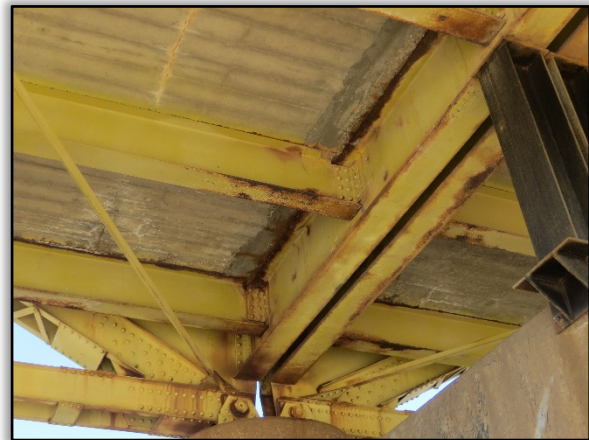
Figure 27. Corrosion of Stringers and Pier Beams

connection angles to the end floor beams which may be related to floor beam web rotation away from the stringer (**Figure 27 and Figure 28**). Corrosion with section loss and corrosion holes were present at stringer ends, with cracks propagating outward from the corrosion holes. The floor system bracing gusset plates had pack rust up to 0.5-inch thick and corrosion holes in the gusset plates at the edge of the floor beam bottom flange and near the truss bottom chord. Corrosion holes in the bracing gussets were mostly less than 1.5 inches in diameter (**Figure 29**) but up to 12 inches long.

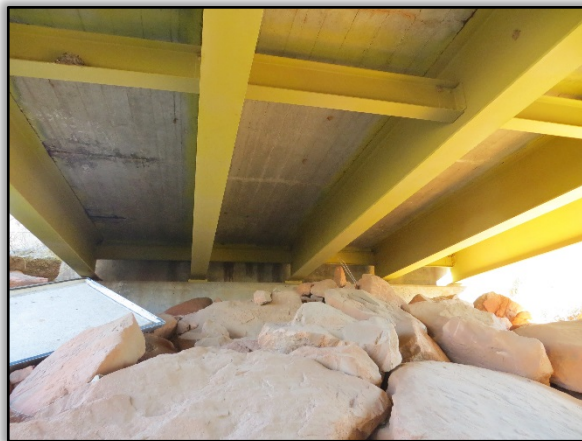
Figure 30. North Steel Beam End Span

The end spans, Span 1 and 40, consist of a steel beam superstructure with steel pier beams at piers 1 and 39 as shown in **Figure 30**. In the 2013 FC-BIR, the steel beams were rated 5 (Fair) and

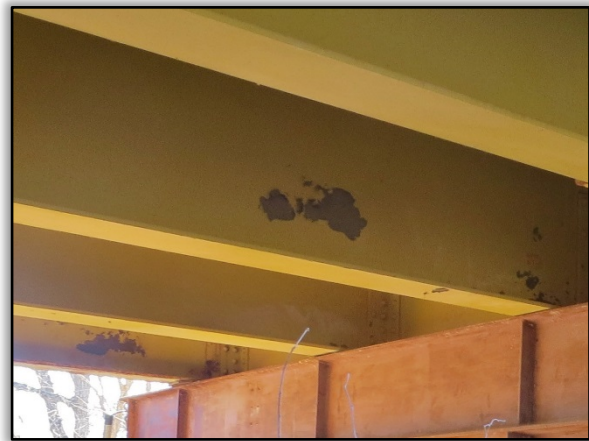
Figure 31. Corrosion near Beam Ends in North End Span

the pier beams were rated 4 (Poor). The steel beams had some corrosion, primarily at the end 1-3 feet of the beams and the top flanges of exterior beams (**Figure 31**). At pier 39, connection angles between the steel beams and the pier beam were deformed, caused by pier beam rotation and sweep due to apparent thermal expansion of pavement. **Figure 32** illustrates the rotation of the pier beam, likely due to pavement expansion according to the 2013 FC-BIR. Pier beams were retrofitted with a supplemental pier beam to reduce movement, shown in **Figure 32** and **Figure 33**. Bearing pads between the steel beam bottom flanges and the supplemental pier beams were twisted, and some were missing. At the abutment, exterior bearing anchor bolts were sheared.

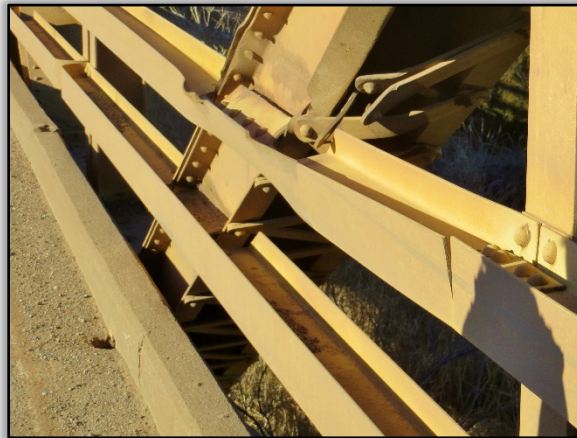
Figure 36. Collision Damage to Metal Rail

This bridge has two different types of railing, a concrete rail on the steel beam end spans and a metal rail on the truss spans. Both bridge rails are substandard and have not been load tested for current AASHTO standards. In Span 1, a section of the bottom rail was detached from the post and not functional (**Figure 34**), and there was damage to the concrete end post where it butted against the metal rail (**Figure 35**). Other sections of the concrete rail were cracked or spalled with exposed reinforcing steel. The metal railing also exhibited multiple locations of apparent vehicular collision damage where the railing was bent or scratched as shown in **Figure 36**.

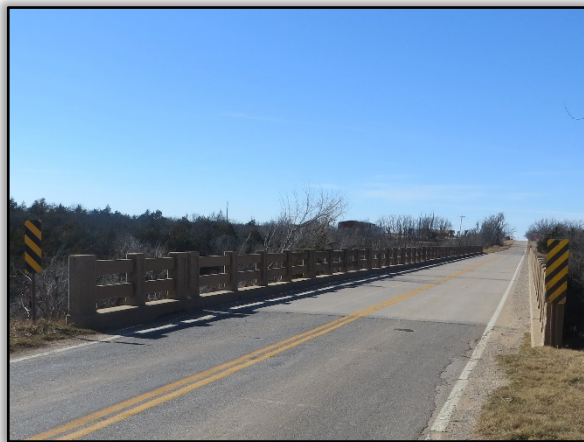
Figure 40. Bridge Deck, Looking West

The deck received a rating of 5 (Fair) in the ODOT BIR. The deck, shown in **Figure 40**, exhibited some cracking throughout all spans. From the item notes in the BIR, cracking was heavier in spans 6, 7, and 8. There was a concrete deck patch measuring approximately 12 square feet on the south side of the bridge at pier 10. The soffit exhibited small areas of delamination covering approximately 2-3 percent of the soffit area. From beneath the deck, approximately 0.5 inch of uplift was noted at beams 3 and 4. Expansion joints have had previous asphalt patches, but the joint seals were leaking. The fixed joints were primarily in acceptable condition; however, there was a spall evident at the easternmost joint.
