HOMINY CREEK K THROUGH TRUSS BRIDGE

JP Number 24365(04)

HISTORIC AMERICAN ENGINEERING RECORD

June 2015

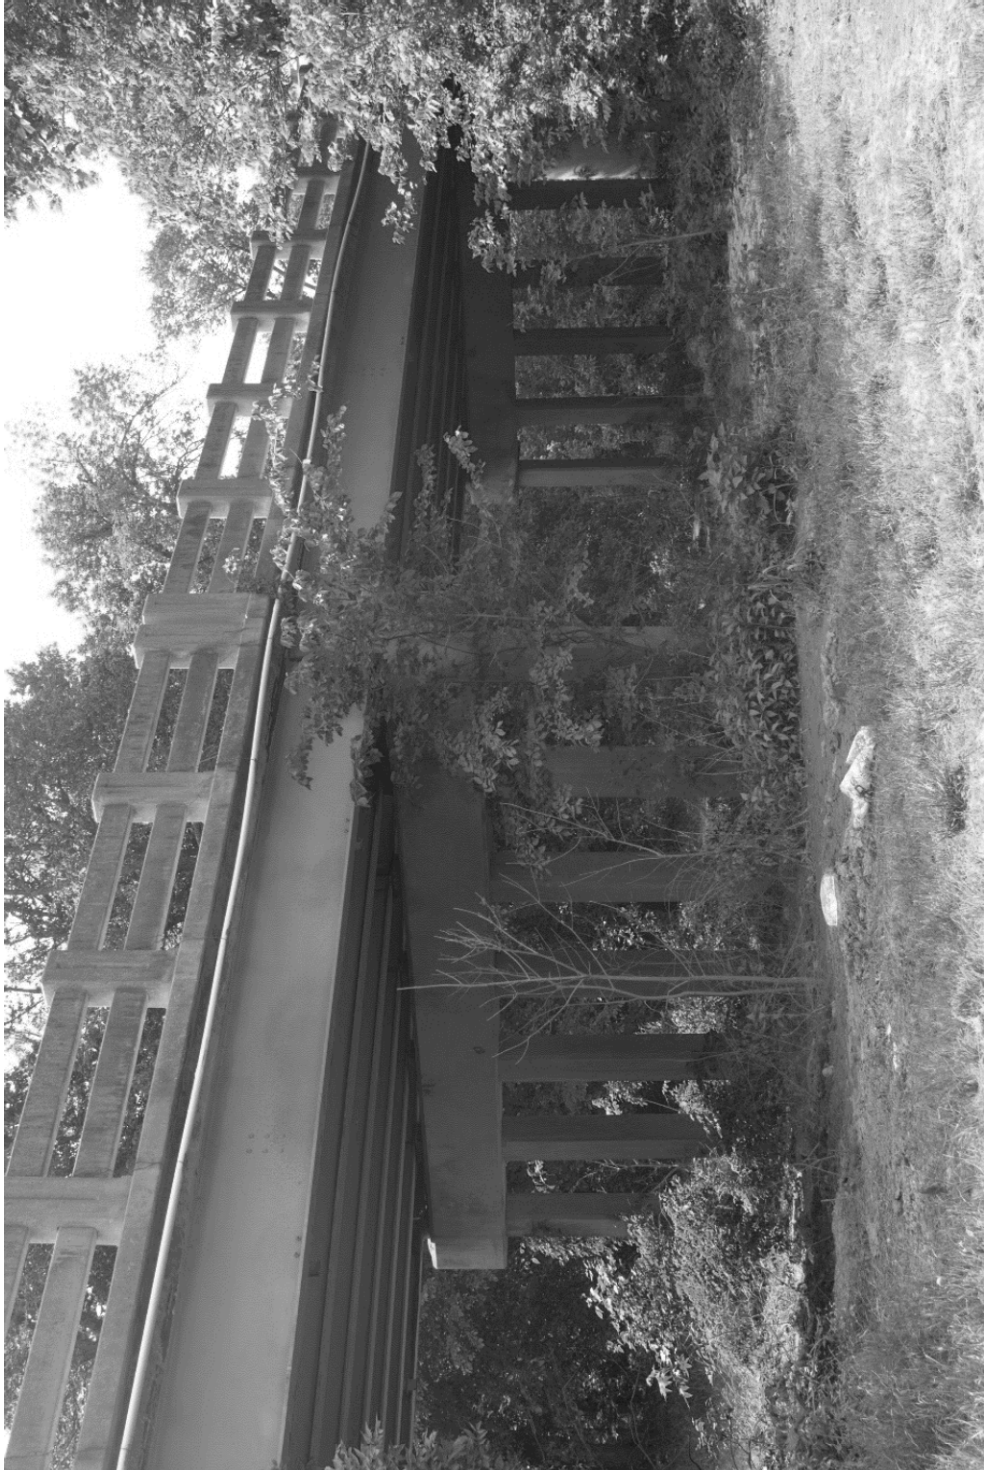
HOMINY CREEK K THROUGH TRUSS BRIDGE  
SEE INDEX TO PHOTOGRAPHS FOR CAPTION  
PHOTO 9

1. GENERAL VIEW, LOOKING N
2. GENERAL VIEW, LOOKING S
3. GENERAL VIEW, LOOKING NW
4. CLOSE UP, LOOKING NW
5. VIEW OF BRIDGE WITHIN SETTING, LOOKING SE
6. GENERAL VIEW, LOOKING SE
7. CLOSE UP, LOOKING NW
8. CLOSE UP, LOOKING NW
9. VIEW OF I-BEAMS AND SUPPORTS, LOOKING SE
10. BRIDGE WITH SUPPORTS, CLOSE UP, LOOKING SW
11. BRIDGE WITH SUPPORTS, LOOKING SW
12. UNDERSIDE OF BRIDGE, LOOKING S
13. UNDERSIDE OF BRIDGE, LOOKING SW
14. UNDERSIDE OF BRIDGE, CLOSE UP
15. CLOSE UP OF EAST RAILING, LOOKING NE

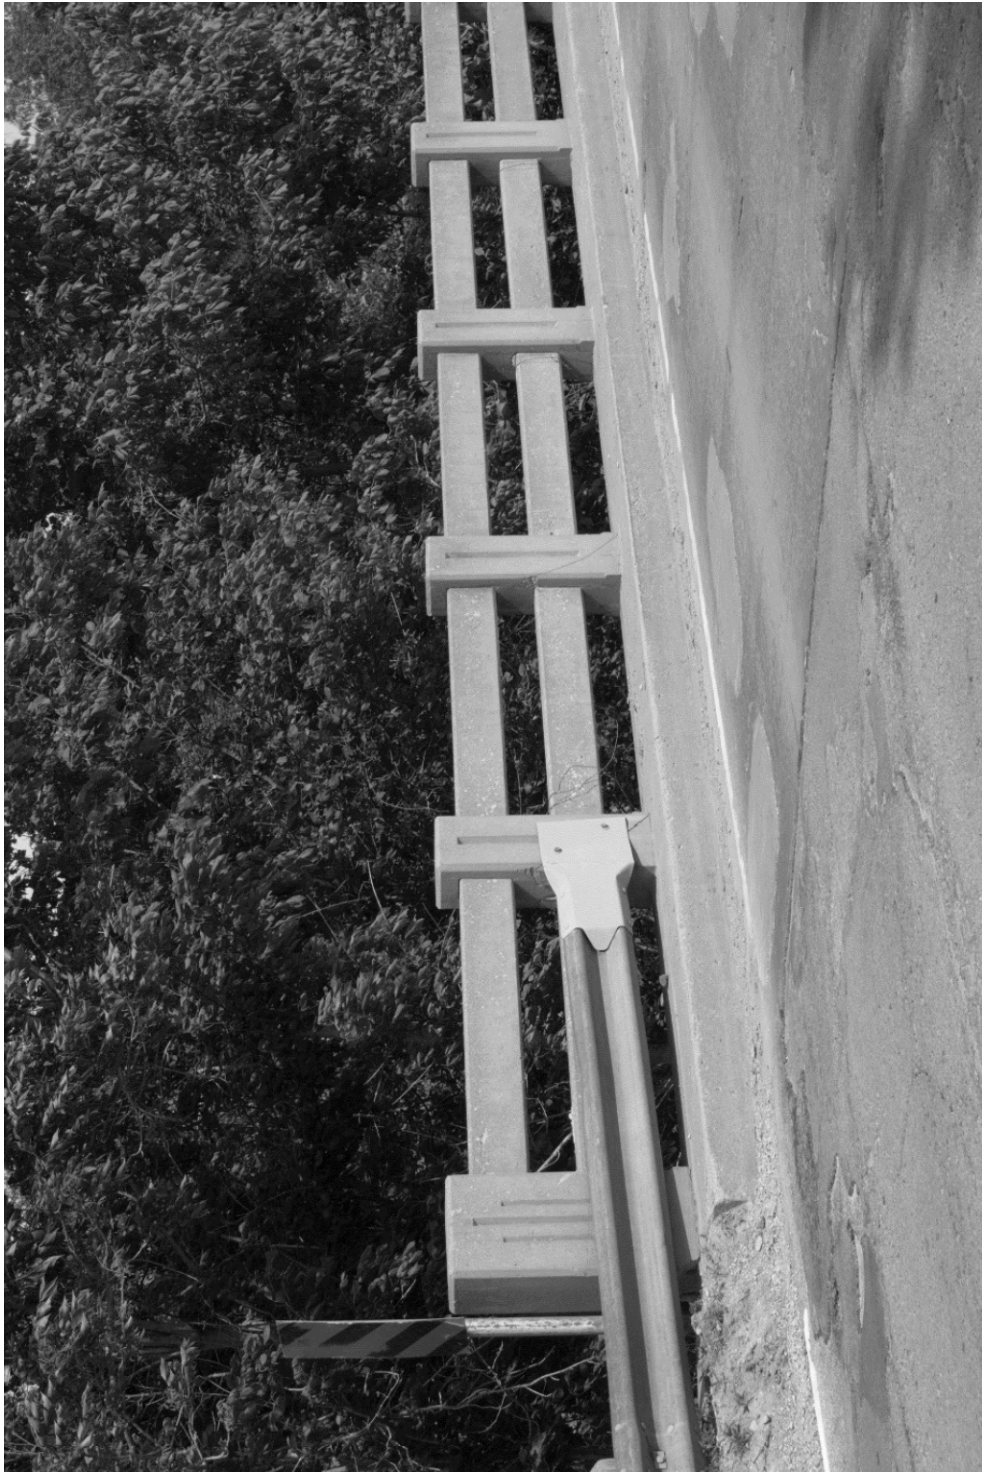
HOMINY CREEK K THROUGH TRUSS BRIDGE  
SEE INDEX TO PHOTOGRAPHS FOR CAPTION  
PHOTO 16

16. CLOSE UP OF WEST RAILING, LOOKING NW
17. CLOSE UP OF THROUGH TRUSS
18. RURAL SETTING OF BRIDGE, LOOKING N
