INDEX TO PHOTOGRAPHS

UNNAMED CREEK SIX-SPAN REINFORCED CONCRETE SLAB WITH MASONRY PIERS WPA BRIDGE
Spanning Unnamed Creek
Altus vicinity
Jackson County
Oklahoma

UNNAMED CREEK SIX-SPAN REINFORCED CONCRETE SLAB WITH MASONRY PIERS WPA BRIDGE

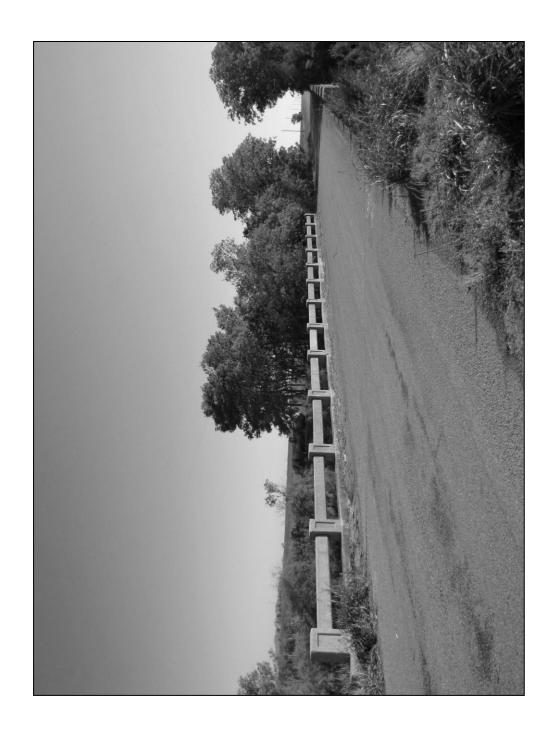
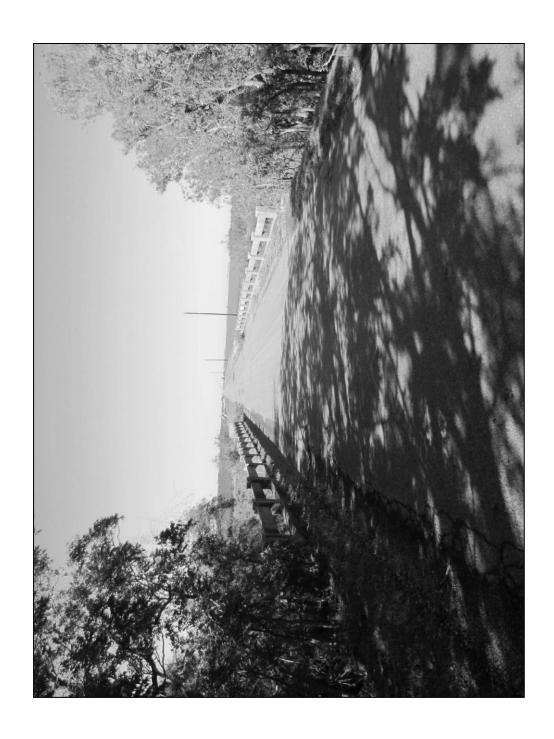
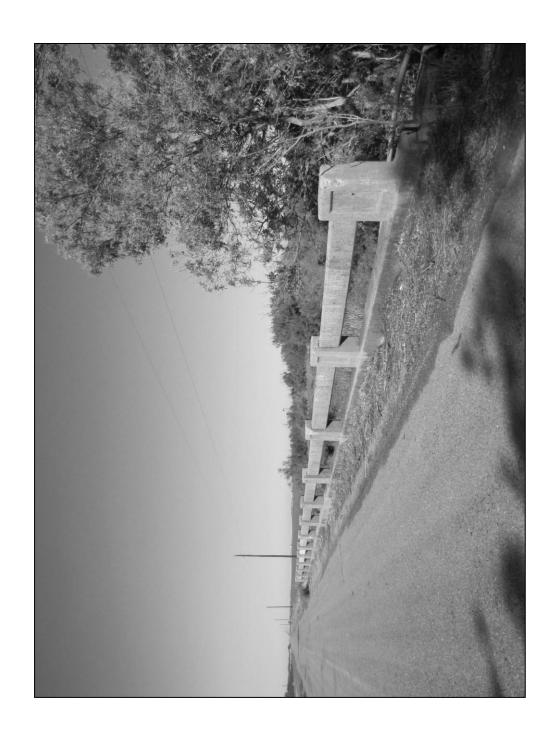
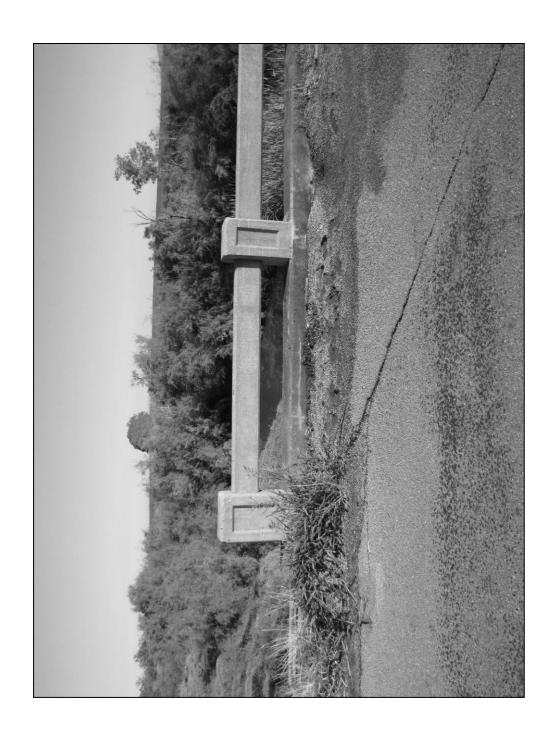
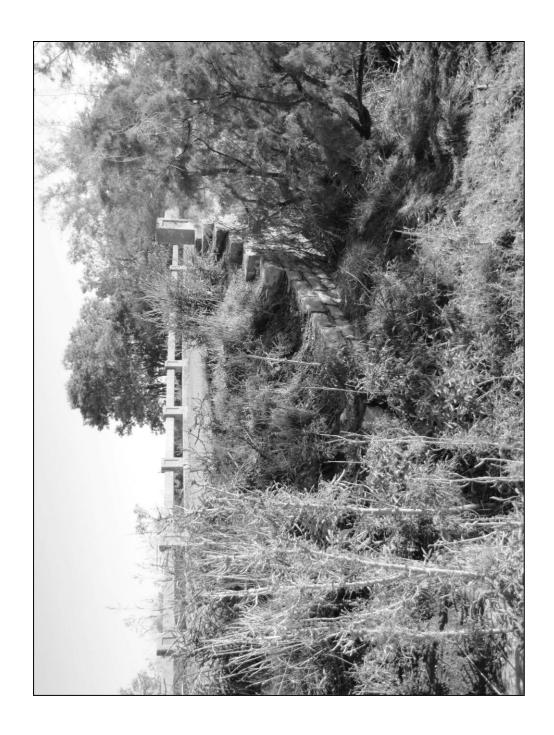
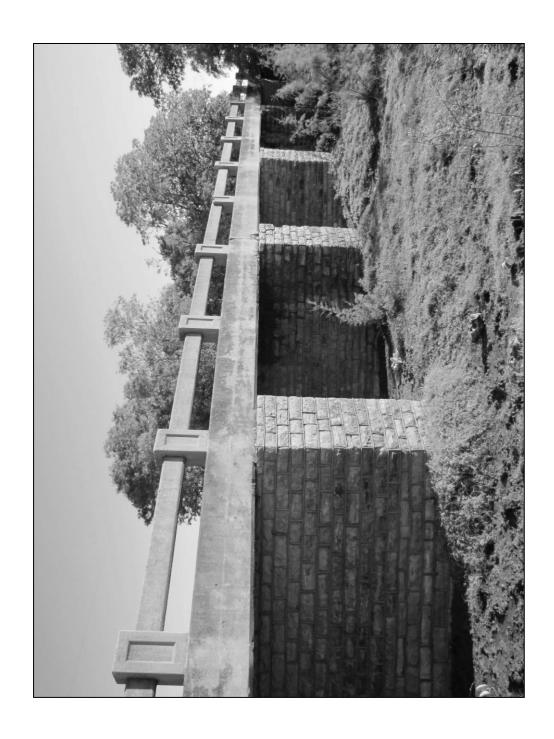
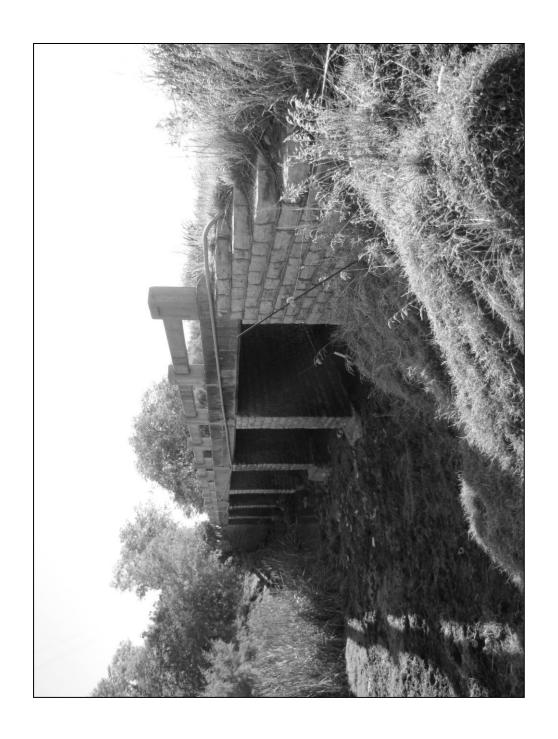
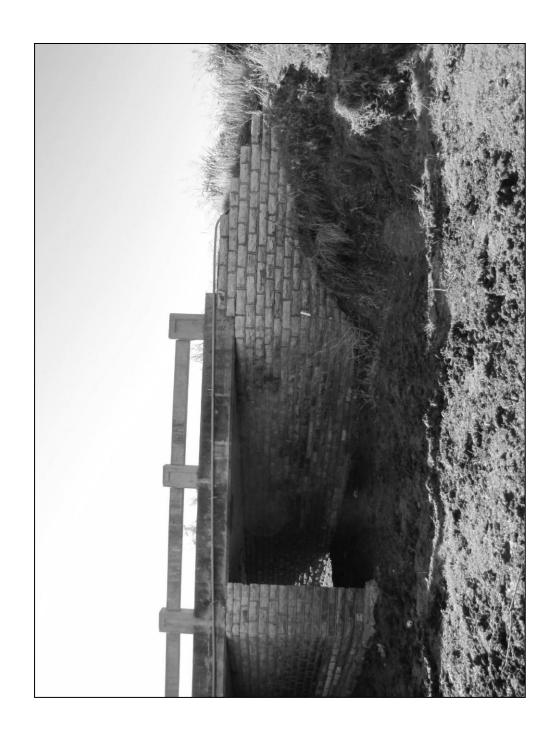
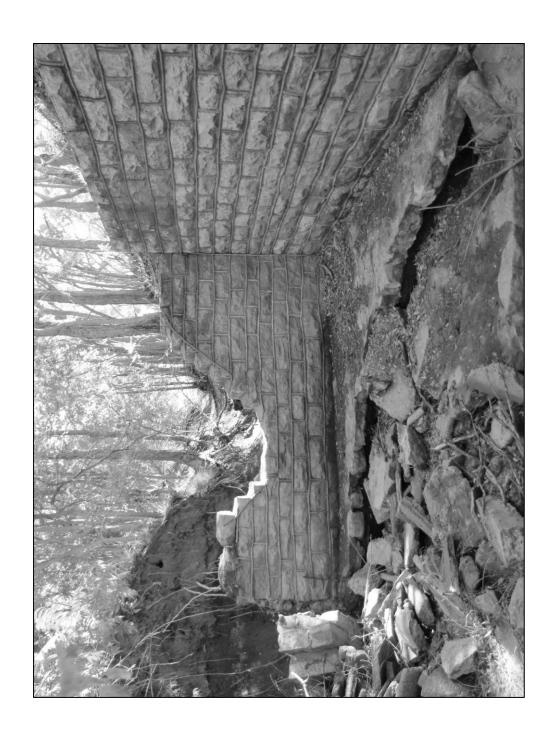
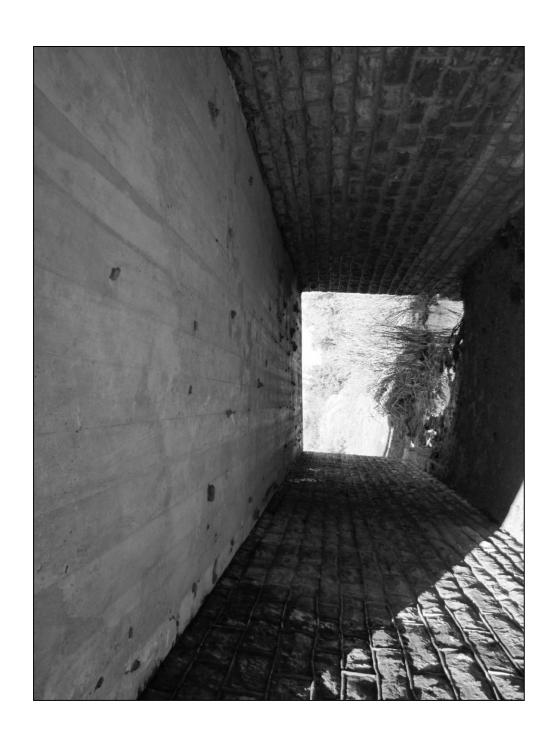
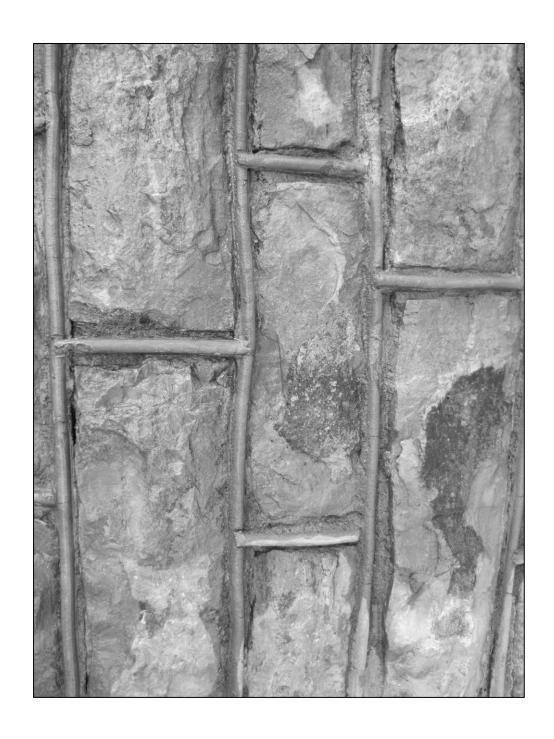
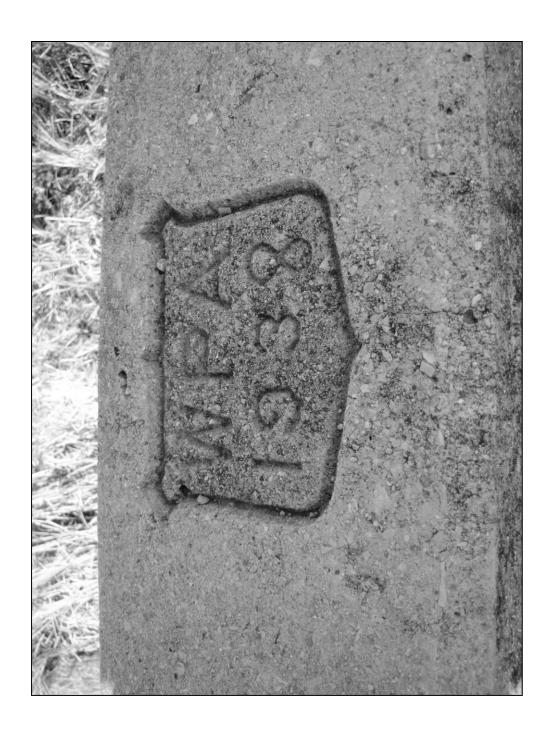
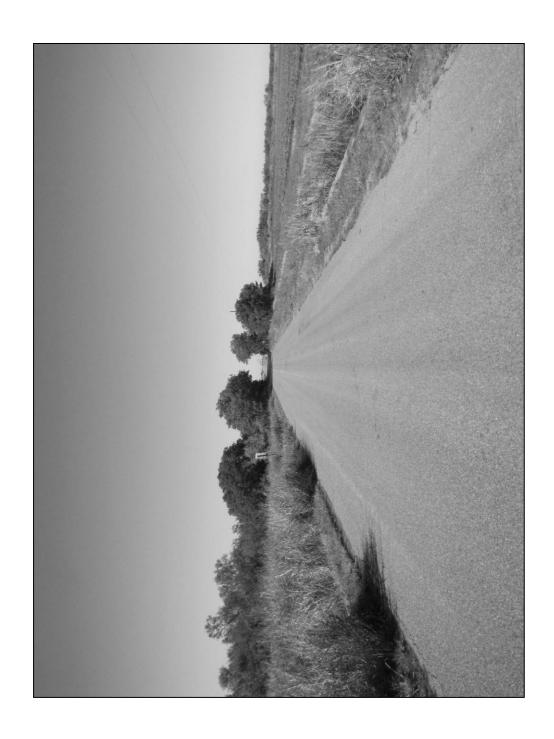
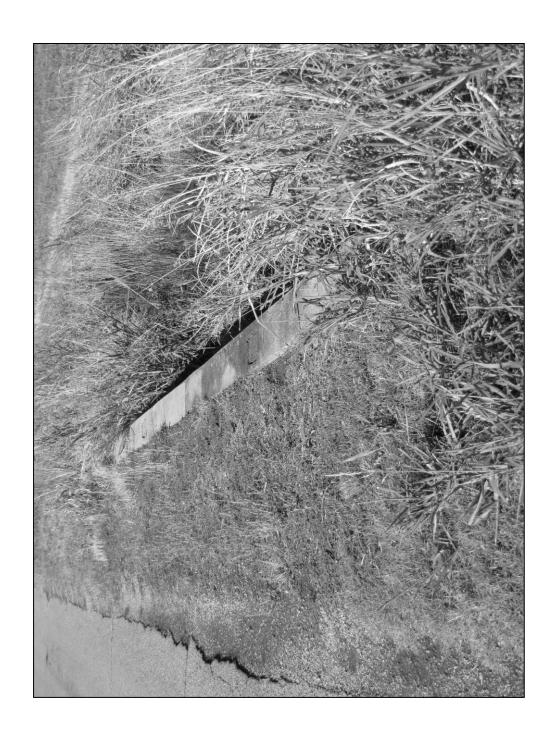
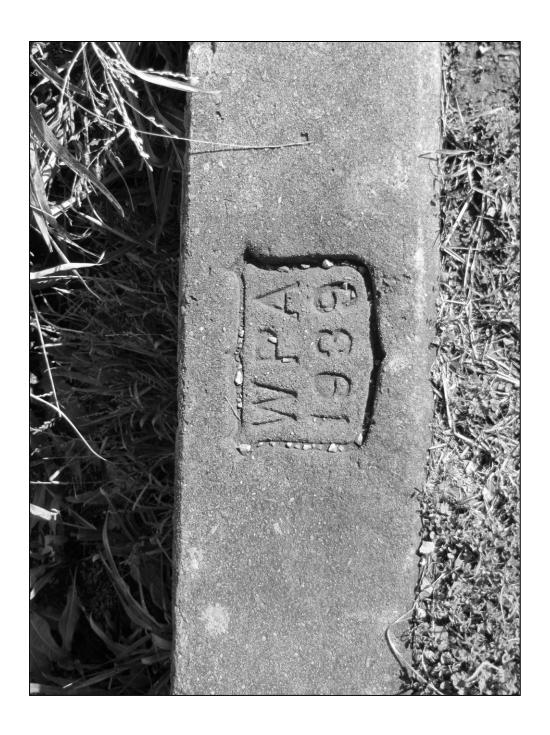
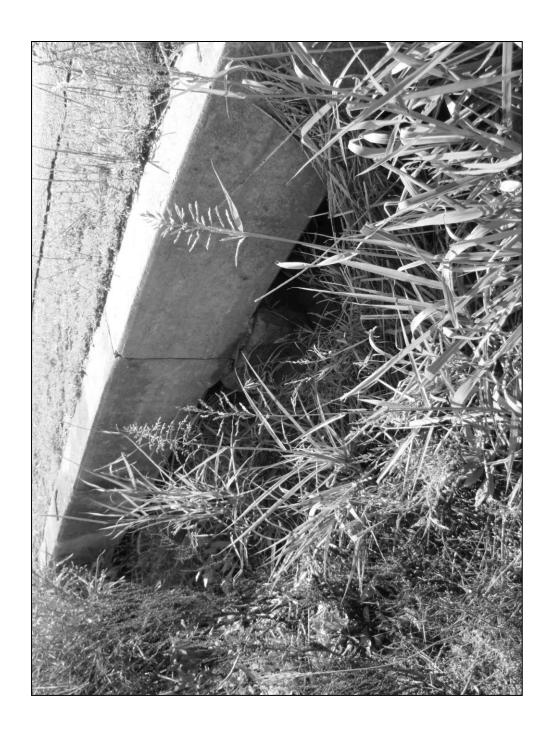
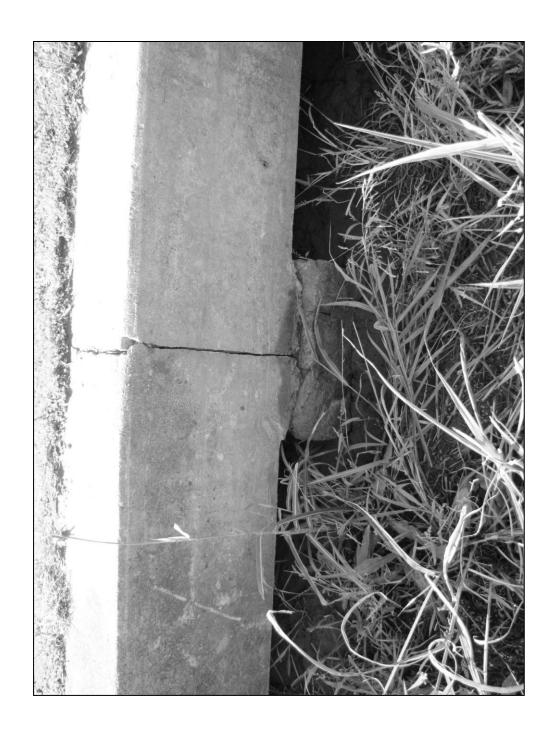
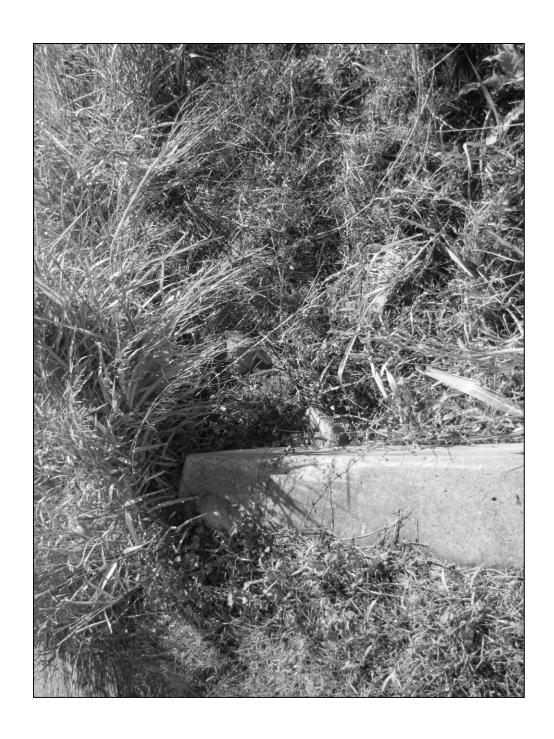
18.

•	
1.	OVERALL VIEW, LOOKING NORTHEAST
2.	OVERALL VIEW, LOOKING WEST
3.	VIEW OF RAILING, LOOKING NORTHWEST
4.	DETAIL VIEW OF RAILING, LOOKING NORTH
5.	DETAIL VEIW OF WING WALL, LOOKING NORTHEAST
6.	OVERALL VIEW OF PIERS, LOOKING NORTHEAST
7.	OVERALL VIEW OF PIERS, LOOKING SOUTHEAST
8.	DETAILVIEW OF WING WALL, LOOKING SOUTHWEST
9.	DETAIL VIEW OF STRUCTURAL WALL, LOOKING EAST
10.	VIEW OF DECK AND PIERS, LOOKING NORTH
11.	DETAIL VIEW OF MASONRY, LOOKING EAST
12.	DETAIL VIEW OF WPA STAMP, LOOKING NORTH
13.	OVERALL VIEW OF ASSOCIATED CULVERT, LOOKING WEST
14.	VIEW OF NORTH END OF CULVERT, LOOKING WEST
15.	DETAIL VIEW OF WPA STAMP ON CULVERT, LOOKING NORTH
16.	VIEW OF CULVERT PIER, LOOKING SOUTHEAST
17.	DETAIL VIEW OF CULVERT PIER, LOOKING SOUTH

DETAIL VIEW OF CULVERT WING WALL, LOOKING WEST
