## Design Support Report for Programmatic Section 4(f) Alternatives Analysis

# U.S. Highway 60 Bridge Over Horse Creek

**Afton, Ottawa County**

NBI Bridge No.: 05017 Structure No.: 5806 0256 X

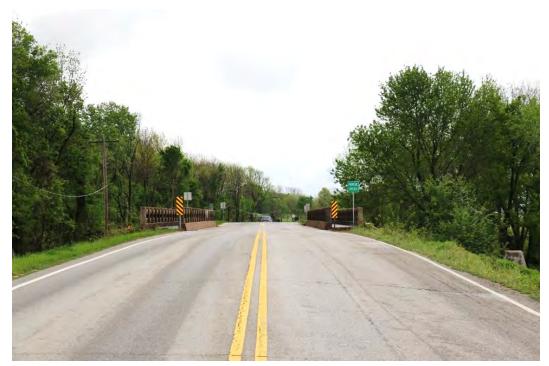
Photo 1. US 60 west roadway approach to the bridge, looking east.

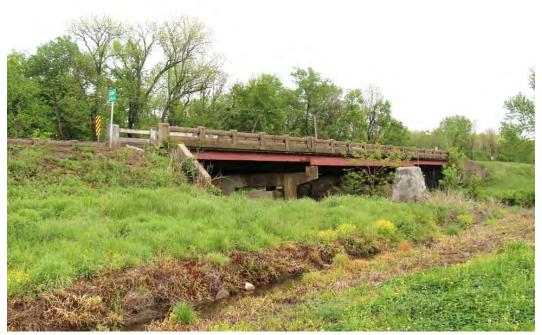
Photo 2. South side of bridge; note sanitary sewer manhole and drainage swale.

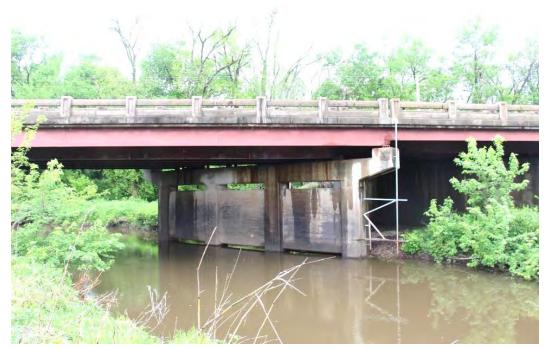
Photo 3. South side of Span 2 and Pier 2; unknown vertical pipe attached to bridge.

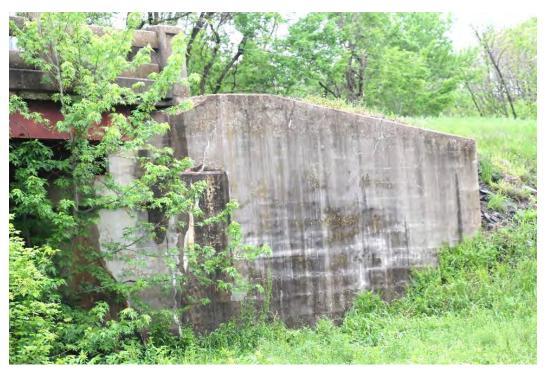
Photo 4. East abutment, south wingwall, cracking and spalling with efflorescence.

- NBI Item 60 Substructure (5, fair condition): The reinforced-concrete piers and abutments are in Condition State 2 – Fair. The west abutment and east abutment have minor spalls and cracks with exposed reinforcing steel; several of the cracks have efflorescence. Other than very minor spalling on top of the concrete caps, the reinforced-concrete piers did not exhibit structural deficiencies.

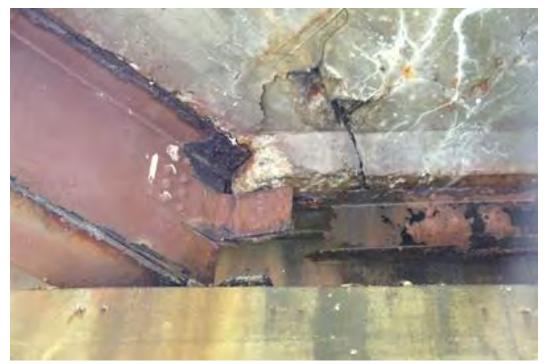
Photo 5. Underside of bridge deck at west abutment; note severely deteriorated steel diaphragm, spalled concrete deck with exposed rebar, and failed deck joint.

- NBI Item 59 Superstructure (4, poor condition): The steel beams that support the roadway concrete deck and concrete sidewalks are in Condition State 2 Fair. The paint system has failed in approximately 25 percent of the surface area of the steel beams, primarily at the ends over the bearings. Minor deterioration of the steel was observed at the ends of the beams; several of the beams have supplemental steel sections welded to them on the bottom flanges at the ends. Steel diaphragms between the beams over the piers and abutments have failed. Many of the steel diaphragms have completely deteriorated with total loss of section; several of the most deteriorated diaphragms have been removed. Steel bearings for the beams have complete paint failure and moderate loss of section.

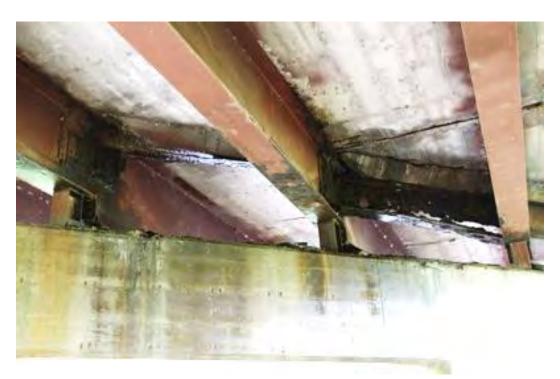
Photo 6. Underside of bridge deck at Pier 1; note severely deteriorated steel diaphragm, spalled concrete deck with exposed rebar, and failed deck joint.

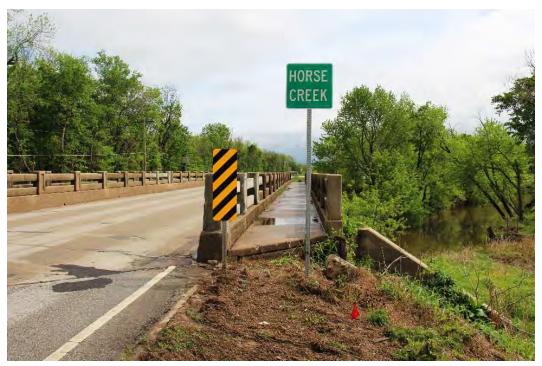
Photo 7. West end of bridge, south side at end of sidewalk, showing concrete railings.

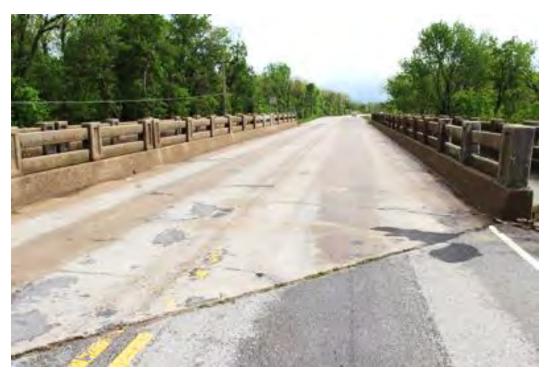
Photo 8. Condition of bridge deck, looking east from west end of bridge; note patched concrete, potholes, and failed deck joints.

- NBI Item 58 Deck (3, serious condition): The entire reinforced-concrete deck is rated in Condition State 3 Poor. The concrete deck has many cracks, patched areas, spalls, and impending potholes with exposed reinforcing steel bars. Joints in the concrete deck have completely failed and are allowing water and debris to drip on to the steel beams and steel diaphragms below the joints. The deck was observed to be pumping or bouncing on the steel beams when traffic passed over. This is because the concrete deck is not physically attached to the steel beams. The reinforced-concrete sidewalks are in fair condition without any potholes or spalled areas. The longitudinal joints between the sidewalks and the bridge railings are unsealed, allowing water to drip on the steel beams below.

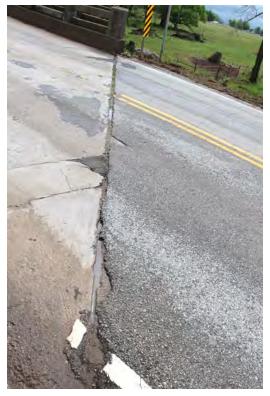
Photo 9. Failed joint between bridge deck and roadway at west end of bridge.

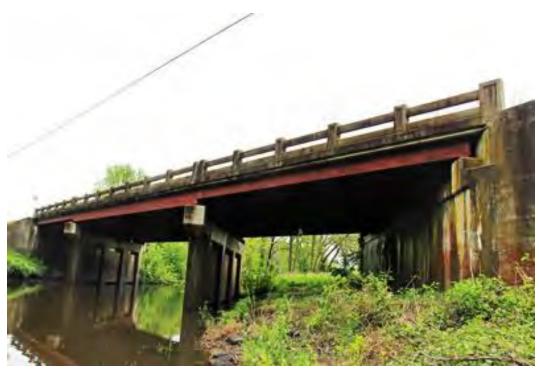
Photo 10. Horse Creek waterway channel under westerly span of bridge; note sediment and soil buildup, reducing waterway opening.

- Patch spalled areas of the faces of both abutments.
- Dredge the creek channel under the westerly span of the bridge and restore the waterway opening through the entire bridge to its originally constructed condition.

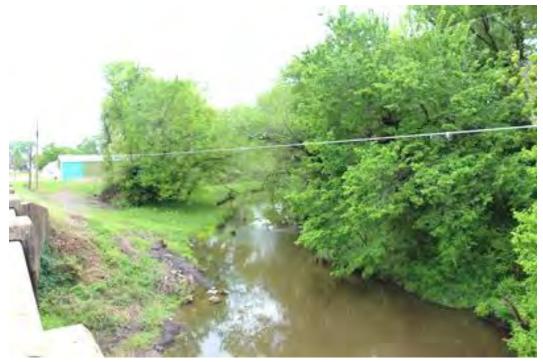
Photo 11. View looking upstream (north) of Horse Creek from north side of bridge.

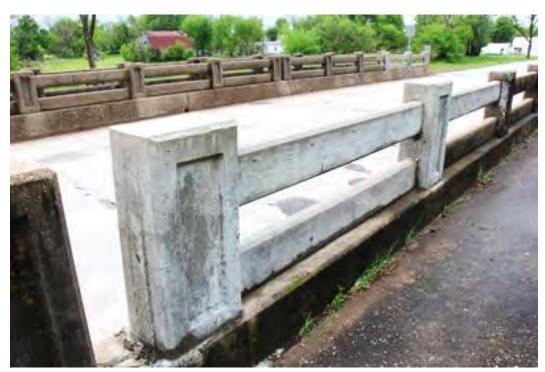
Photo 12. Repaired concrete bridge railing; note color and texture of repaired section compared to original railing.

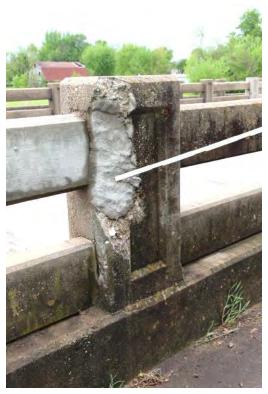
Photo 13. Repaired concrete railing post; note color and texture of repaired post compared to original post.

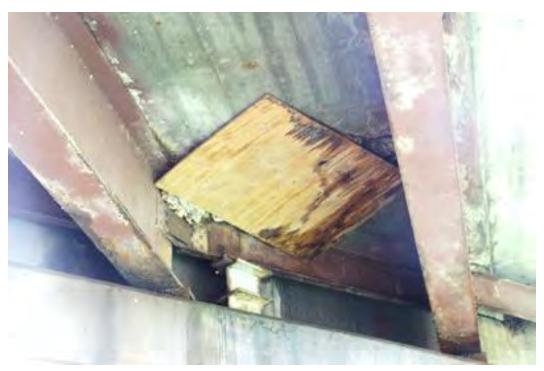
Photo 14. Underside of bridge deck at east abutment; note plywood used to form underside of concrete patch in deck; also note supplemental steel support under steel diaphragm.

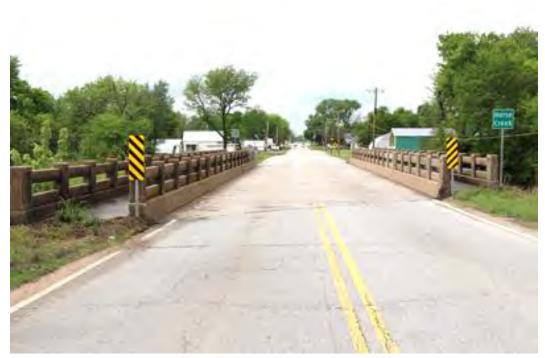
Photo 15. US 60 east roadway approach to the bridge, looking west.

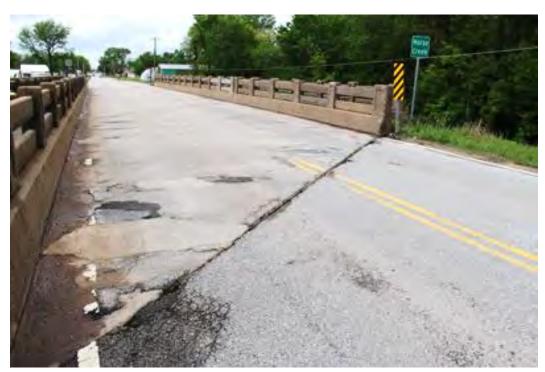
Photo 16. Condition of bridge deck at east abutment, south side; note patched and potholed concrete and failed deck joint.

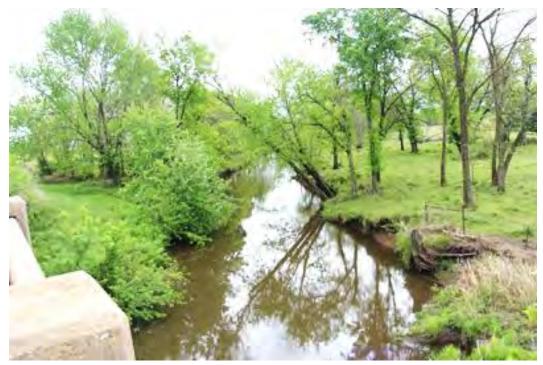
Photo 17. View looking downstream (south) of Horse Creek from south side of bridge.

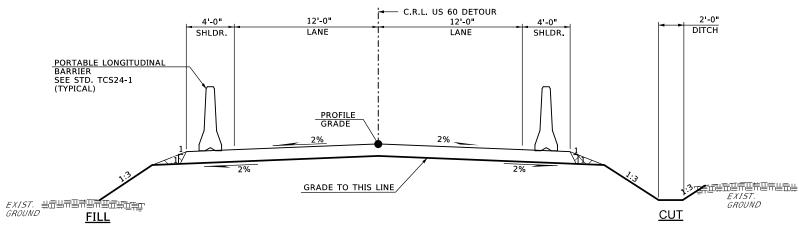
TYPICAL SECTION - DETOUR 2 STA. 2340+65.00 TO STA. 2349+46.52 N.T.S.

- 1 PERMANENT SLOPE PROTECTION REFER TO DETAIL SHEET 5.
- TO BE BACKFILLED & COMPACTED AS PART OF THE FINISHING OPERATIONS. COST TO BE INCLUDED IN TBSC TYPE E.
- 3 FILL SLOPE DEPTHS ARE DEFINED FROM EDGE OF SHOULDER.
- 4 TOPSOIL NOTE:
  THE CONTRACTOR SHALL STRIP ALL OF THE AVAILABLE TOPSOIL,STOCKPILE IT AND PLACE IT BACK ON THE SECTION IN ACCORDANCE WITH SECTION 205 OF THE STANDARD SPECIFICATIONS. RESERVED TOPSOIL SHALL BE SPREAD FIRST ON THE COMPLETE SLOPES OF THE CUT SECTIONS AND THE REMAINDER ON COMPLETED BY SLOPES OF THE BURNEY AREAS LOCATED BY TILL SLOPES OR OTHER PRIORITY AREAS LOCATED BY THE ENGINEER. ALL ADDITIONAL COSTS ASSOCIATED WITH OPERATION SHALL BE INCLUDED IN THE PAY ITEMS FOR SALVAGED TOPSOIL, LUMP SUM.

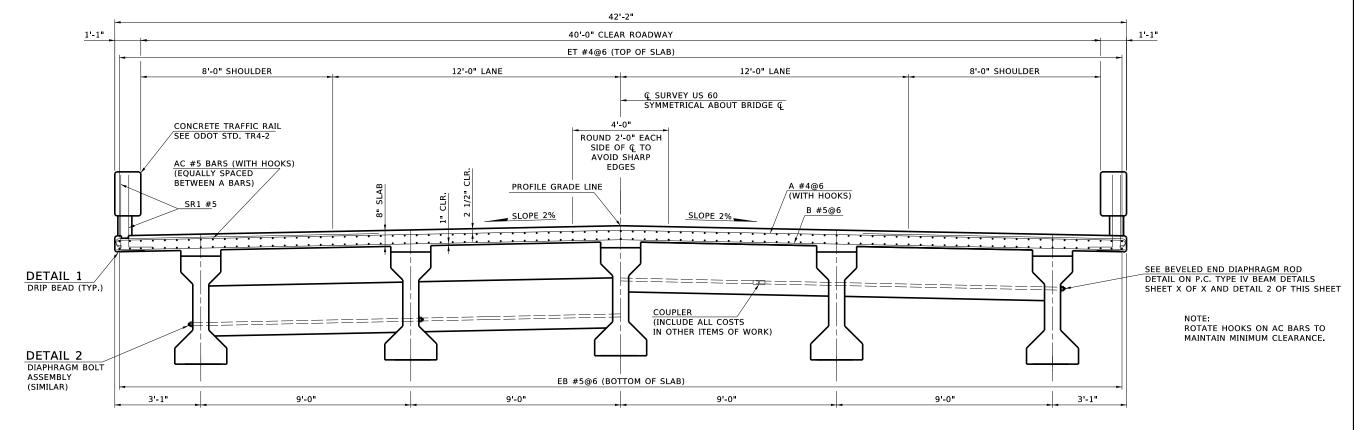
#### HALF SECTION AT INTERMEDIATE DIAPHRAGMS

#### HALF SECTION AT END DIAPHRAGMS
