**Geophysical, Archaeological, and Architectural Investigations at
101 Ranch Historic District,
Ponca City vicinity, Kay County, Oklahoma**

Prepared by
URS Corporation
Dallas, Texas

Contract Number: EC-1217H
Task Order Number: 009
URS Project Number: 37974201

September 2012

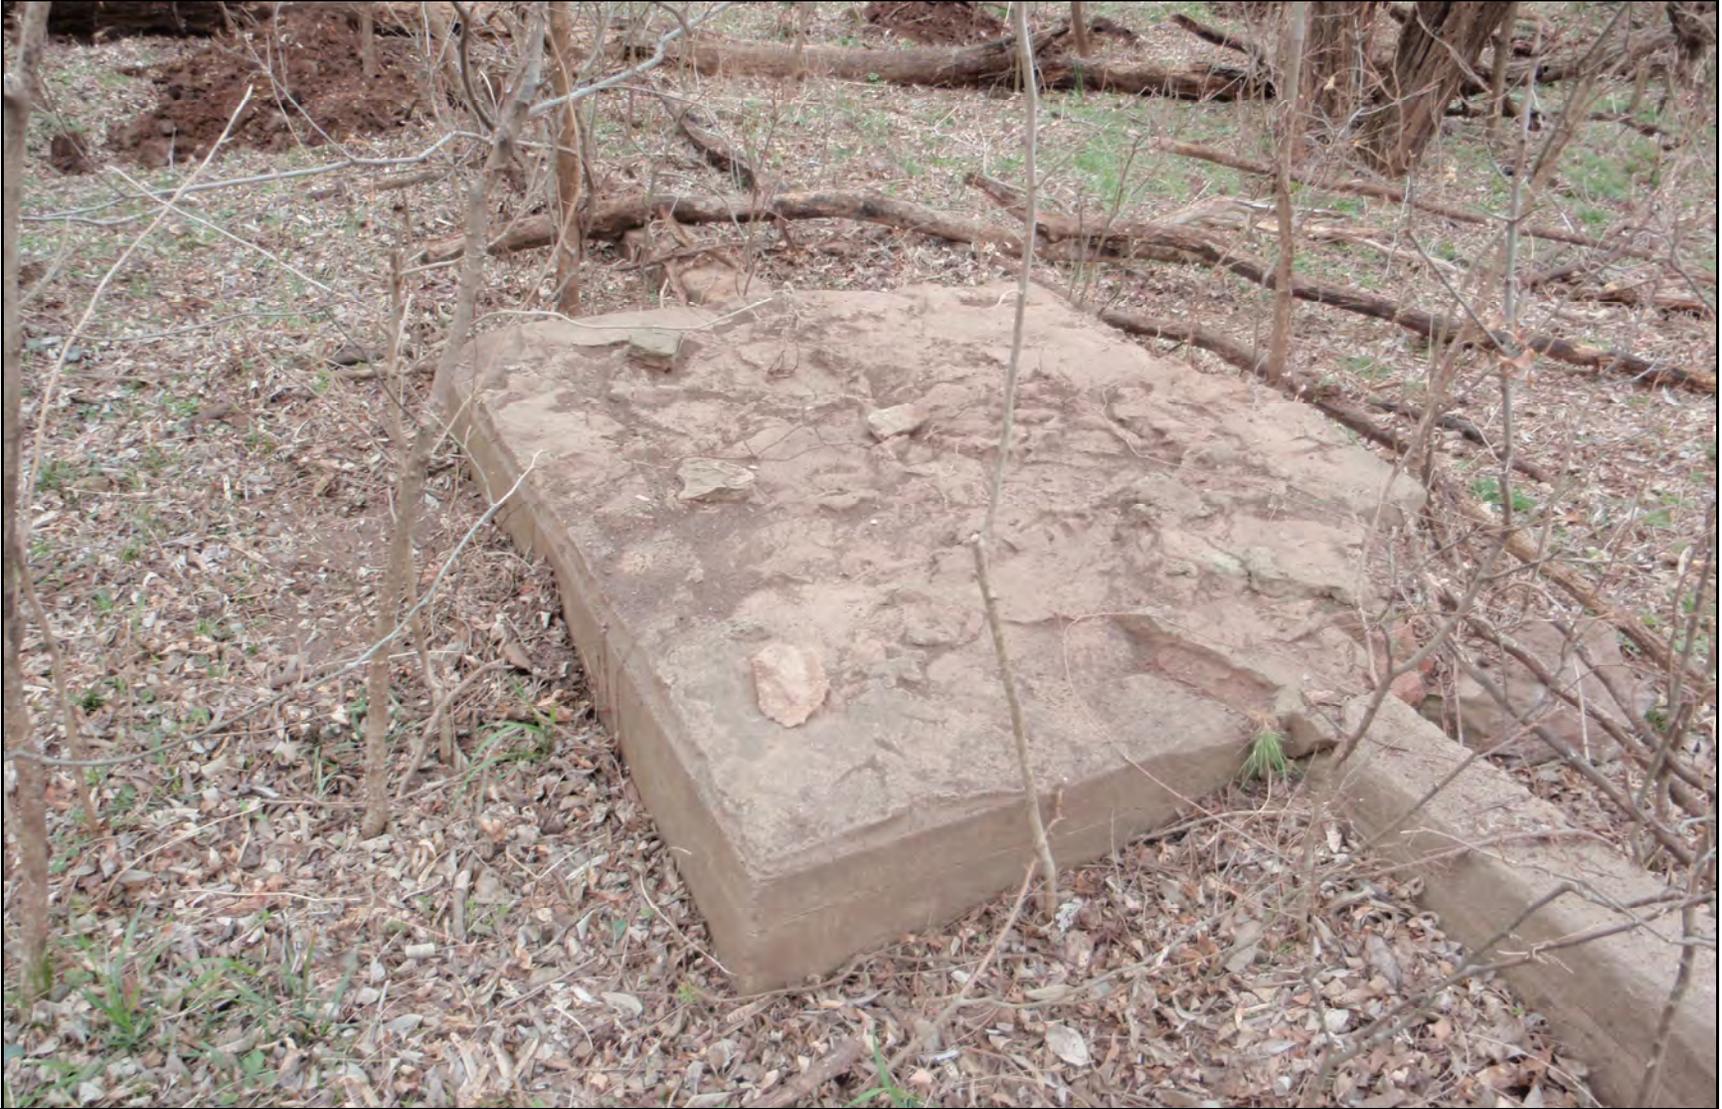
Figure A85

This investigation did not provide sufficient information to determine that the Riverside Camp is a contributing element to the historic district. There is potential for intact features and deposits, but it has not been established that the observed foundation and cellar were present when the area was used as the Riverside Camp. The investigation establishes the presence of intact features in the area, but their association and function with the Riverside Camp are unknown. As such, the archaeological remains located here do not presently demonstrate the ability to yield significant information about this aspect of the NRHP 101 Ranch Historic District. It is recommended that further

View of concrete footer in Riverside Camp.

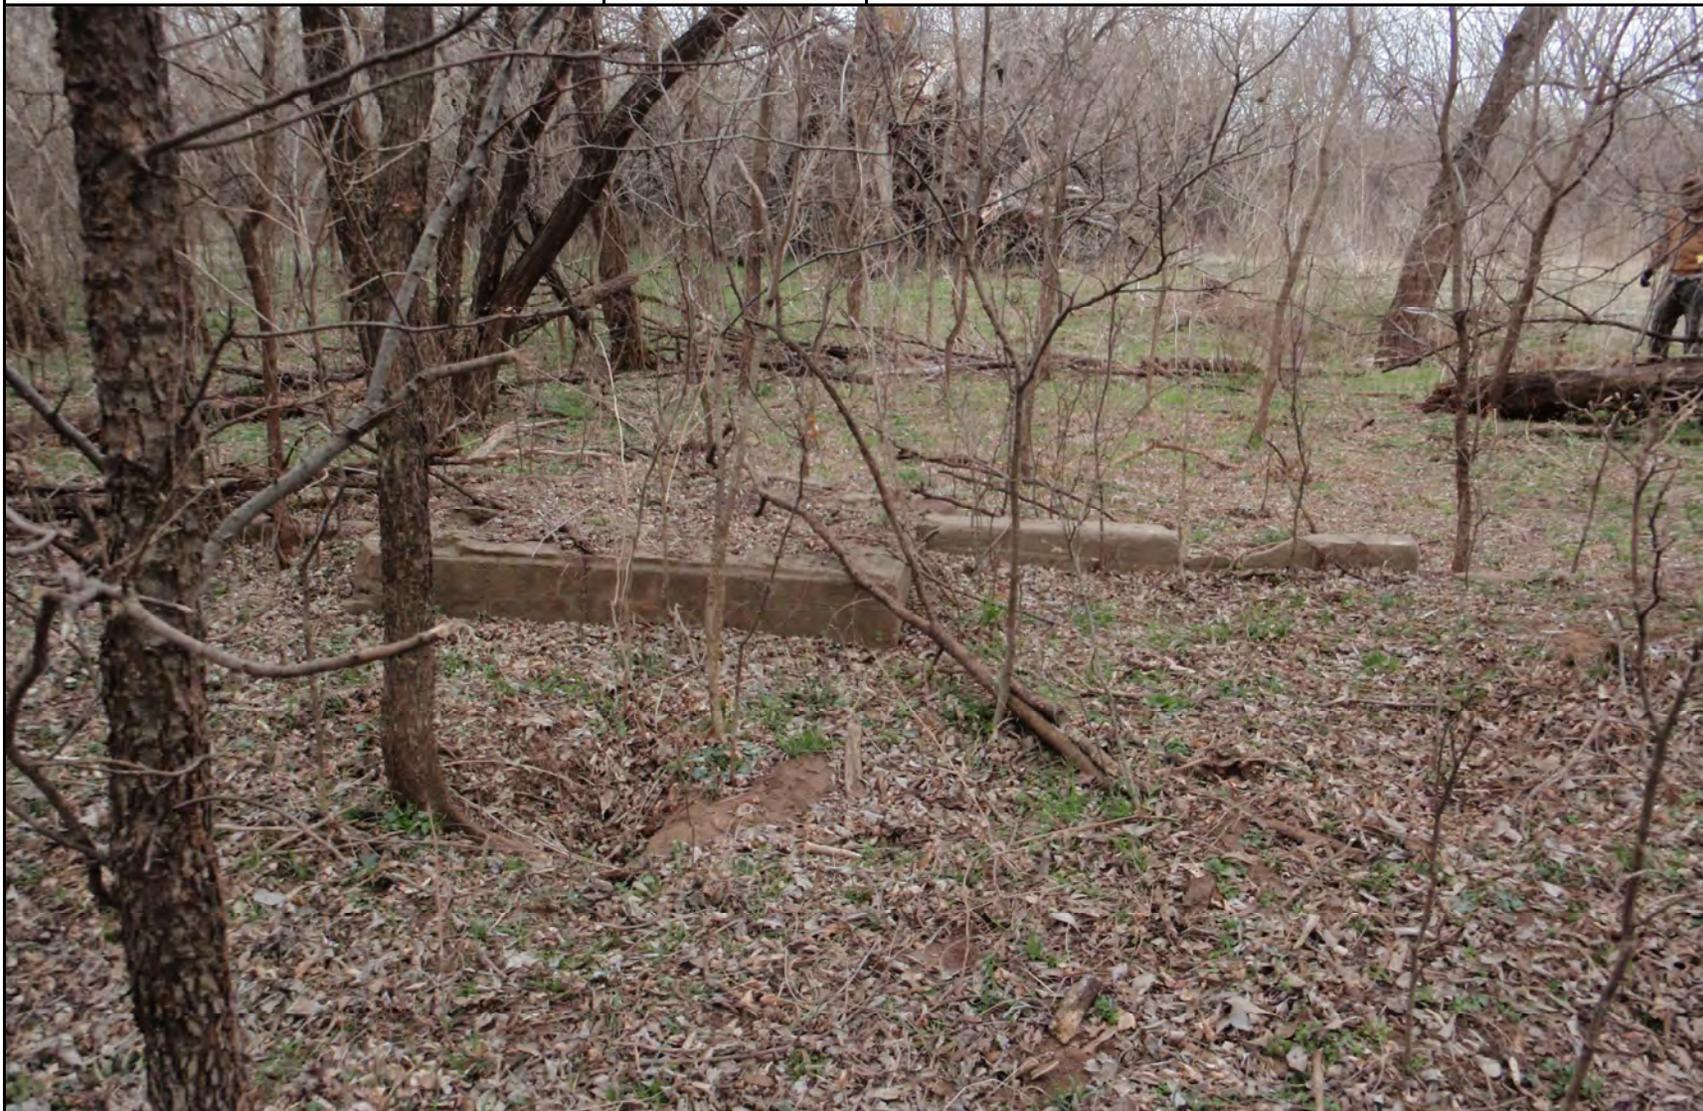
Figure A86

View of concrete footer in Riverside Camp.

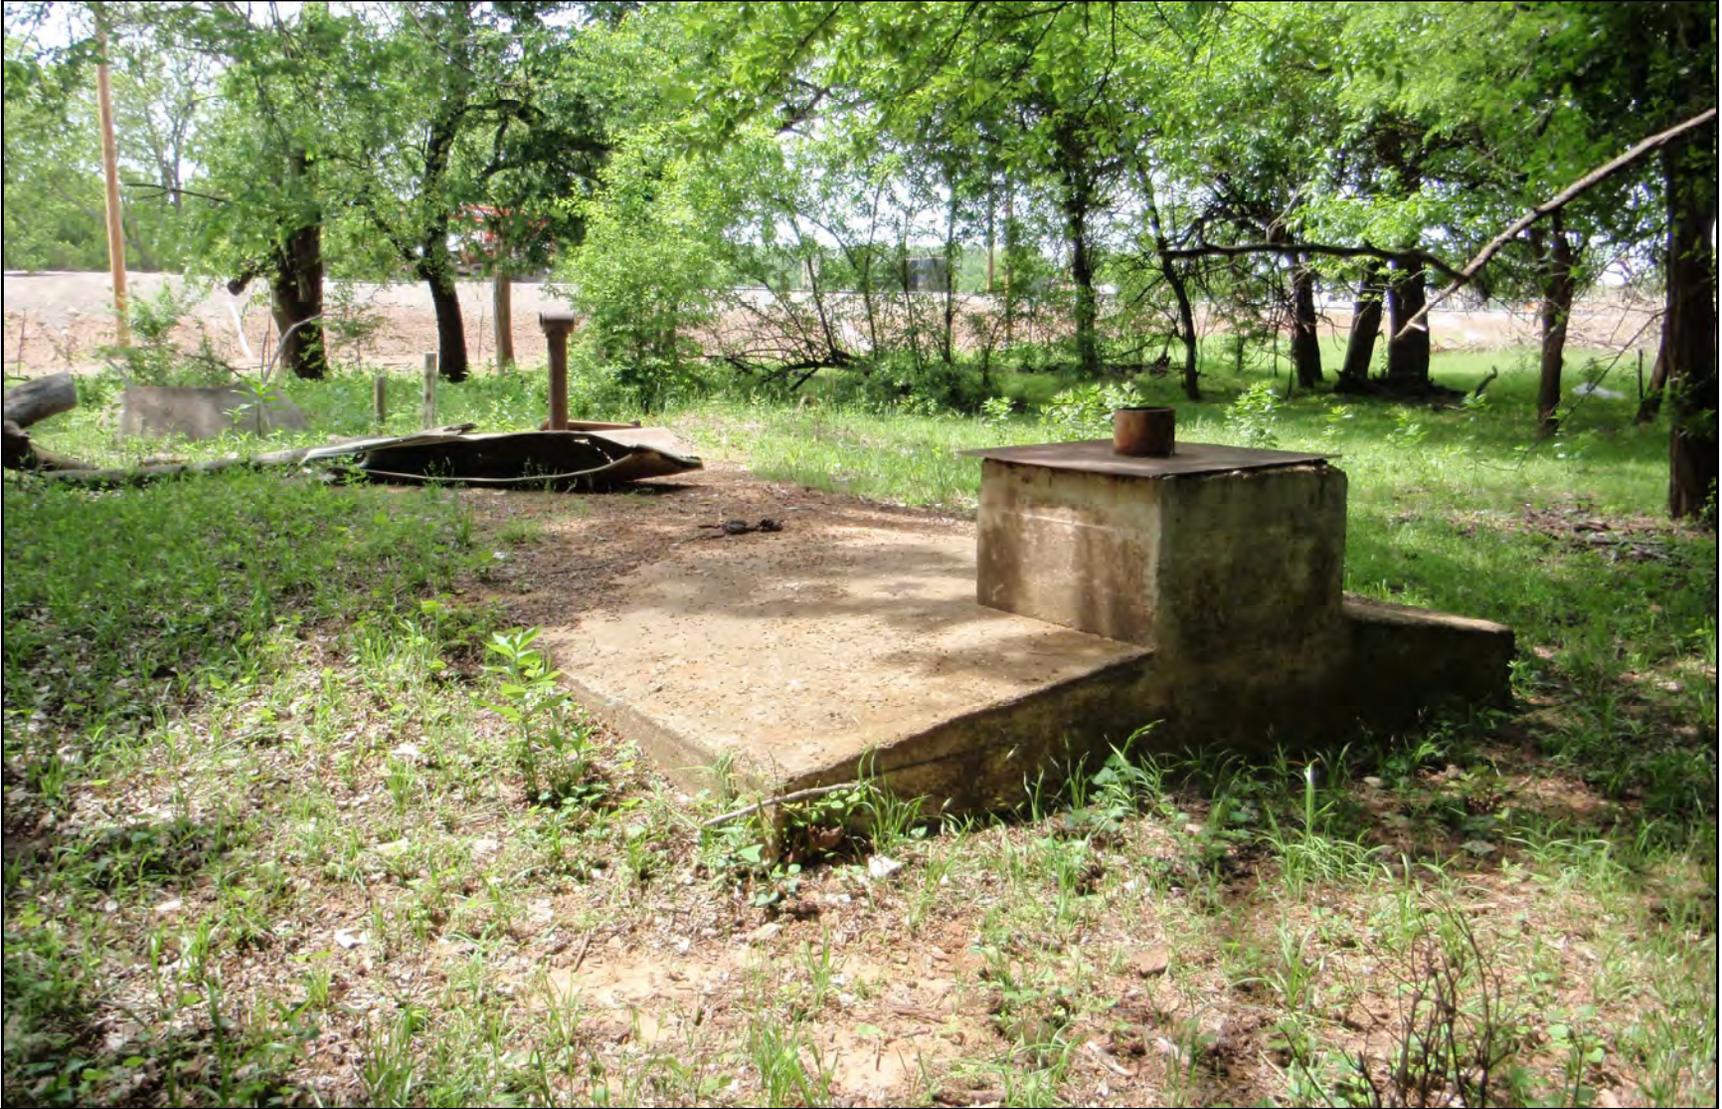
Figure A105

View of storm shelter at schoolhouse.

The school house foundation is approximately 20 x 30 ft
The storm cellar is constructed of reinforced concrete and approximately 10 x 17 x 12 ft with a narrow stairwell leading in. A coal/wood stove is at the rear of the cellar.

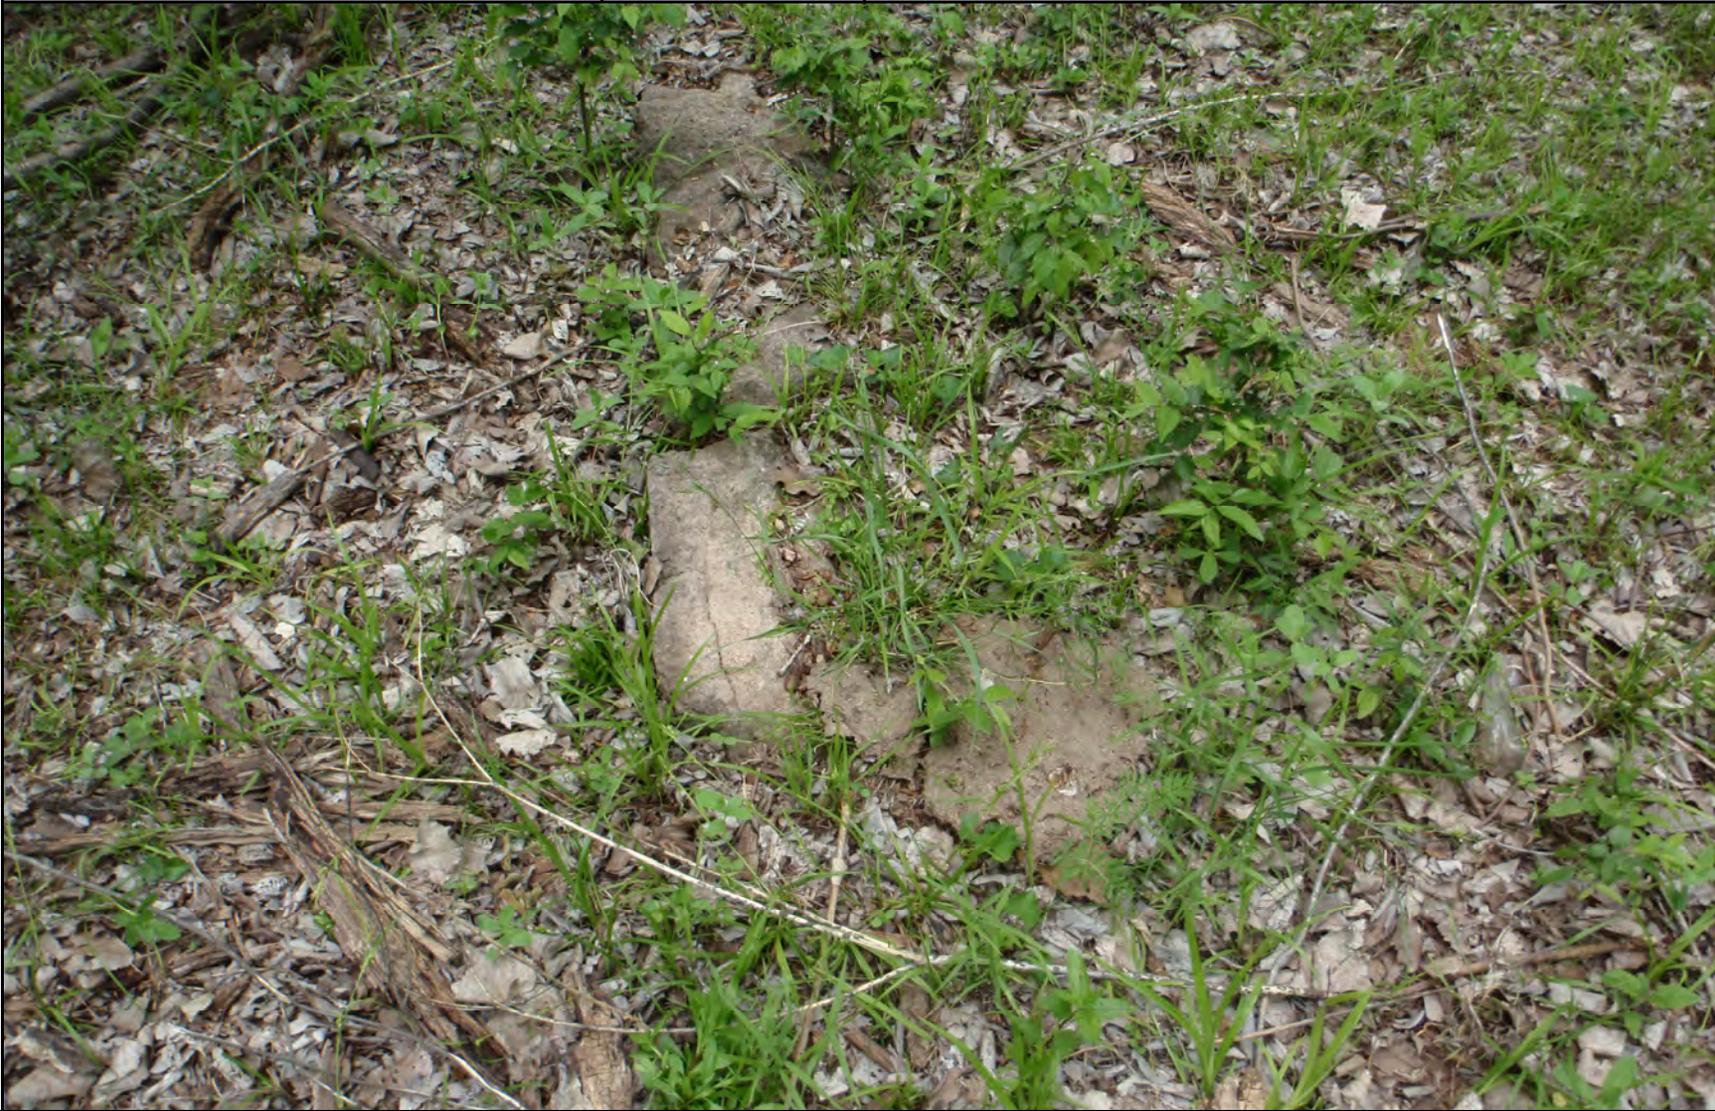
Figure A106

View of footer at schoolhouse.

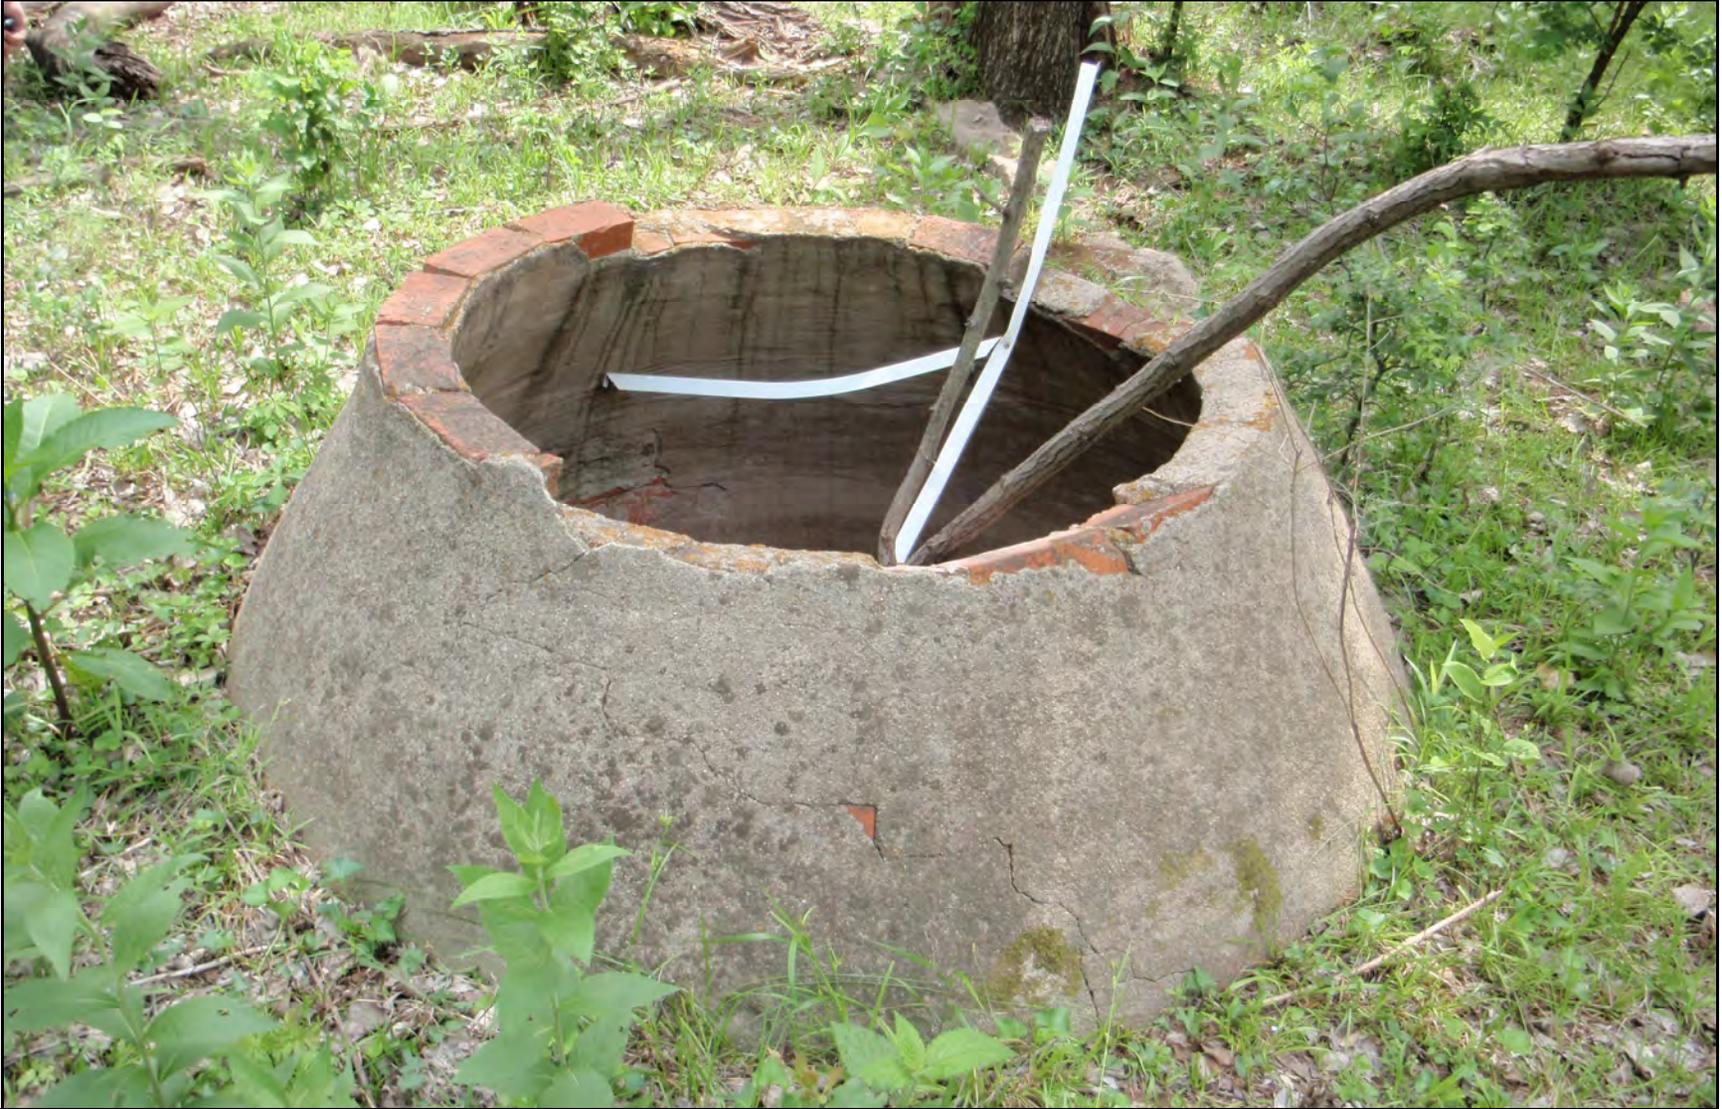
Figure A107

View of well or cistern at schoolhouse.

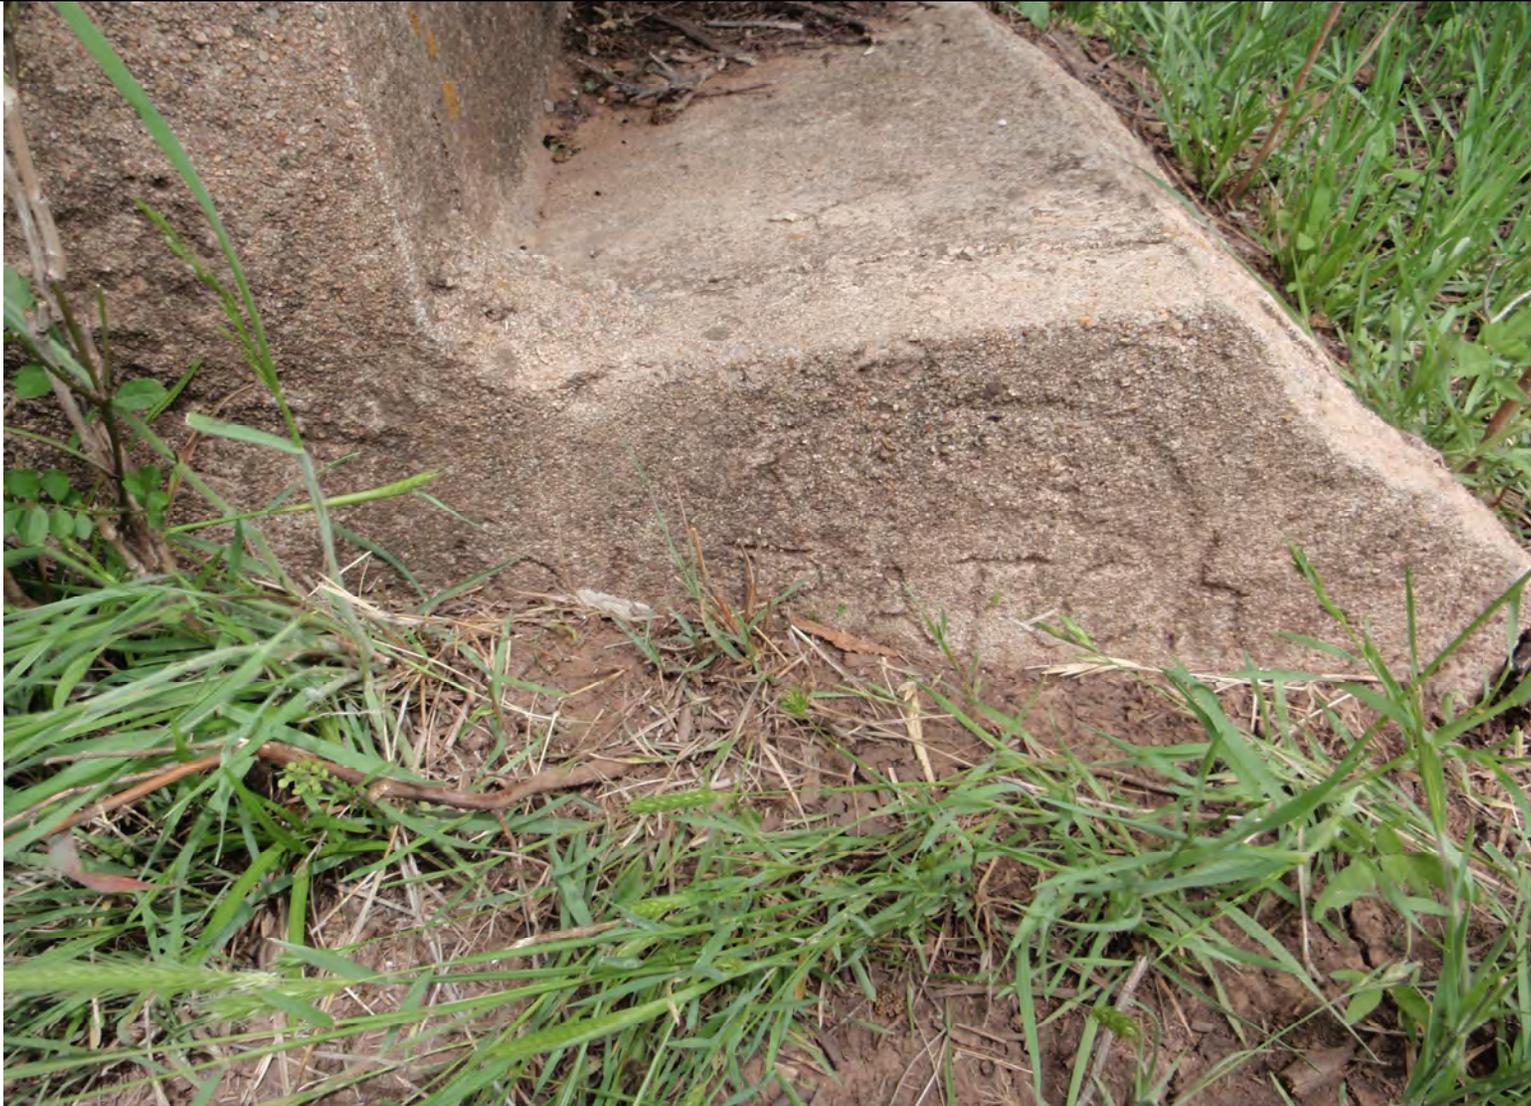
Figure A110

View of footer at grandstands showing "101 RANCH" written in the concrete surface.

Type	Count	Comment
Historic Glass	0	
Historic Metal	0	
Historic Ceramics	0	
Faunal/Bone	0	
Charcoal	0	
Other	1	No artifacts were observed on the surface or while uncovering the footings with the exception of a large concrete block that had “101 Ranch” inscribed in it.

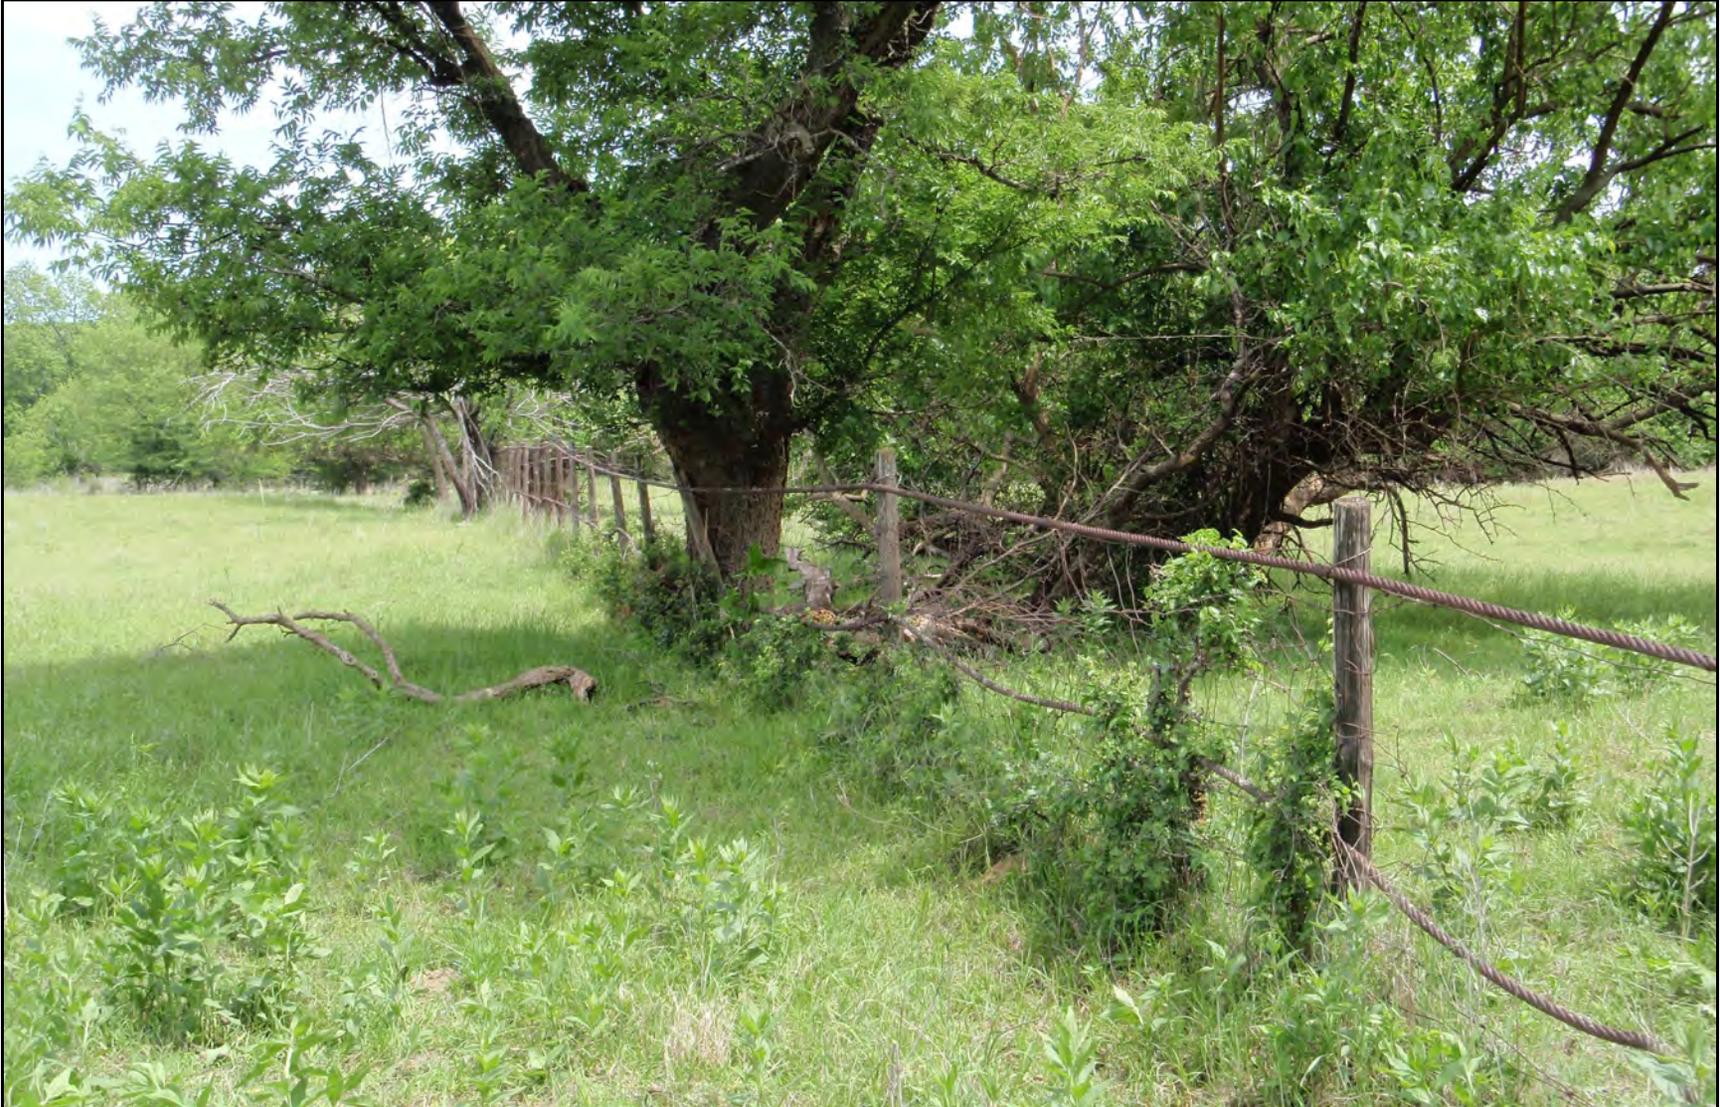
Figure A112

View of fence that once surrounded the Round-Up arena

Located midway to the east on the east-west axis, a two-cable fence extended from the grandstand footings. The cable is identical to a partially exposed buried cable that was observed in the summer camp area. East of the end of the footings, the two-cable fence and hog wire were still standing.

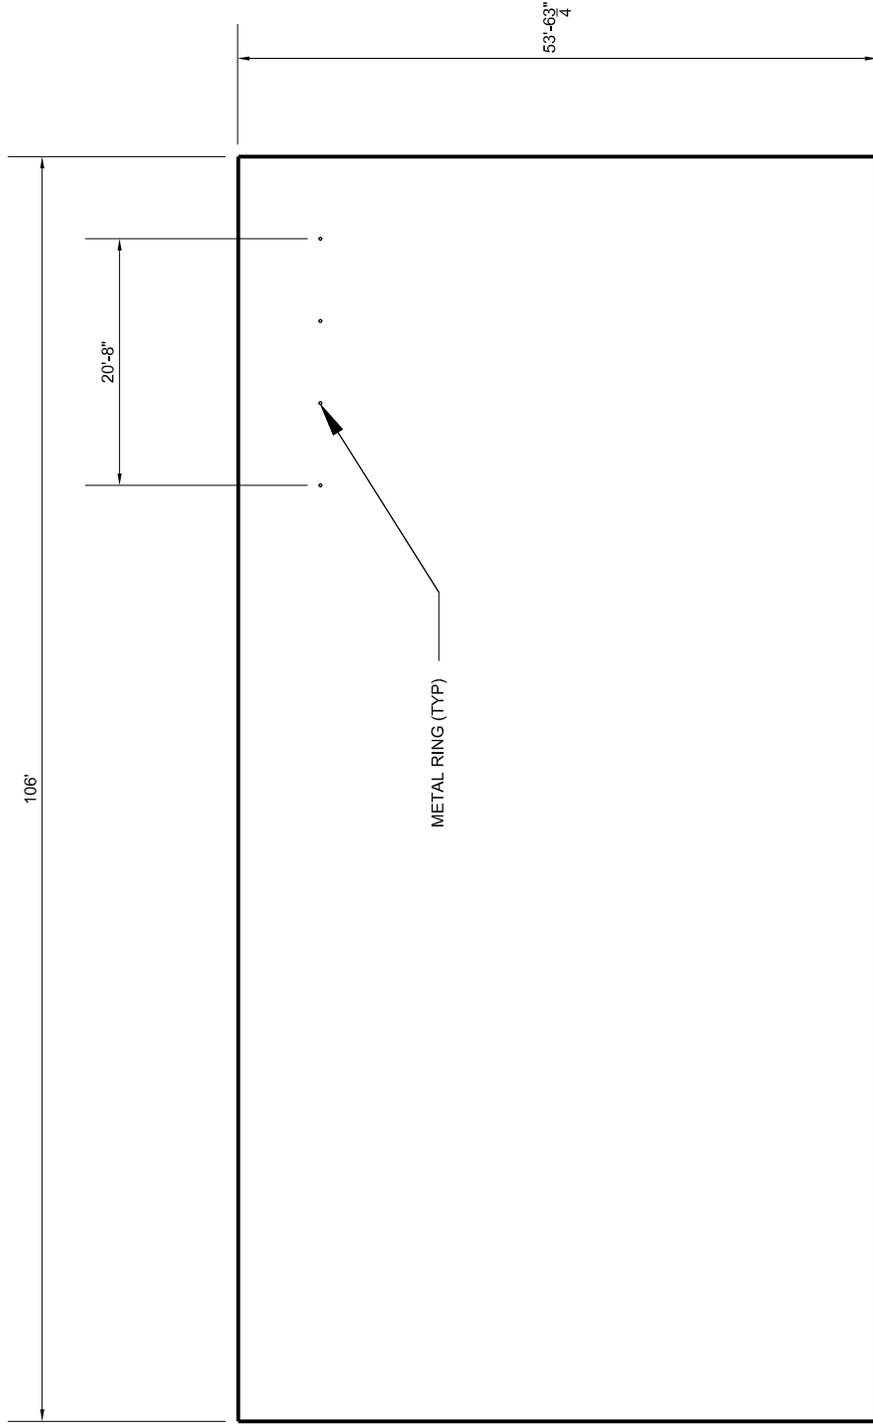
101 MILLER RANCH
GRANDSTANDS
1/64" = 1'-0"

The Round-Up Grandstands and Arena area are situated on the east side of SH 156, located in a cow pasture allowing good visibility of the ground surface for exposed features. The grandstand footings, a slab foundation, and a two-cable fence.were located and recorded.
