# Fracture Critical Bridge Inspection Report

NBI Bridge No.: 04085

Route U.S. 281 over S. CANADIAN RIVER  
Canadian County

Re: Fracture Critical Bridge Inspection Report  
Structure No.: 0902 0000 X  
NBI No.: 04085  
US 281 over South Canadian River  
ODOT Field Division 4, Canadian County

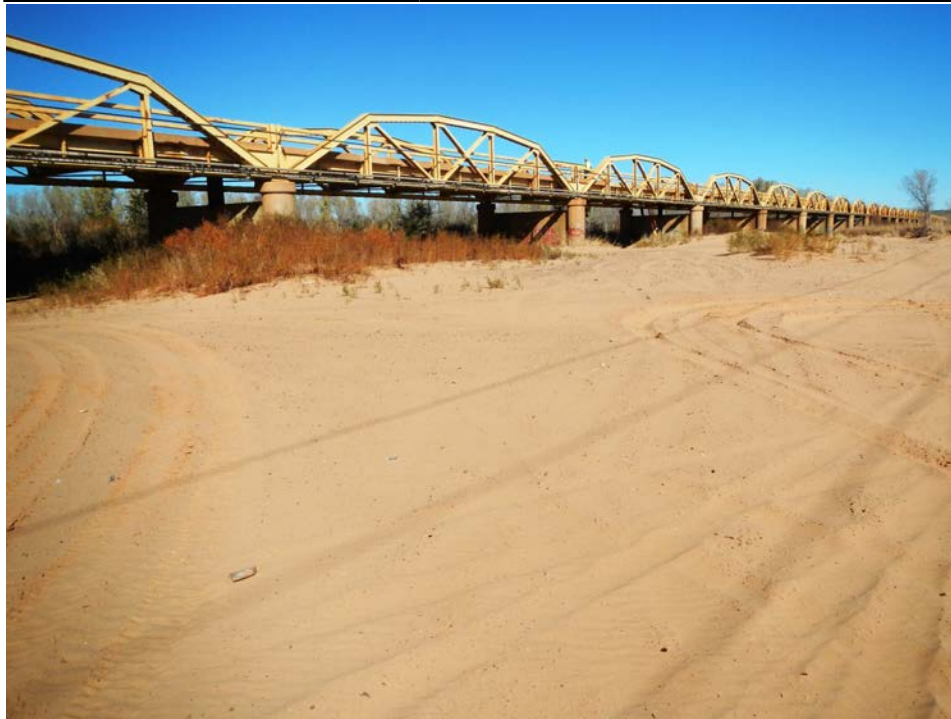
Photograph 1 - Elevation looking northwest.

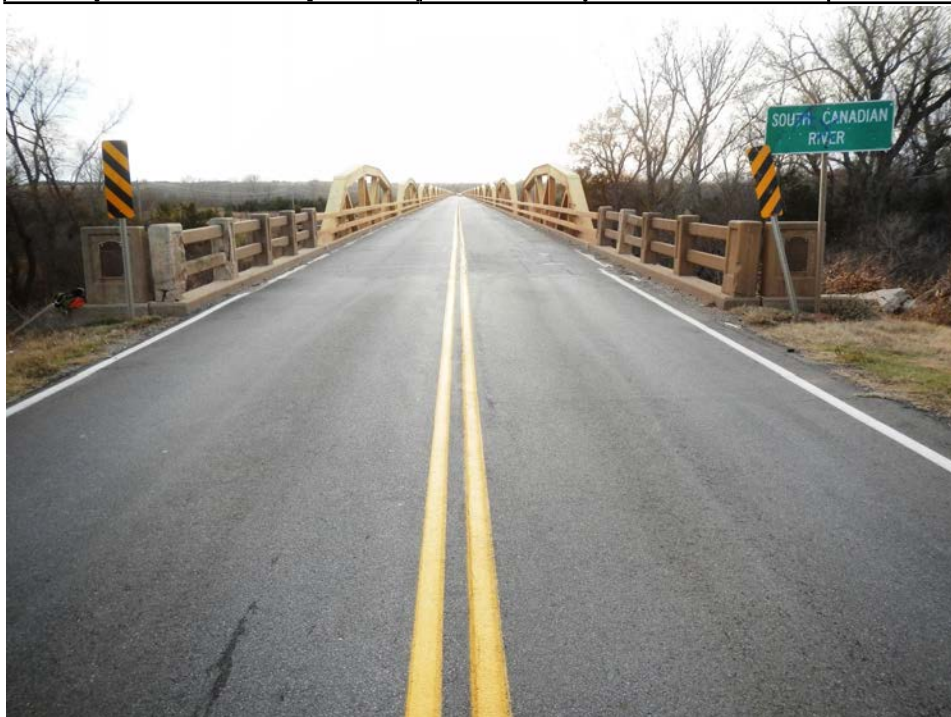
Photograph 2 - End view looking south.

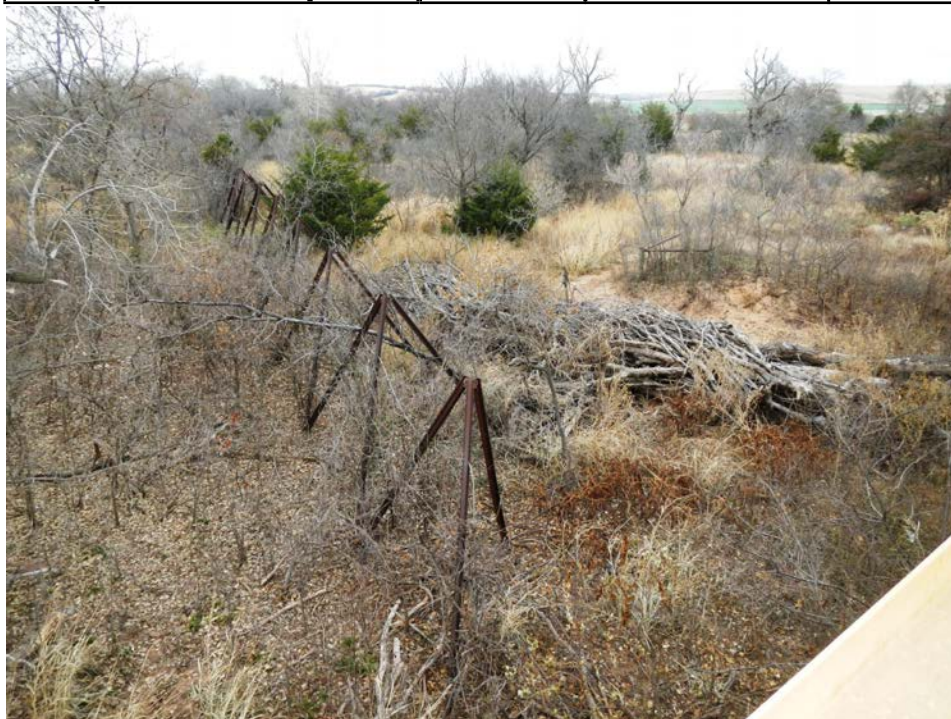
- **PX** – Local scour was observed around piers 7 through 9. The scour hole at pier 9 measured 12 to 16 feet deep measured to the top of the column foundations.
- Riprap has been installed around the north abutment and a drift fence consisting of tripods composed of railroad rails and cable exists northwest of pier 38 (**photo 46**).

Photograph 46 - Looking northwest at drift fence installed upstream (west) of pier 38.

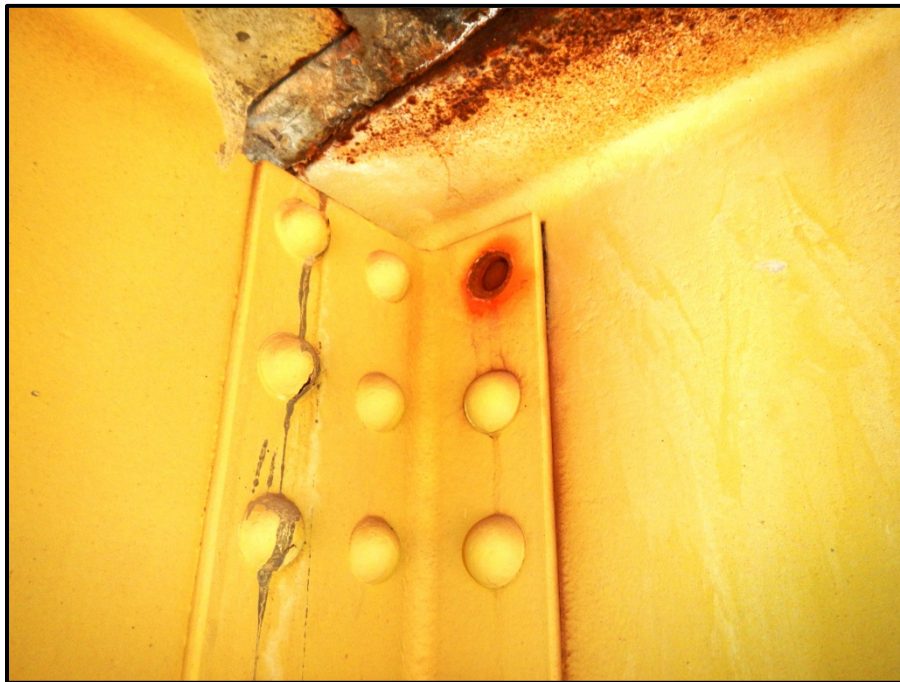
Photo 14

Broken rivet heads where the rivet shank is no longer effectively within the shear plane between the connection angle and the floor beam web exists at the following locations:
