Consulting Party Meeting

US-281 Bridgeport Bridge over the
South Canadian River

Friday June 26, 2015

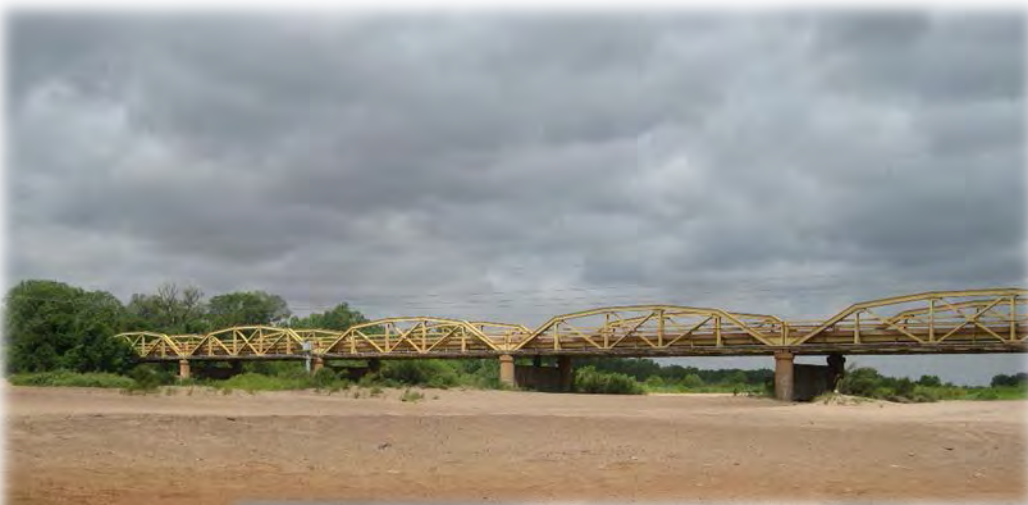
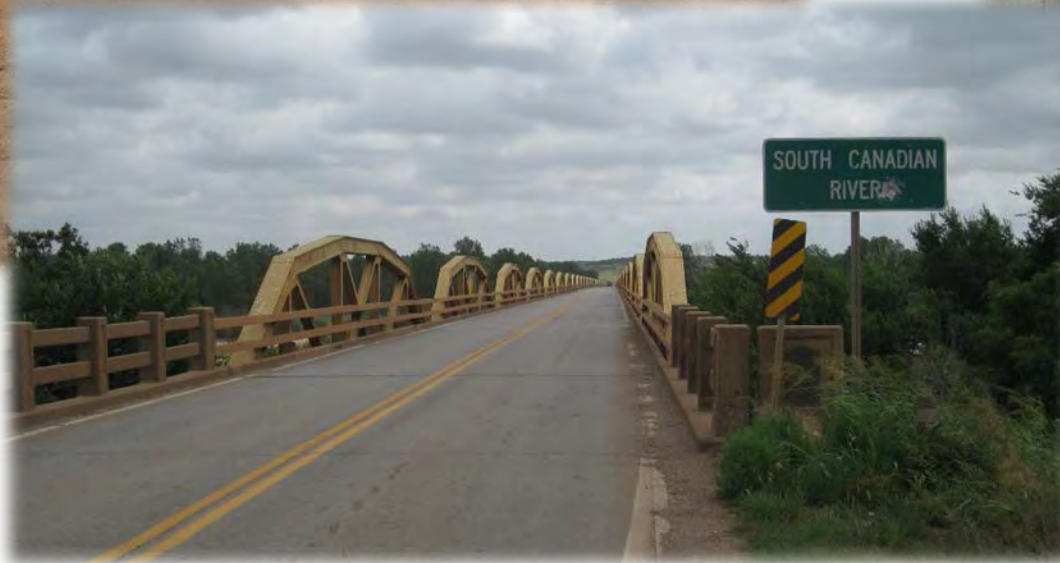
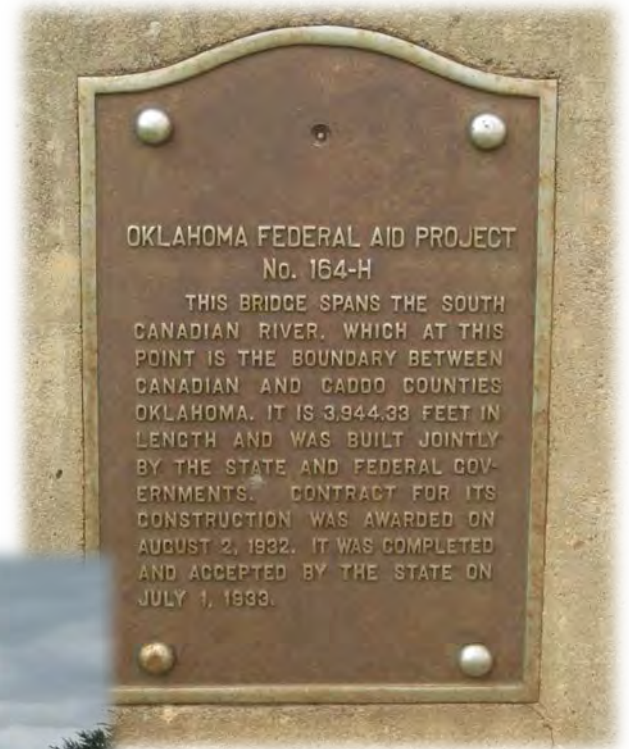
US-281 Bridge over South Canadian River:

- Also known as:
 - **The Bridgeport Bridge*
 - The Grapes of Wrath Bridge
 - The William H. Murray Bridge
 - “The Pony Bridge”
- Constructed in 1932-1933, put into use in 1934
- 38-Span Camelback Pony Truss Bridge, 2nd Longest Bridge still in existence in Oklahoma
- A contributing feature of the NRHP-listed 17.7-mile-long Bridgeport Hill-Hydro Route 66 Segment Historic District AND is individually eligible
- **Arguably the most historically significant bridge still standing in Oklahoma**

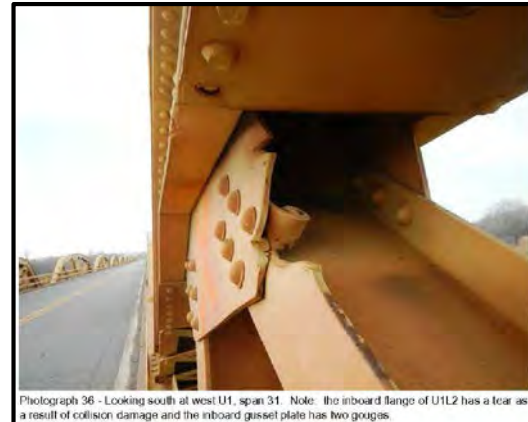
Photograph 36 - Looking south at west U1, span 31. Note: the inboard flange of U1L2 has a tear as a result of collision damage and the inboard gusset plate has two gouges.

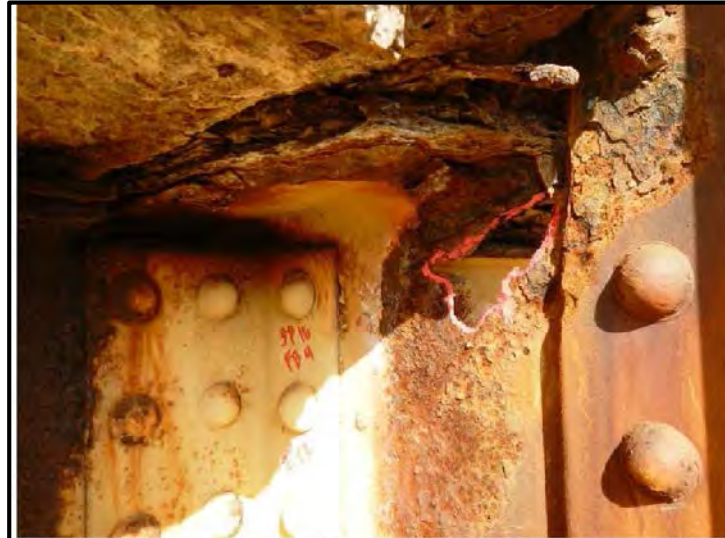
Photograph 23 - Looking northeast at floor beam 4, span 16 at the east truss connection. Note: 3 1/2-inch vertical by 4 1/4-inch horizontal corrosion hole through the floor beam web at the connection to the truss.

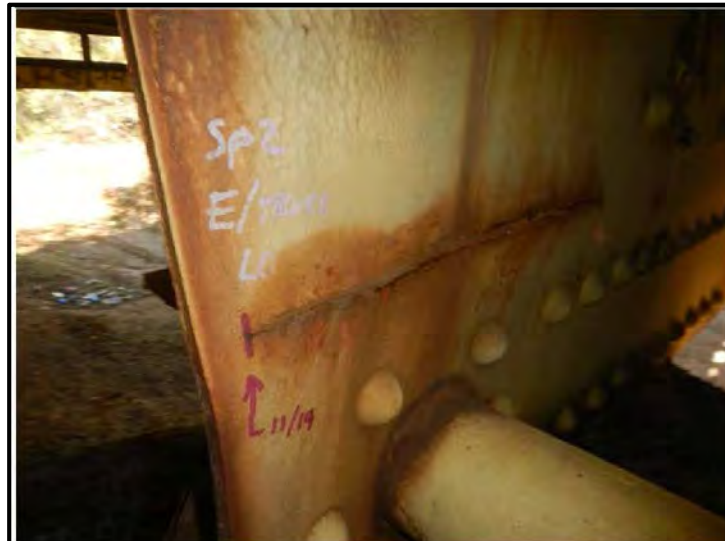
Photograph 14 - Looking northwest at span 2, L0, east truss, inboard gusset plate. Note: Crack has grown 5 7/8 inches since 2013 bringing the crack to 15 1/8 inches total length.
